# **HVS-NORDIC**

The activity of the first period in Finland 1997 - 1999

Finnra Reports

21/2000

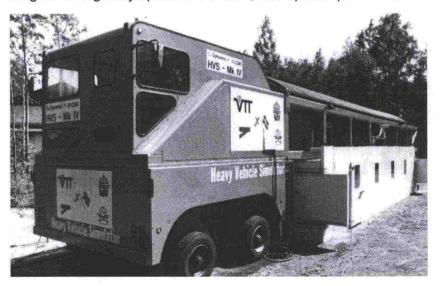
Figure 1. HVS-NORDIC accelerated testing facility.

The machine is called HVS-NORDIC. The HVS Mark IV is a mobile full-scale accelerated pavement-testing facility (Figure 1), whose loading is linear. It can be run over a short distance by itself at walking speed, in practice only at the same test site. It can be moved as a semi-trailer over longer distances to other test areas or to VTI in Sweden. Since it has steering wheels, it can turn even relatively sharp corners, in spite of its long length. Its highway speed is 50 km/h, and special permits are needed.

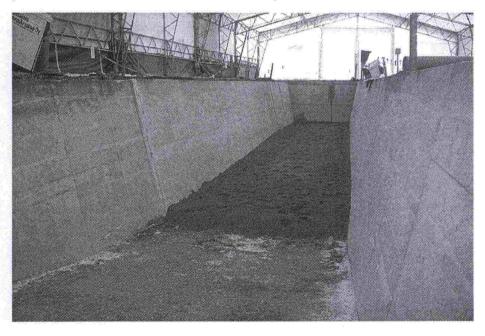
Figure 2. Concrete pool in Otaniemi.

The test site is located a few hundred metres from the office of VTT's personnel. The site is smaller than planned because of the problems with the city planning office. The site includes two test pits. One test pit is made of concrete, the walls have thermal insulation and there is complete water table regulation. Its length is 36 m including a 16-m-long slope. Its depth is 2.5 m and its width 4 m at the top and 3 m at the bottom. There is a 3x3 m part of the test pit that is 4.5 m deep for special studies. Two or three test pavements can be constructed in a test pit.

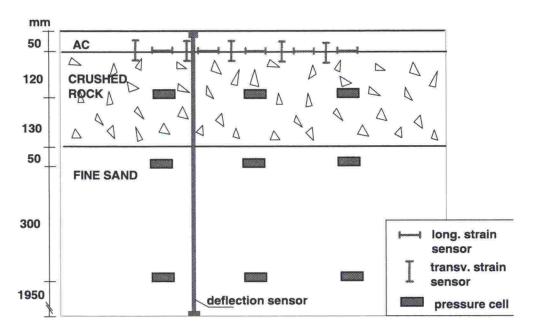
Figure 3. Instrumentation plan.

Stress in unbound layers is measured with stress sensors that have been bought from the University of Nottingham. These are installed three at the same level (triplicates because the installation may sometimes cause some problems). The height levels are in the middle of the base course and 100 mm and 350 mm in the subgrade.

Deflection under the moving wheel load is measured by a deflection rod anchored at the bottom of the subgrade near the concrete or rock bottom.

The position of the sensors is shown in Figure 3.

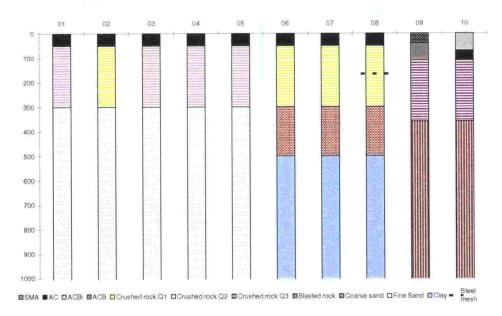
Figure 4. Test sections in Finland for the years 1997-1998. The abbreviations are described on page 3.

Test section 01 is the thin reference pavement. This is a typical pavement for low-volume roads in Finland. The research idea was first to study the lifetime and deterioration process of this common pavement. The purpose was also to gain experience of the facility and to complete the first test in reasonable time, within few weeks.

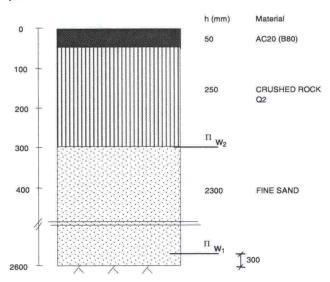
Figure 5. The structure of test 01.

The test had the basic instrumentation without deflection gauge. Response measurements were taken in the beginning of the test (initial measurements) and during loading.

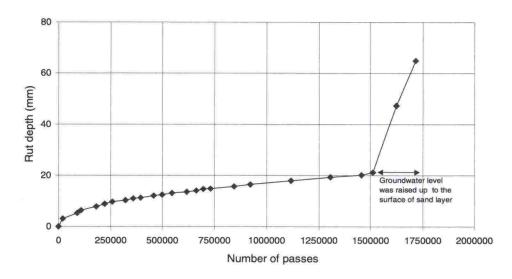
Figure 6. Rut depths vs. number of passes during test 01.

The development of ruts can be seen in Figure 6. It lasted for 1.6 million repetitions without cracks, only 25-mm rutting was found.

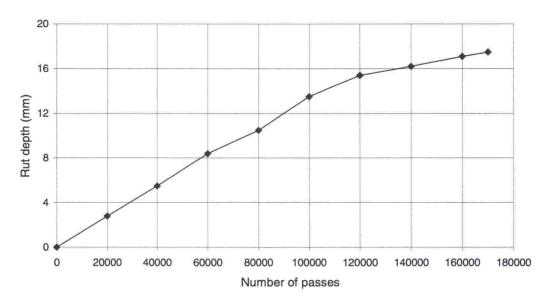
Figure 8. Rut depths vs. number of passes during test 02.

After 0.17 million passes only 18 mm rutting could be seen but no cracks (Figure 8). After these loadings, the test had to be stopped and thawing test constructions were made in the same test pool.

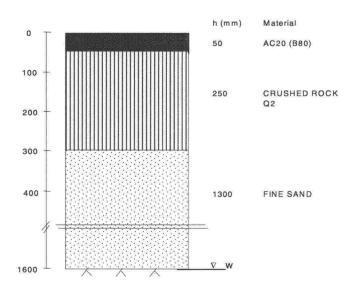
Figure 9. Structure of test 03.

The third test structure was constructed in test pit no. 2 (rock pool) in Otaniemi (Figure 9).

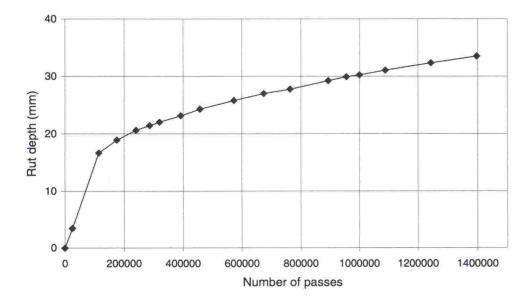
Figure 10. Rut depths vs. number of passes during test 03.

In the beginning of the test, rut depth increased very much but after 0.2 million loadings, rutting increased slowly but linearly (Figure 10).

The first crack was found after 0.9 million load repetitions. Loading was continued up to 1.4 million passes in anticipation of many cracks. However, after the first crack, only two more cracks were found and they did not get wider during the test. All these cracks were longitudinal and the length was about 0.4 m.

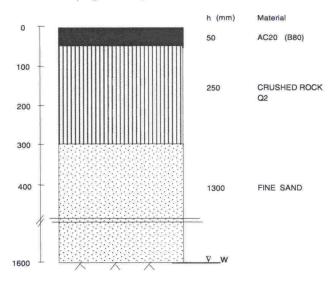
Figure 11. Structure of test 04.

The fourth test structure was constructed in test pit no. 2 (rock pool) in Otaniemi (Figure 11).

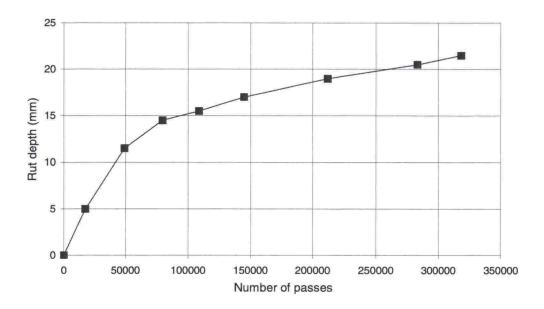
Figure 12. Rut depths vs. number of passes during test 04.

In the beginning, up to 75 000 load repetitions, rut depth increased very much (Figure 12). After that, rutting increased slowly but linearly. No difference was found in rutting during tests 03 and 04 although the loading mode (uni-/bi-directional) was different. The test was interrupted after 0.32 million load repetitions, because the HVS had to be moved to load thawing tests at that time.

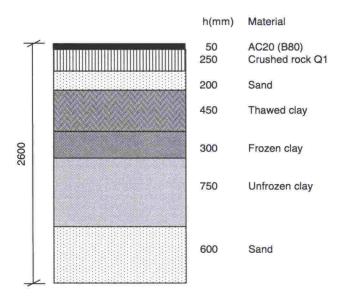
Figure 14. Structure of test 06.

The sixth test structure was constructed in test pit no. 1 in Otaniemi (Figure 14). The research idea was that the subgrade was made of frost-susceptible material. Above it was a thin (0.50 m) pavement with a 50-mm asphalt concrete (AC) surface layer. It was planned to freeze and thaw the subgrade so that the thaw-weakening conditions would correspond to the natural state. The road was frozen to about 1.5 m depth during winter. Before HVS testing, the pavement was thawed to a depth of 0.9 m from the surface (most critical situation in subgrade).

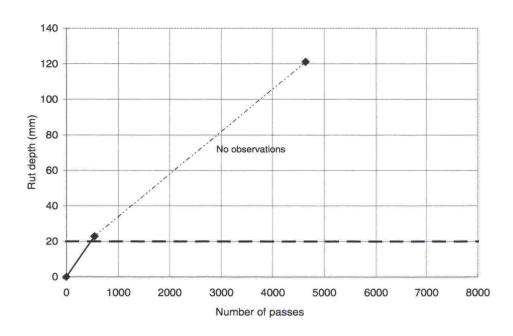
Figure 15. Rut depths vs. number of passes during test 06.

The test wheel load was 50 kN. The rut depth reached 40 mm in about 1 250 overpasses (Figure 15). The wheel load that was used was high regarding the bearing capacity of the frost-susceptible pavement. The test wheel speed (10 km/h) was low in comparison with normal traffic speeds. Thus, the load impacts took a longer time, and the loading effect in the subgrade was long-term. This caused a fast development of rutting and cracks.

Because the overlay was relatively thin, the critical location for deformation was the surface of the soft subgrade. The material modulus of thawed clay was low, so deflections under the wheel loads were high. The majority of the elastic and plastic deformations developed in the thawed clay. Tensile stress and strains at the bottom of the asphalt concrete exceeded material strength. This caused a fast development of cracks at the bottom of the bound layer and fast deterioration of the overall pavement.

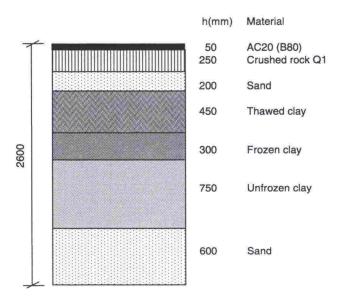
Figure 16. Structure of test 07.

The seventh test structure was constructed in test pit no. 1 in Otaniemi (Figure 16). The subgrade was made of the same frost-susceptible material as previously, but this area was tested with a lower wheel load. The road was frozen to about 1.5 m depth during winter. Before HVS testing, the pavement was also thawed to a depth of 0.9 m from the surface (the most critical situation in subgrade).

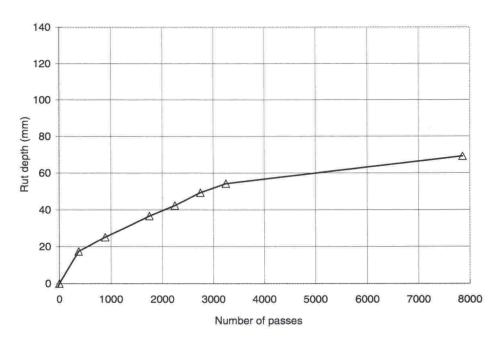
Figure 17. Rut depths vs. number of passes during test 07.

With the unidirectional dual wheel load of 40 kN, this un-reinforced test road constructed on frost-susceptible subgrade reached a rut depth of 40 mm in about 2 050 overpasses (Figure 17).

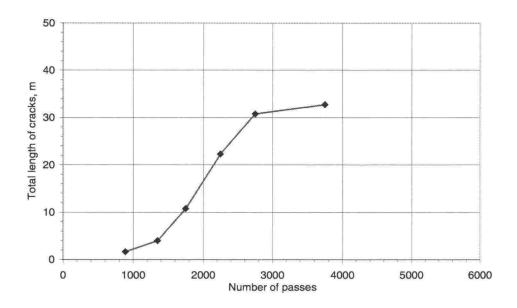
Figure 18. Total length of AC's surface cracks vs. number of passes.

Tensile stress and strains at the bottom of the asphalt concrete exceeded material strength. This caused a fast development of cracks at the bottom and surface of the bound layer (Figure 18).

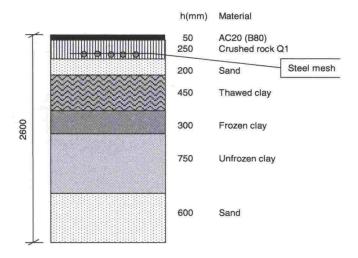
Figure 19. Structure of test 08.

The eighth test structure was constructed in test pit no. 1 in Otaniemi. The subgrade was made of the same frost-susceptible material as previously, but in this area, a reinforcing steel mesh was installed in the base layer (Figure 19). The road was frozen to about 1.5 m depth during winter. Before HVS testing, the pavement was also thawed to a depth of 0.9 m from the surface (most critical situation in subgrade).

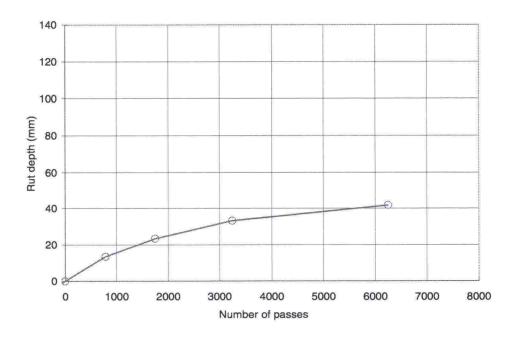
Figure 20. Rut depths vs. number of passes during test 08.

The test load was 40 kN. On the reinforced area, for the rut depth of about 40 mm the number of overpasses was about 4 600 (Figure 20). The results showed about twice as good wheel load capacity for the steel mesh reinforced section compared to that without steel reinforcement.

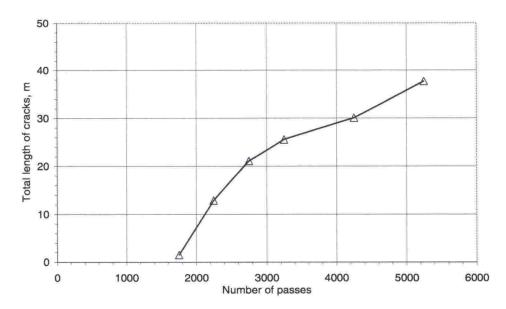
Figure 21. Total length of AC's surface cracks vs. number of passes.

Cracking versus the number of passes is presented in Figure 21. One can see that cracks appear on the road surface later than in the case without steel reinforcement in the base layer.

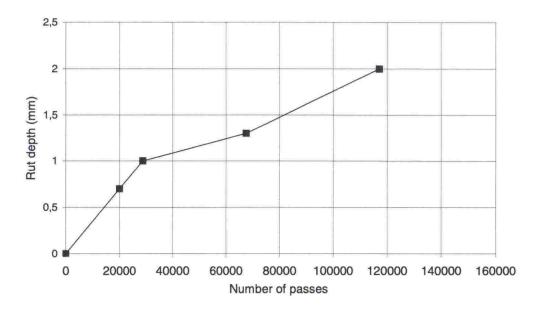
Figure 23. Rut depths vs. number of passes during test 09.

After initial response measurements only 0.14 million loadings were done in this test because the HVS chain broke. Very little rutting could be seen on the road surface (Figure 23) and naturally no cracks.

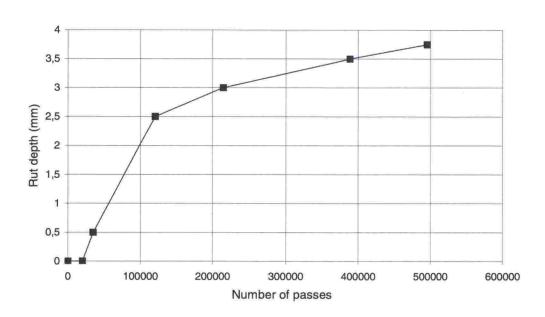
Figure 25. Rut depths vs. number of passes during test 10.

After the initial response measurements, only 0.5 million loadings were done in this test. Less than 4-mm rutting could be seen on the road surface (Figure 25) and naturally no cracks. This test was interrupted because the HVS was transported to Sweden for the VTI tests.

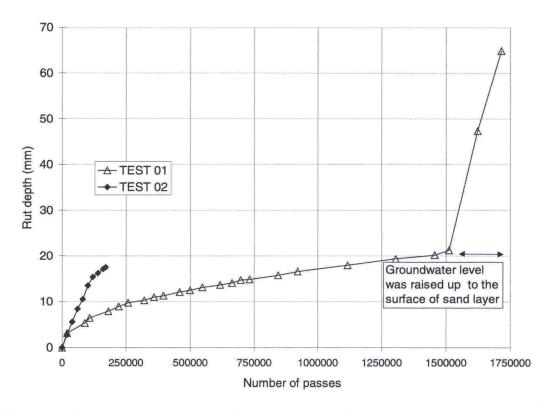
Figure 26. Rut depths vs. number of passes, test 01(low-quality base, 60 kN dual wheel load) and test 02 (high-quality base, 80 kN dual wheel load).

The number of expected passes needed to deteriorate pavement 01 was about 250 000, based on theoretical calculations and VTT experience from the OECD test in Nantes 1990, in which VTT participated /2/. However, the section lasted for longer. This was because section 02 was loaded with 80 kN wheel load for only 0.17 million passes due to the lack of time. The effect of the quality of base layer material in dry circumstances (water-table level 2.3 m from road surface) is very little. The difference in rutting (Figure 26) between the sections is because of different wheel loads

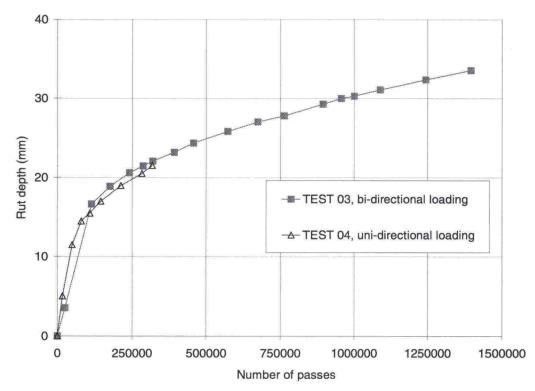
Figure 27. Rut depths vs. number of passes, test 03(70 kN single-wheel load, bi-directionally) and test 04 (70 kN single-wheel load, uni-directionally).

No difference was found in rutting during tests 03 and 04, although the loading mode (uni-/bi-directional) was different (Figure 27). Therefore, it is reasonable to use the bi-directional loading mode to double the load repetitions in the set time.

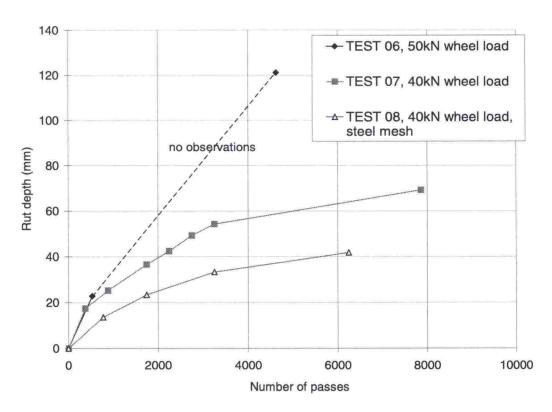
Figure 28. Rut depths vs. number of passes, test 06 (50 kN dual wheel load unidirectionally), test 07(40 kN dual wheel load uni-directionally) and test 08 (steel reinforced structure, 40 kN dual wheel load uni-directionally).

The tests 06-08 were so called thawing tests. The structures of the tests 06-08 were similar to each other, except for 08 which was reinforced with steel mesh in unbound base layer. Subgrade was made of the frost-susceptible material. The road was frozen to about 1.5 m depth during winter. The structures were loaded by HVS when the pavement was thawed to a depth of 0.9 meter from the road surface (most critical situation for road).

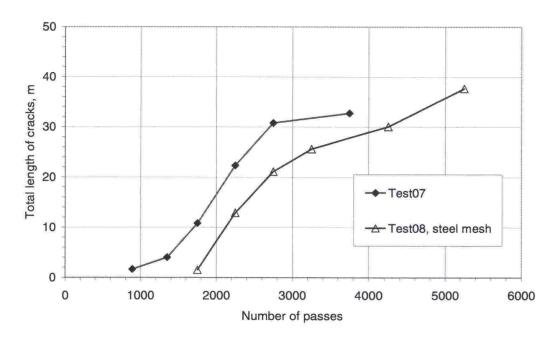
Figure 29. Crack length vs. number of passes, test 07(40 kN dual wheel load uni-directionally) and test 08 (steel-reinforced structure, 40 kN dual wheel load uni-directionally).

The steel mesh reinforced section also exhibited better resistance against cracking. The cracks appeared on road surface later than in the case without steel reinforcement in the base layer (Figure 29).

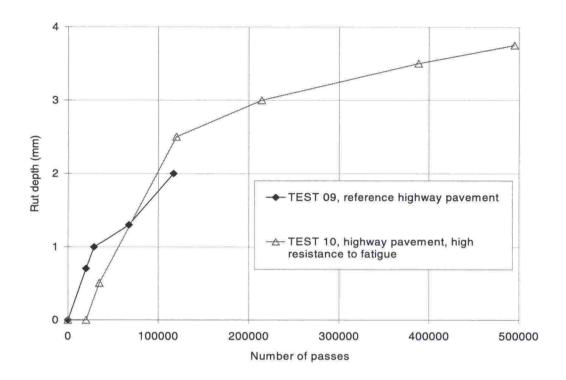
Figure 30. Rut depths vs. number of passes, test 09 (conventional structure) and test 10 (innovative structure, high resistance to fatigue), 60 kN dual wheel load for both tests.

After the initial response measurements, only 0.50 million loadings were done in test 10. Less than 4-mm rutting could be seen on the road surface (Figure 30) and naturally no cracks. These tests were interrupted because the HVS was transported to Sweden.

However, the structures could be compared to each other. Based on the response measurements and laboratory fatigue criteria, the innovative structure had 30 times better resistance to traffic loading. However, the construction costs of the bituminous layers were only 10 % higher for the innovative structure.

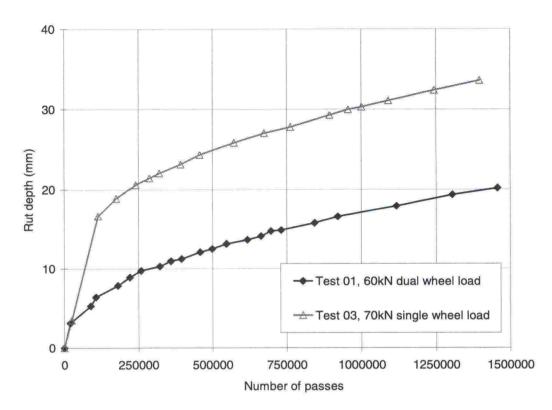
Figure 31. Rut depths vs. number of passes, test 01 ( 60 kN dual wheel load) and test 03 (70 kN single-wheel load).

Figure 31 presents the rutting of the two tests. The road structures are similar but test 01 was loaded with 60 kN dual wheel, and test 03 with 70 kN single-wheel (Table 6). In the latter case, rutting is about double compared to the former. In test 03, also a few cracks were found after 0.8 million loadings.

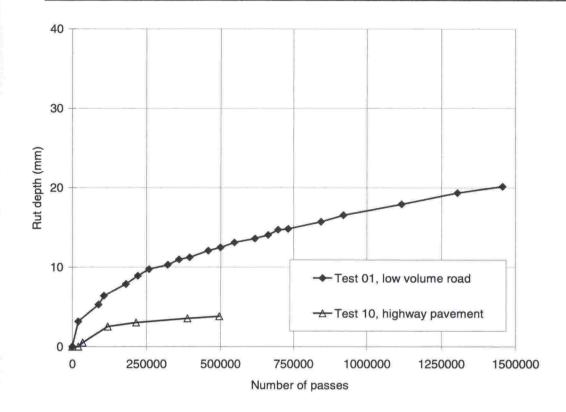
Figure 32. Rut depths vs. number of passes, test 01 (50-mm bituminous layers, 60 kN dual wheel load) and test 10 (110-mm bituminous layers, 60 kN dual wheel load).

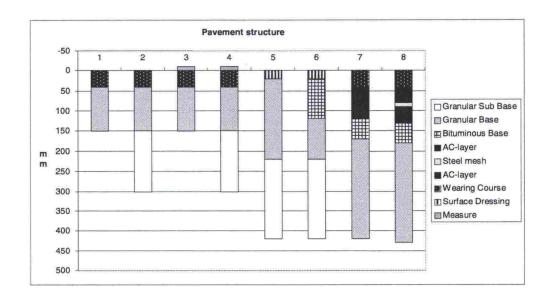
Figure 34. HVS pavement structures in Sweden 1998-2000.

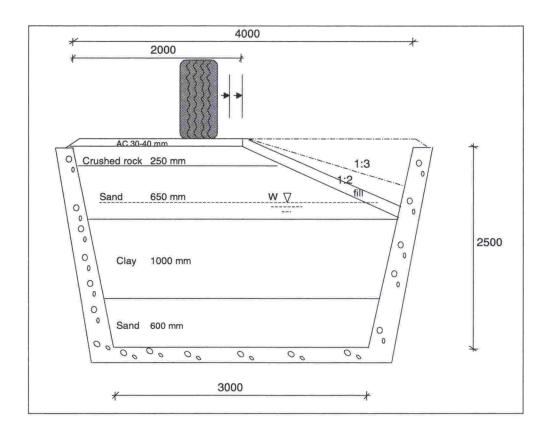
Figure 35. HVS pavement structures in Low volume road research project in Finland 2000 - 2001.

In the second period in Finland, one reinforced (in unbound layer) structure (as apart of EC project REFLEX) will be constructed and tested. A similar structure without steel reinforcement is planned for testing. The third planned pavement structure in the same test pool includes also light weight material (expanded polystyrene, EPS). These three pavements have thin bituminous layers and are for low-volume roads.

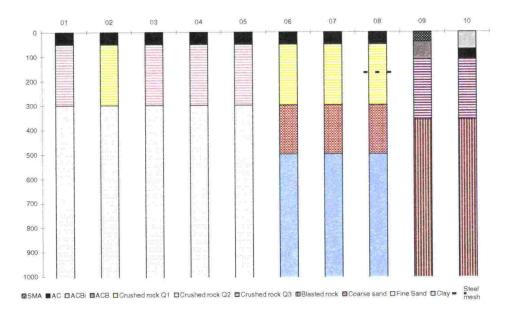
Figure 4. Test sections in Finland for the years 1997-1998. The abbreviations are described on page 3.

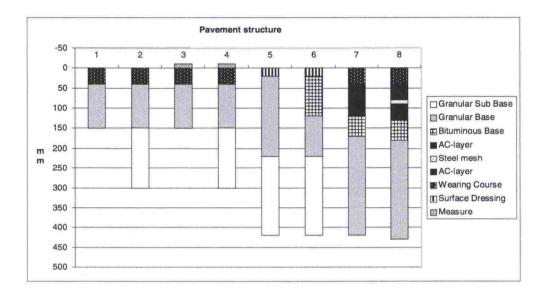
Figure 34. HVS pavement structures in Sweden 1998- 2000.

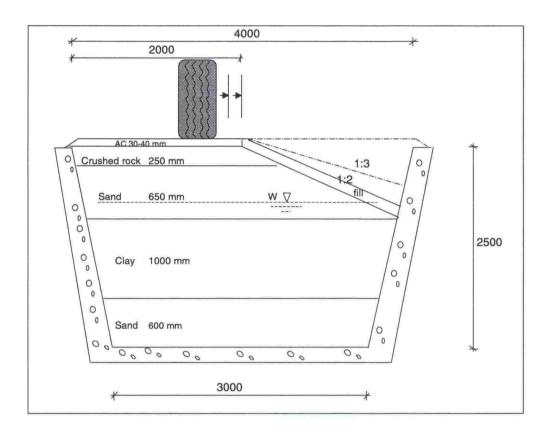
Figure 35. HVS pavement structures in Low volume road research project in Finland 2000 - 2001.

In the **second period in Finland**, one reinforced (in unbound layer) structure (as apart of EC project **REFLEX**) will be constructed and tested. A similar structure without steel reinforcement is planned for testing. The third planned pavement structure in the same test pool includes also light weight material (expanded polystyrene, EPS). These three pavements have thin bituminous layers and are for low-volume roads.
