Reinforcement of the edge of a steep-sloped pavement

HVS-Nordic Heavy Vehicle Simulator test structures

Finra Reports 38/2003

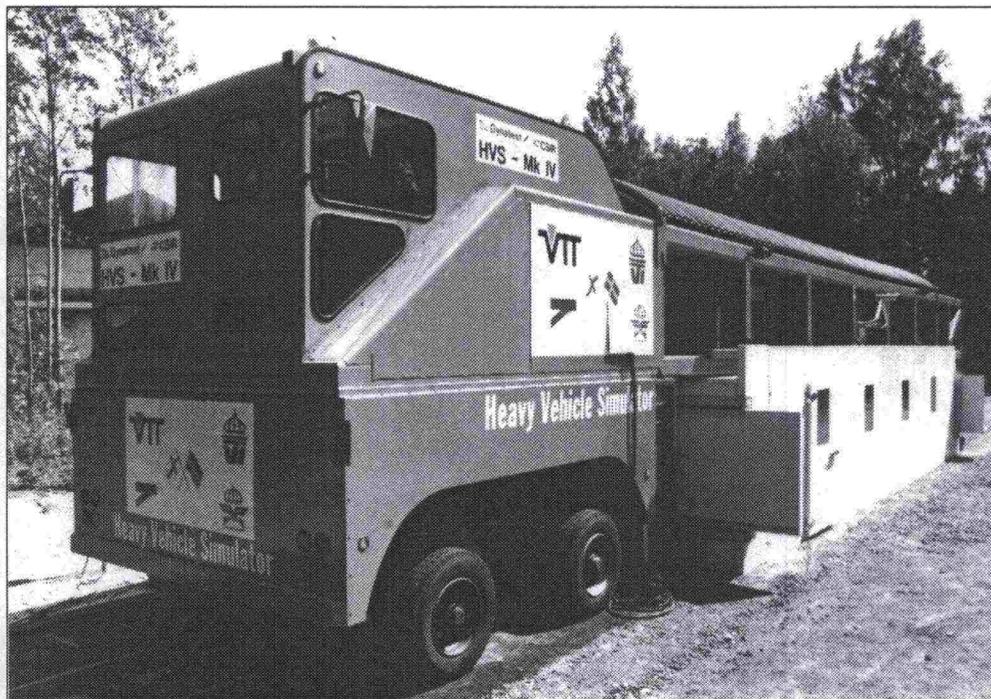
Figure 1.1. The Heavy Vehicle Simulator (HVS).

The Heavy Vehicle Simulator (HVS) is 23 m long, 3.7 m wide, 4.2 m high and its total mass is 46 metric tons (Figure 1.1). The maximum width of HVS's loading area is 1.5 m. The total length of the loading area is eight metres, of which six metres can be used with even wheel load and speed. At either end of the loading area, a distance of one metre is necessary for accelerating and braking the wheel, and, in one-way application of load, for lowering and lifting the wheel to and from the surface. The speed of the wheel can be adjusted from 1 to 15 km/h. However, in long-term loading, the maximum speed is 12 km/h. Any distribution with 50 mm lateral adjustments can be selected as the lateral movement of the test wheel. The load can be applied either one-way or in both directions.

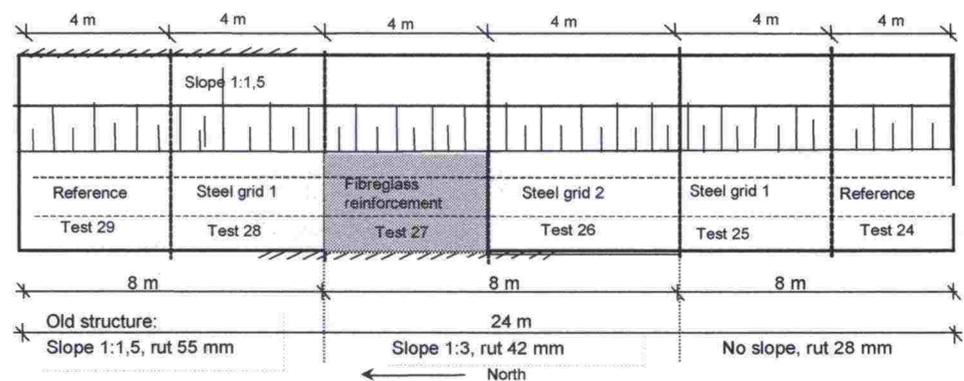
Figure 2.1. Test structures and their state before rehabilitation.

For this study, the 8-metre long test structures were divided into two 4-metre strips each, which could be directly compared. In order to obtain comparable results between the different structures, two identical pairs of structures were tested, each with steel grid 1 and an unreinforced reference structure. The numbers of these structures were 24 and 25, and 28 and 29. The middle structures were reinforced with another type of steel grid and fibreglass reinforcement. The structures were repaired by filling in the ruts and then spreading a new asphalt layer over the entire structure. The reinforcements used, the positions of the structures – also in relation to the old structures – and their numbering are presented in Figure 2.1 and Table 2.1.

In the Low-volume roads study, the structures were designed to correspond to the structure of low-volume roads. Due to the earlier tests, each of the structures was in a different condition. Figure 2.1. shows the new structures and the condition of the structures before rehabilitation. The rut in the steep-sloped structure (28–29) showed a noticeable longitudinal crack, several millimetres wide, towards the centre lane. The other structures showed little distress besides rutting, that is, only a few short, narrow cracks.

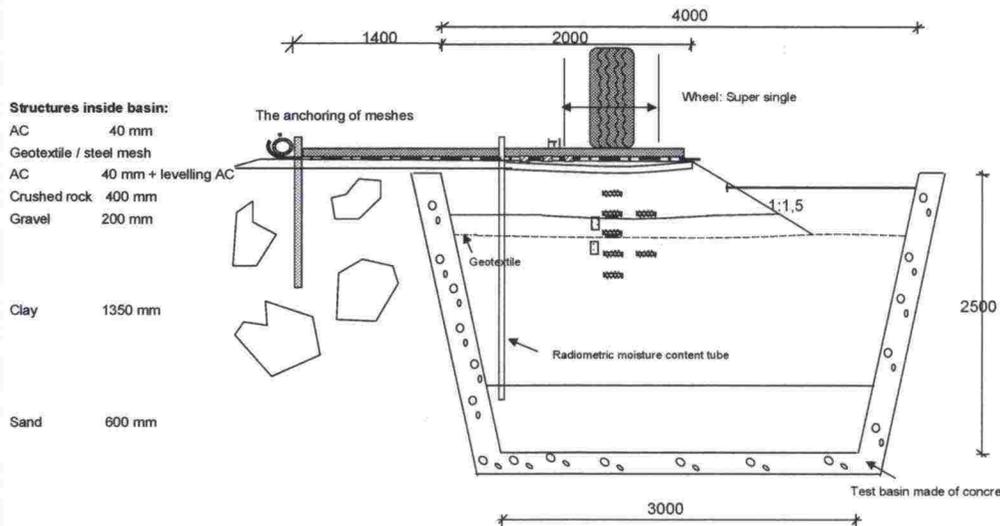
Figure 2.2. Cross-section of the test structure with the steep slope.

The standard cross-section of the test structures is presented in Figure 2.2. After the first phase tests were completed, the structures, which had rutted during the loading, remained outside unprotected over the winter 2001–2002. Towards the end of the previous testing phase, the tops of the topmost Emu-Coil sensors had been excavated and levelled. Furthermore, the bearing capacity of the structures after the tests had been determined with Loadman measurements. The structures had visibly rutted in the first phase of the study and cracks could be observed. The cracks were mainly short and narrow. Only the inside edge of the rut in the structure with the steep slope (structure 28–29) showed a crack for the entire length of the rut.

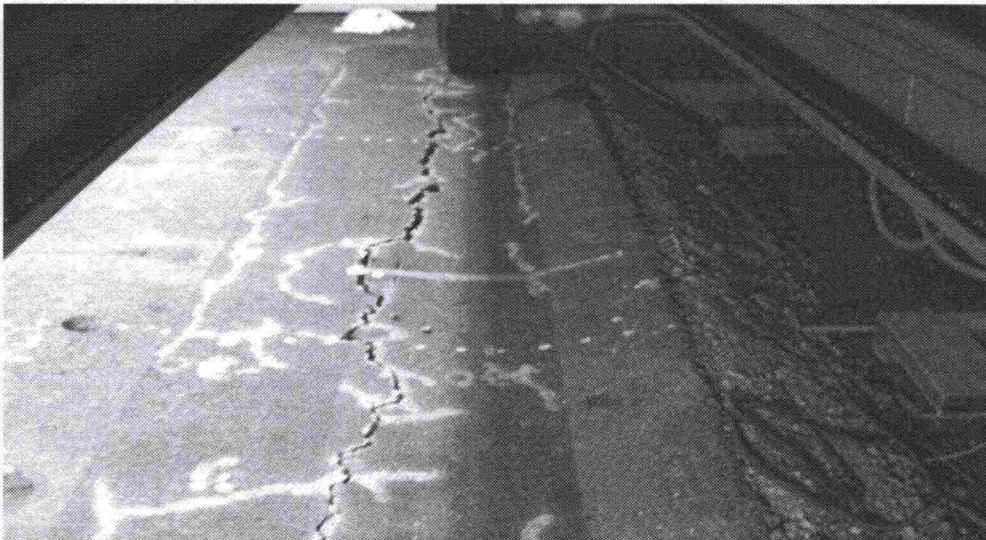
Figure 2.3. The test structure with the steep slope before repairing

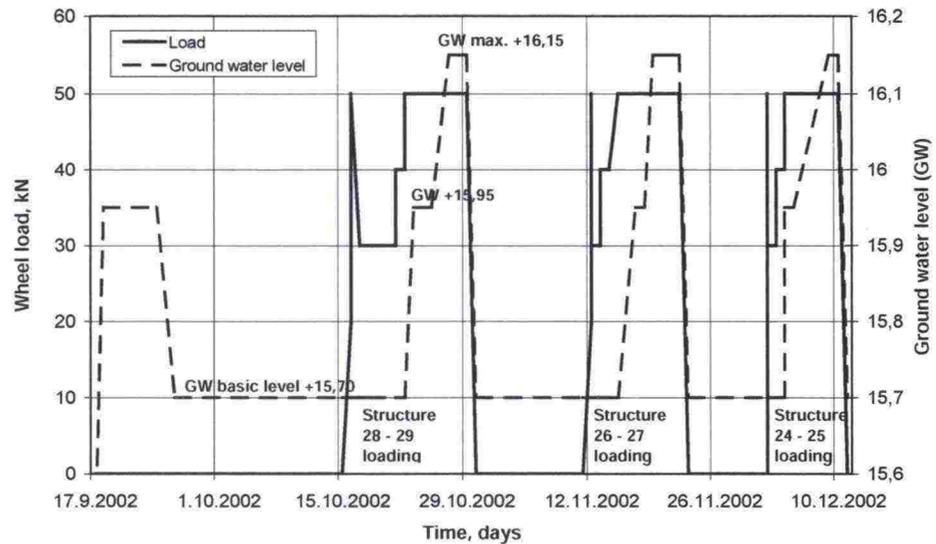
Figure 2.4. Ground water level and loading times of the different sections.

During the 50 kN load in the loading of each section, the ground water table was elevated to the top of the gravel layer (W2 +15.95), and also to the layer of crushed rock (W3 +16.15). The variation in the ground water level and the loads on each section are presented in Figure 2.3 and Table 2.2.

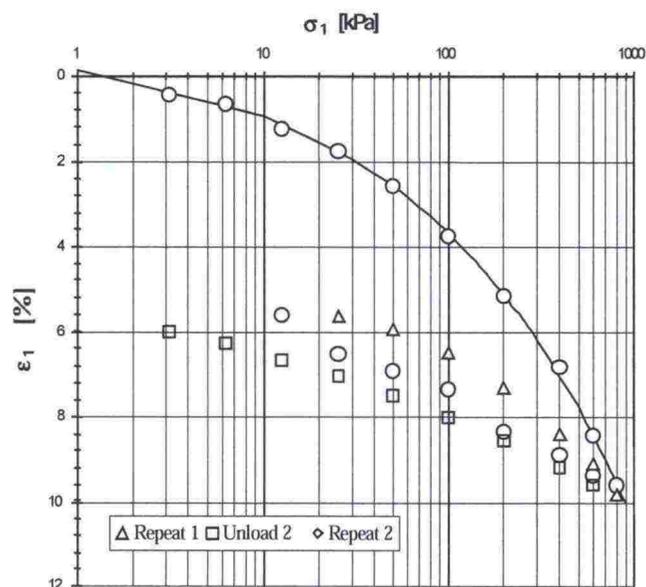
Figure 3.1. Consolidation test. Clay. Load-deformation curve.

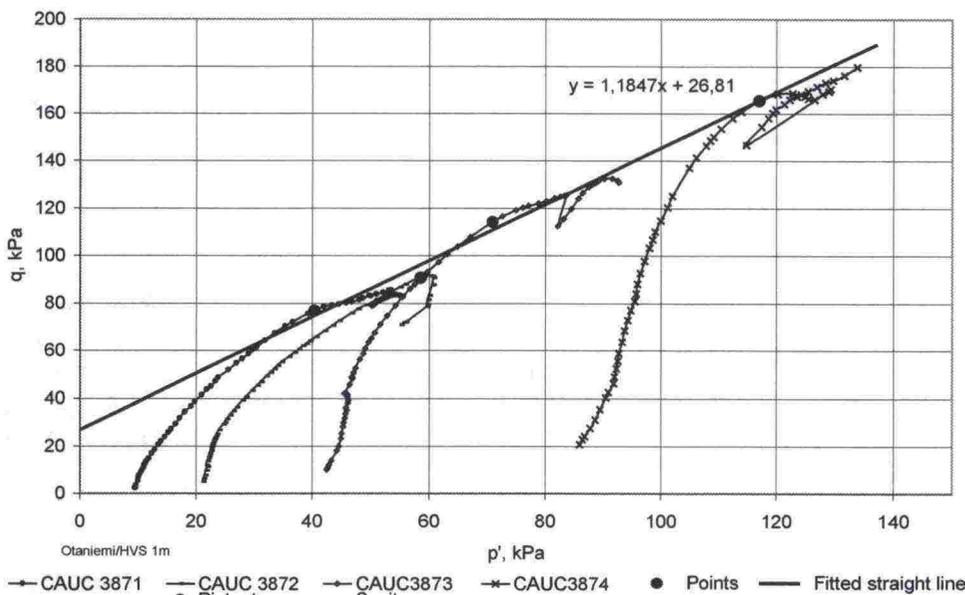
Figure 3.2. Triaxial test. Clay. Stress paths.

The stress paths of the triaxial tests are presented in Figure 3.2, which also shows a straight line used for calculating the strength parameters. The strength parameters determined from the results of the triaxial tests are presented in Table 3.2.

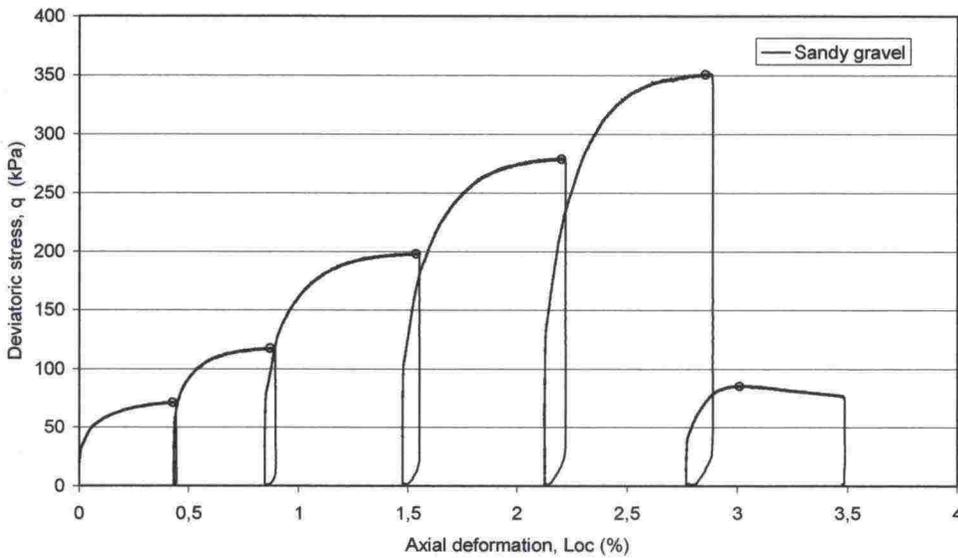
Figure 3.3. Strength test. Development of deviatoric stress in different tests as confining pressure changes.

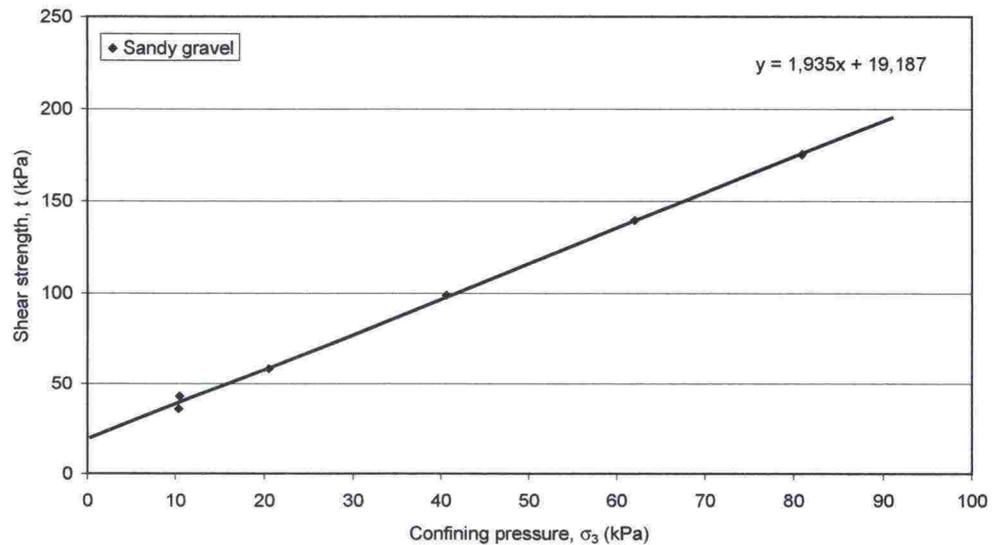
Figure 3.4. Strength test. Determining strength parameters on confining pressure – shear strength axes.

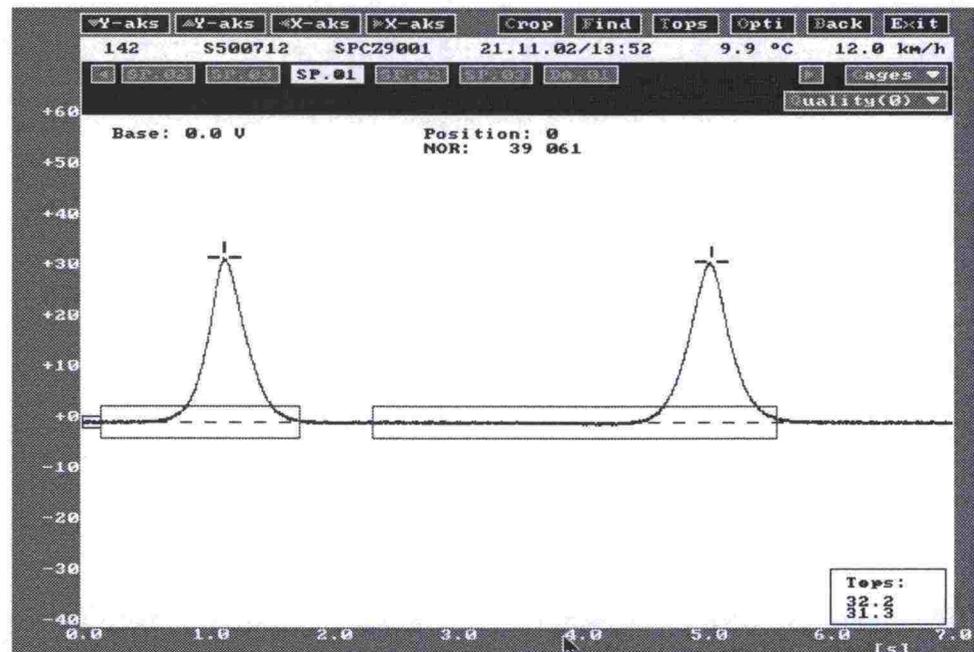
Figure 4.1. Measurement signal of an earth pressure cell and determination of the maximum values.

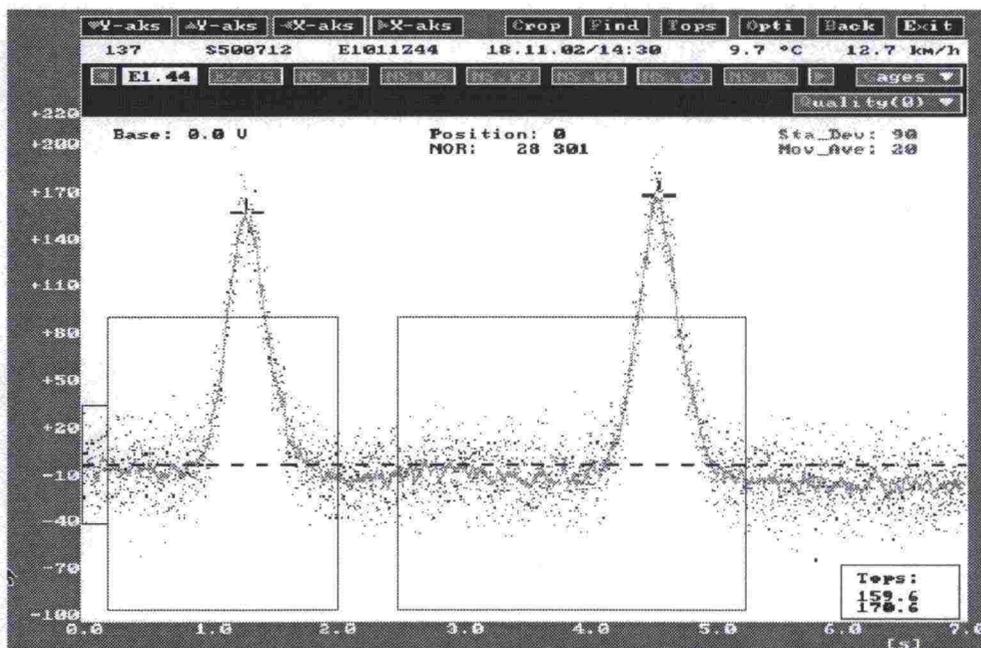
Figure 4.2. Measurement signal of an Emu-Coil sensor and determination of the maximum values.

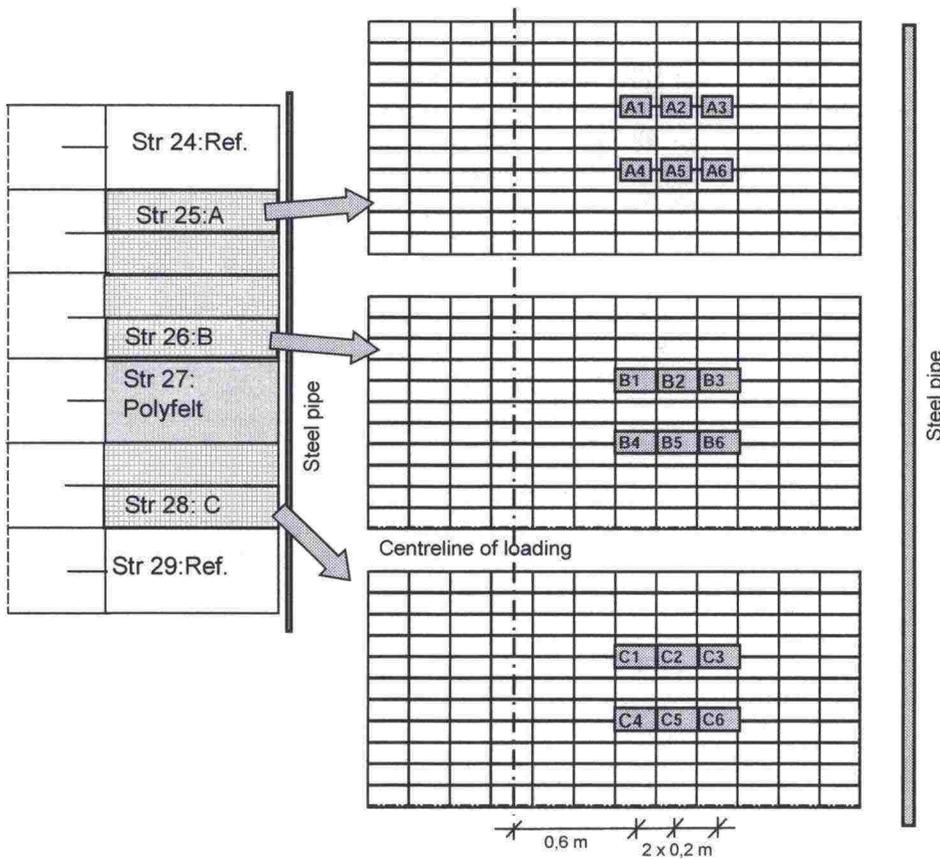
Figure 4.3. Position of the strain gauges.

The performance of the reinforcements was monitored with strain gauges. The gauges were only installed to steel reinforcements, as the fastening and functioning of the gauges in fibreglass reinforcement was uncertain. The gauges were installed transversely to the steel grid left of the centre line. There were two gauges on the opposite sides of the steel wire and the tensile strain was calculated as the average of the measurements from these two gauges. There were two instrumented wires in each steel grid test section. The gauges were positioned in three consecutive openings of the tested steel wire as shown in Figure 4.3. Both transient and permanent strain was measured. The measurement results are presented in Appendix 7.

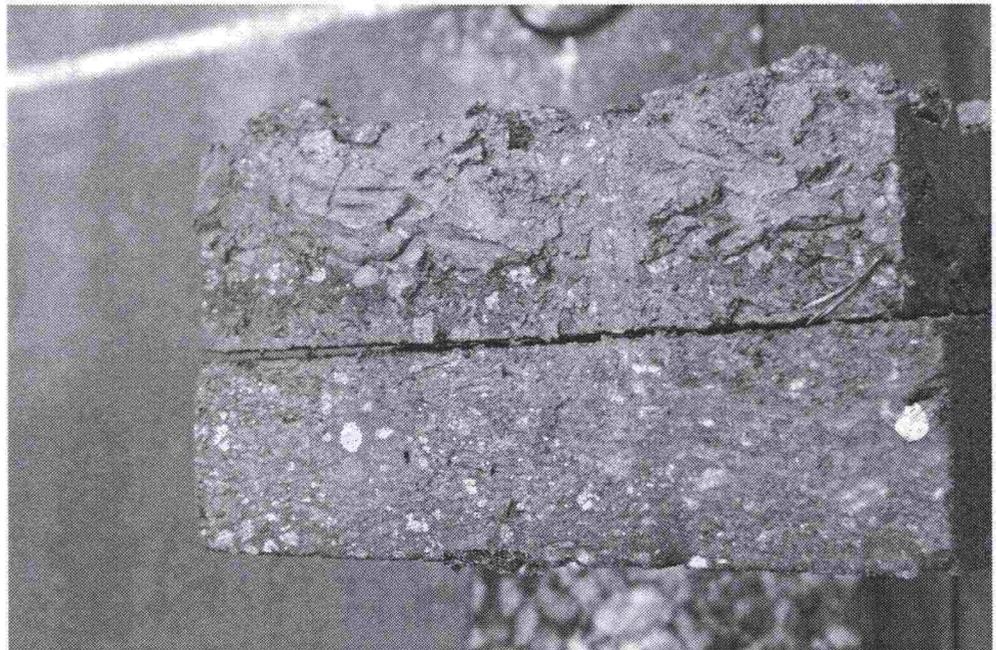
Figure 4.4. Asphalt layer sample sawed from structure 25. Asphalt layers have come apart.

After the test was completed, the structure was lightly protected with frost protective 50 mm EPS plates that were removed in the spring, after the structures had thawed. Before digging the structures open, the research team conducted falling weight deflectometer measurements, the results of which are given in Section 5.9. The structures were dug open and the surfaces levelled. Samples of both unbound and bound pavements were taken on the same occasion. The strength properties of the samples from the unbound layers (clay and gravel) were determined for later calculations. Samples were also sawn from the asphalt layer and the reinforcements for deflection tests and determining the strength properties. While taking samples of the asphalt layer, it was discovered that the asphalt layers of structure 25, in particular, had come apart (Figure 4.4).

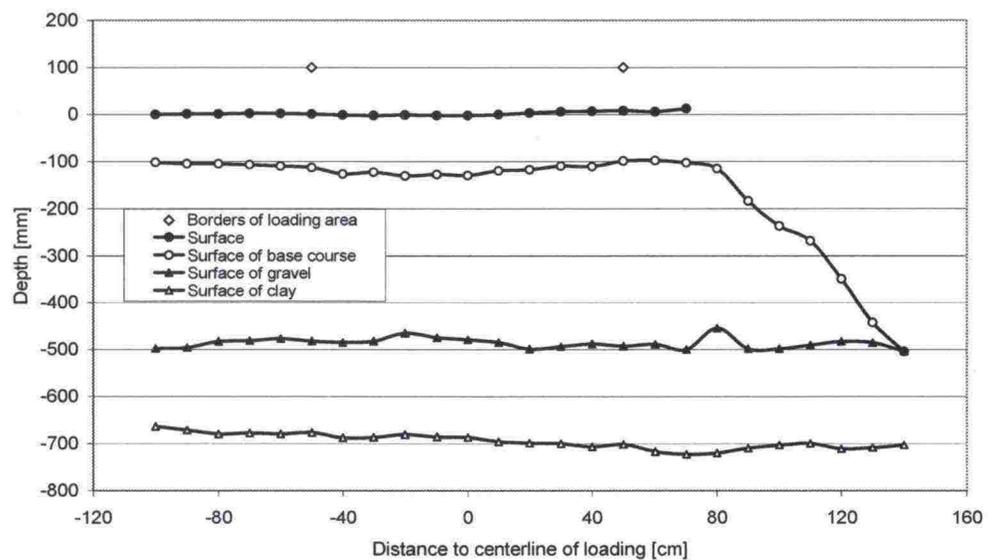
Figure 4.5. Levelling of the tops of the layers after loading in structure 24 (reference structure).

The structures were dug open in the middle of the loading area in each pair of structures, that is, at the joining of structure 24 and 25, and so forth. After being dug open, the surfaces of the pavements were levelled. The levelling results, structure by structure, are given in Figures 4.5–4.7. However, only one structure per pair is shown, as there were no great differences within the pairs.

reliably due to inadequate measurement results. However, subsequent measurements of the structures clearly indicated that the majority of deformations had occurred in the base course (Figures 4.5–4.7). According to the Emu-Coil measurements, the lower part of the base course accounted for 16–22%, the gravel 13–17%, upper part of the clay 7–13% and slightly lower parts of the clay for 1–14% of the total rutting. It is probable that by far the largest deformations in this test occurred in the upper part of the base course. Some of the remaining deformations occurred lower in the clay. The distribution of deformations differs from that of the first phase, in which the upper and lower parts of the base course deformed more or less equally (Figure 5.6).

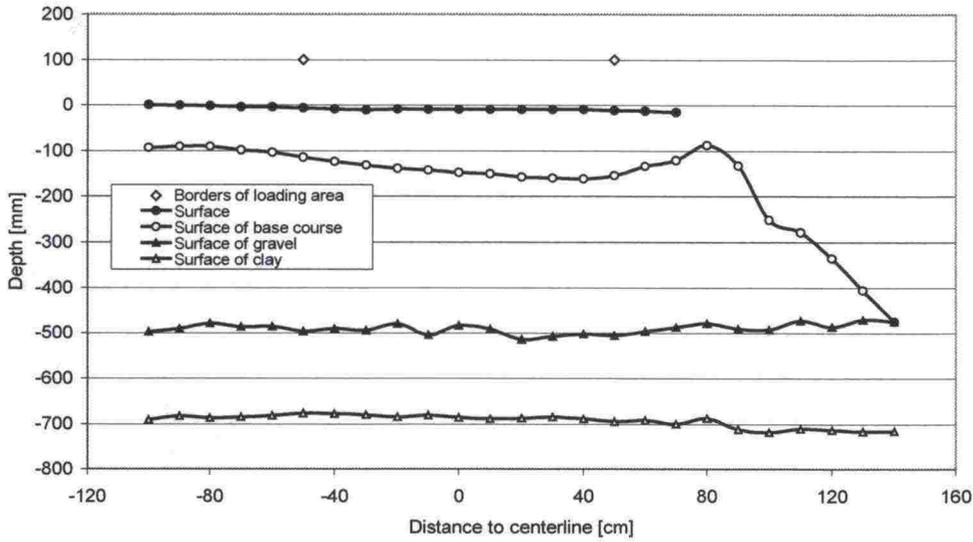
Figure 4.6. Levelling of the tops of the layers after loading in structure 26 (8 mm steel grid).

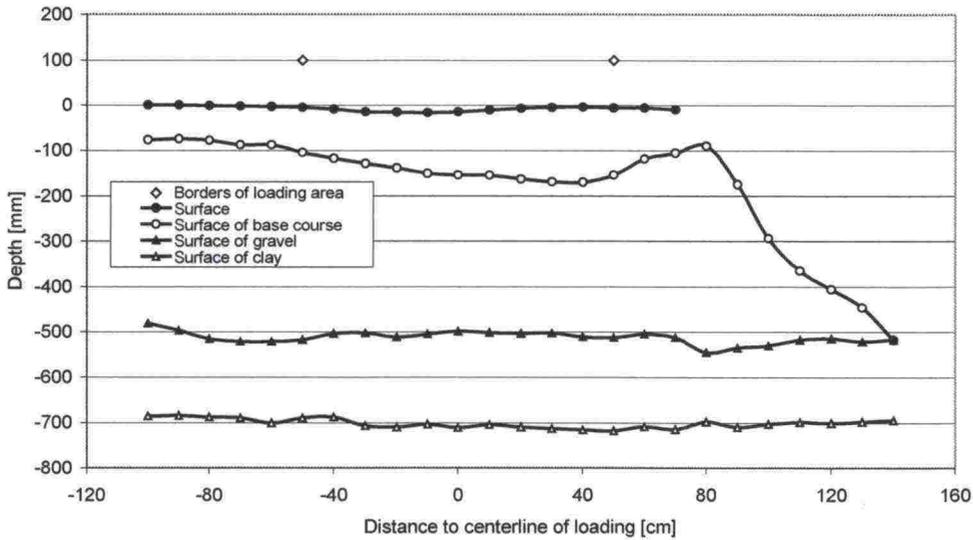
Figure 4.7. Levelling of the tops of the layers after loading in structure 29 (reference structure).

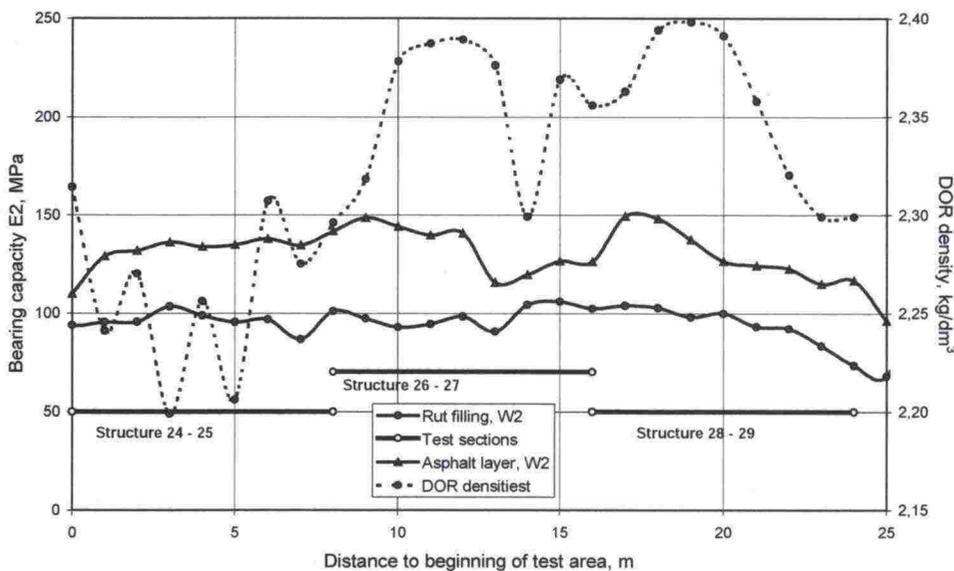
Figure 5.1. Bearing capacity and density measurements during rehabilitation.

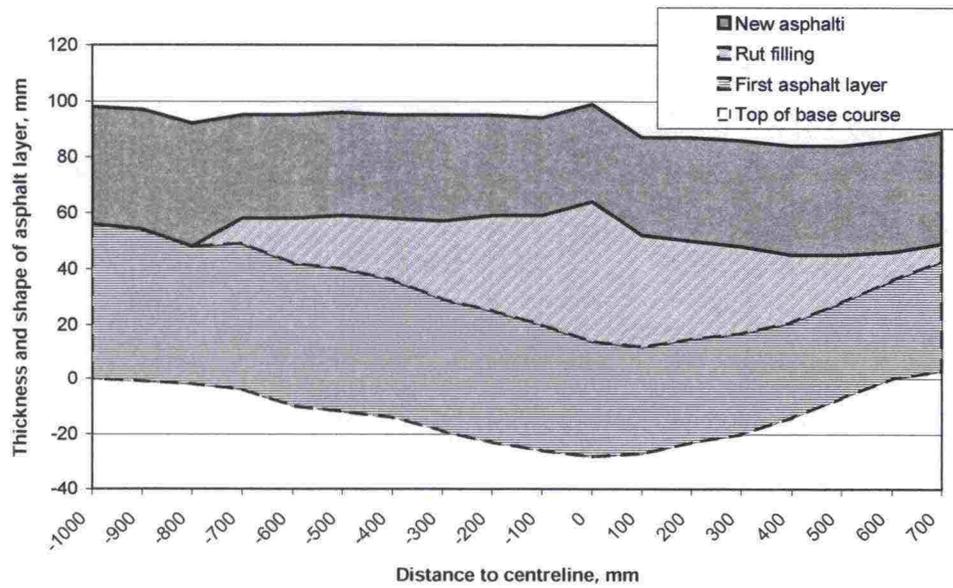
Figure 5.2. Structure 24–25. Cross section of the thickness and shape of asphalt layers at the centreline of the structure.

Levelling during rehabilitation monitored the thickness of the rut levellings and asphalt layers. Figures 5.2 to 5.4 present the cross-directional thickness of the asphalt layer in different structures. Figure 5.4, furthermore, shows the estimated position of the wide crack resulting from the first phase of loading. The figures are drawn on the assumption that the asphalt layer from the first phase was not deformed or its thickness changed during the first tests. According to the levelling, the total thickness of asphalt layers on the loaded area $\pm 300 \text{ mm}$ from the centreline were:

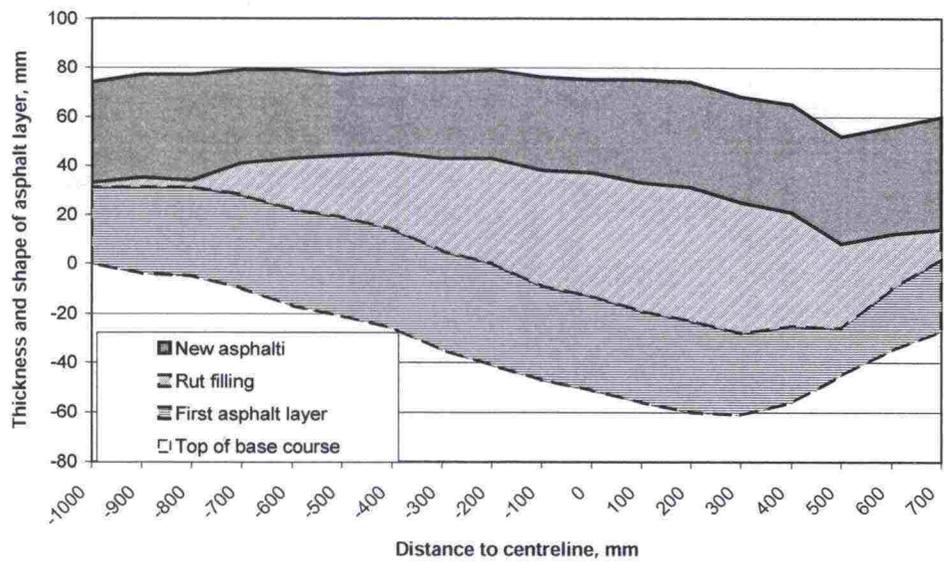
Figure 5.3. Structure 26–27. Cross section of the thickness and shape of asphalt layers at the centreline of the structure.

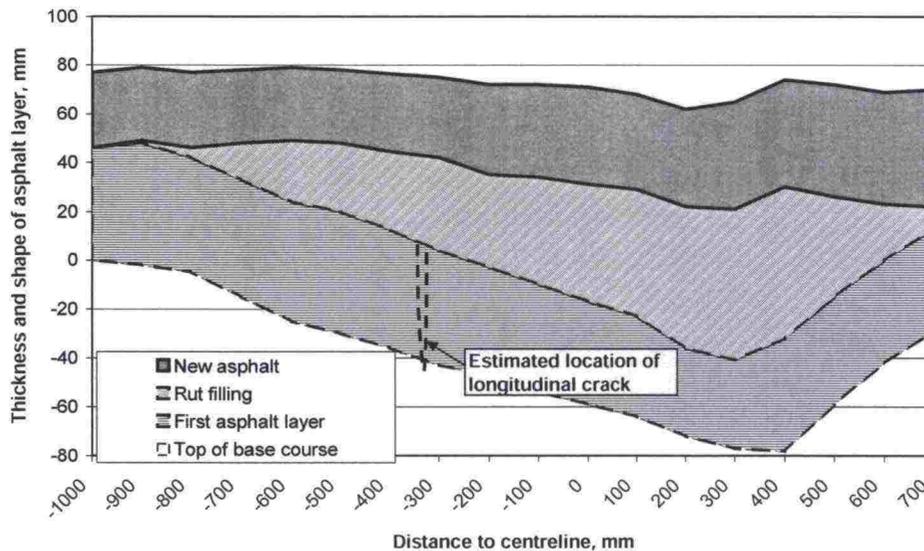
Figure 5.4. Structure 28–29. Cross section of the thickness and shape of asphalt layers at the centreline of the structure.

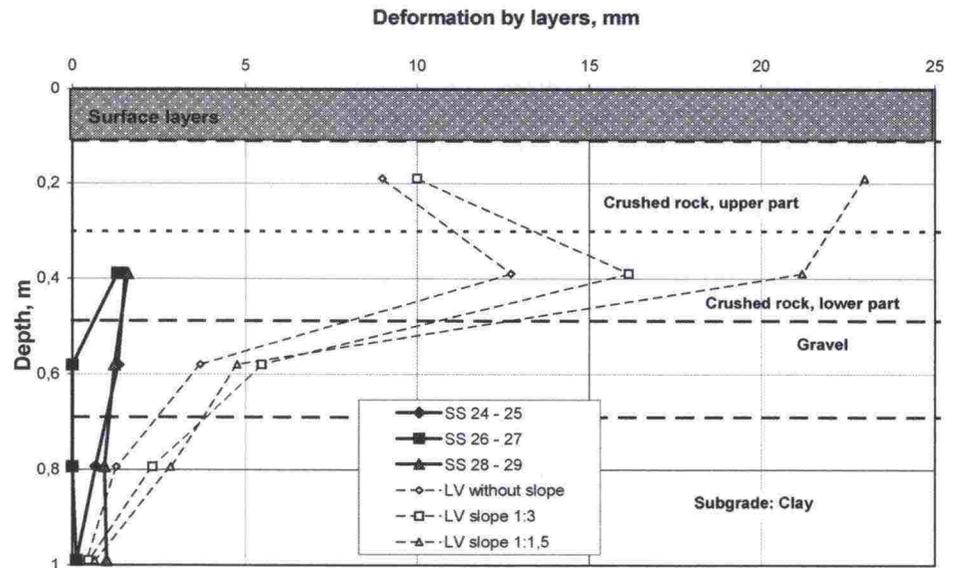
Figure 5.5. Vertical displacements in different tests.

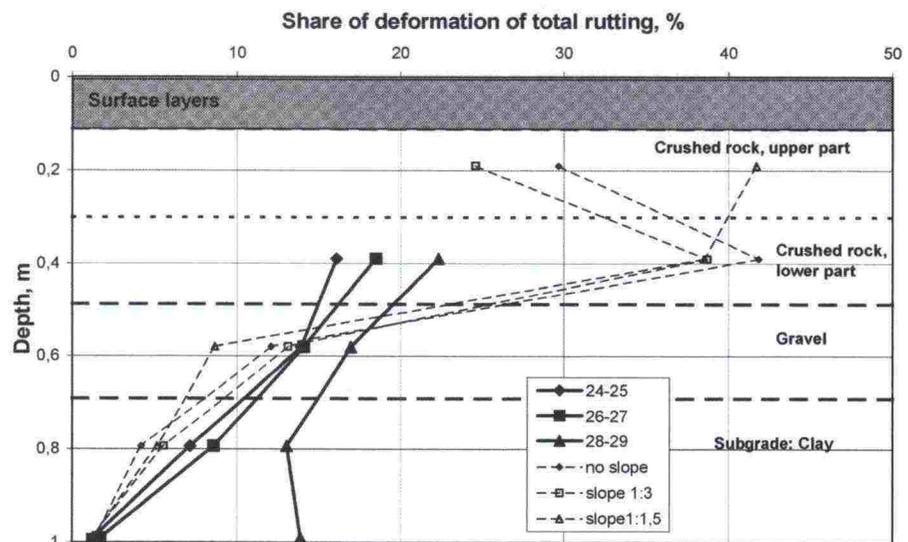
Figure 5.6. Share of vertical displacement of pavement in the total rutting of the surface.

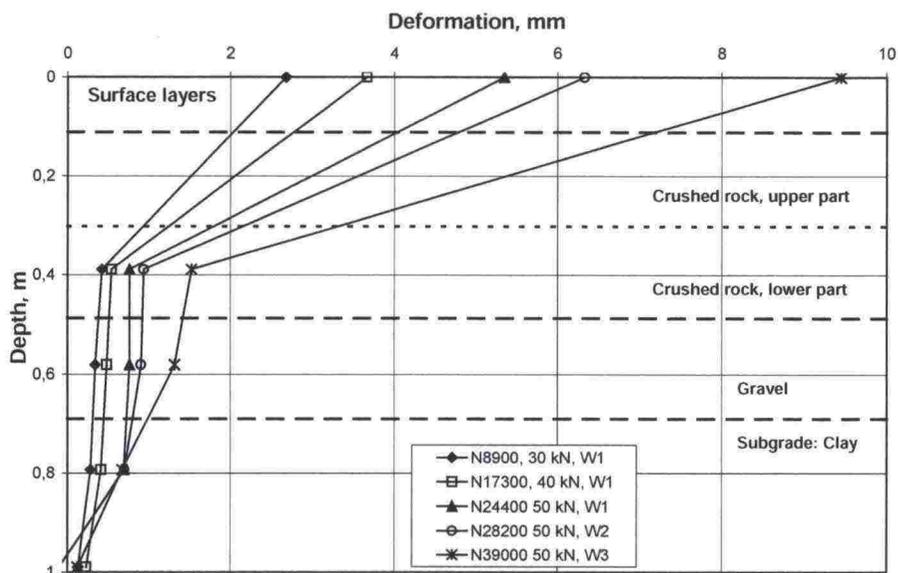
Figure 5.7. Structure 24–25. Changes in vertical displacements under different loads and at different water table levels.

Changes in the load or moisture content did not have a significant effect on the vertical deformation distribution. Figure 5.7 shows the vertical displacements in structure 24–25 under different loads and at different water table levels. The distribution showed an identical shape on all structures.

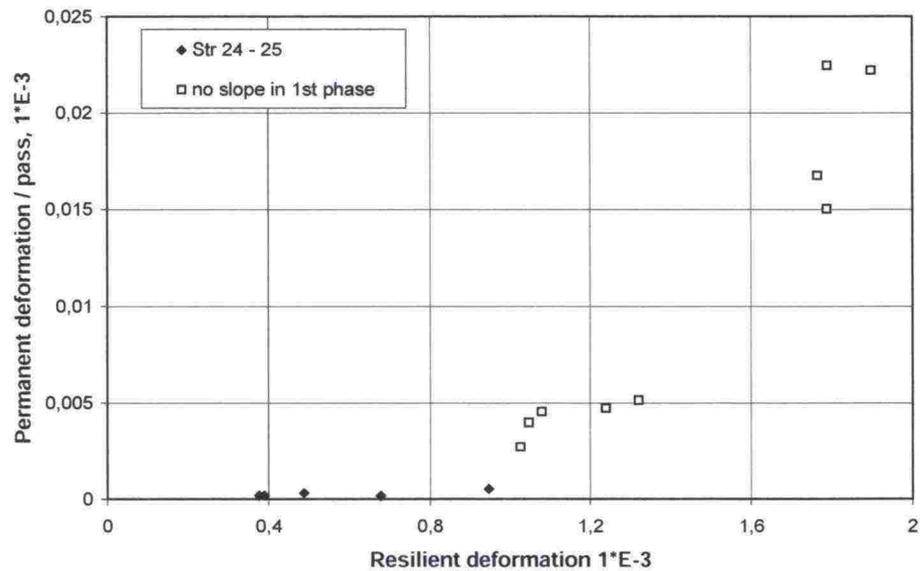
Figure 5.8. Structure 24–25. Ratios of permanent and transient vertical displacement in the crushed rock layer in this and the Low-volume roads study.

The level of deformations in unbound layers remained low, as Figure 5.8 indicates. It is not possible to determine the threshold value for plastic performance (shakedown value) for different loads or moisture contents on the basis of the results for this test alone. Figure 5.8 also shows the deformations of the corresponding structures in the first test phase. The threshold value can be roughly estimated from the combined results of these two tests. No great differences were observed in the ratio of deformations between the different structures. The Figure does not show the ratio of deformations in the preloading stage. Instead, it only presents the stage of 'decelerating' performance.

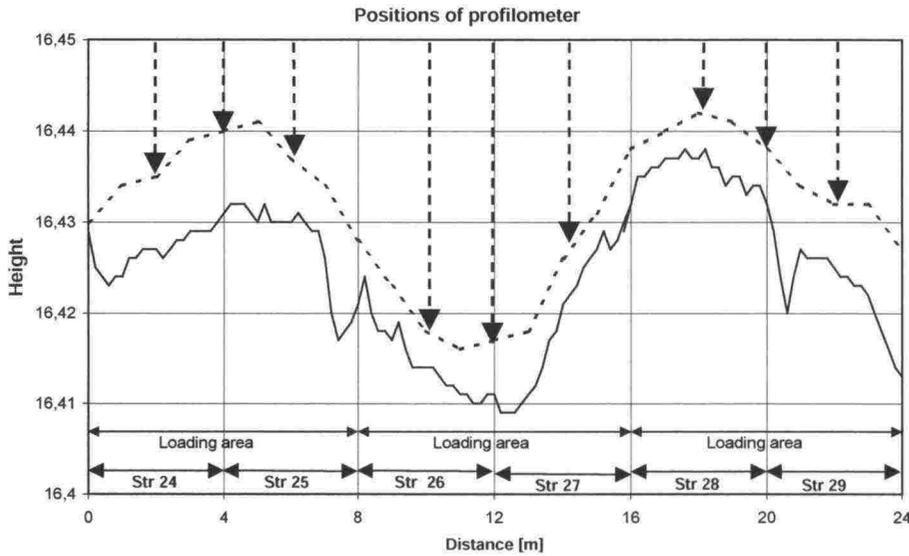
Figure 5.9. Longitudinal section on the centreline of loading before and after the test and the positions of the profilometer lines.

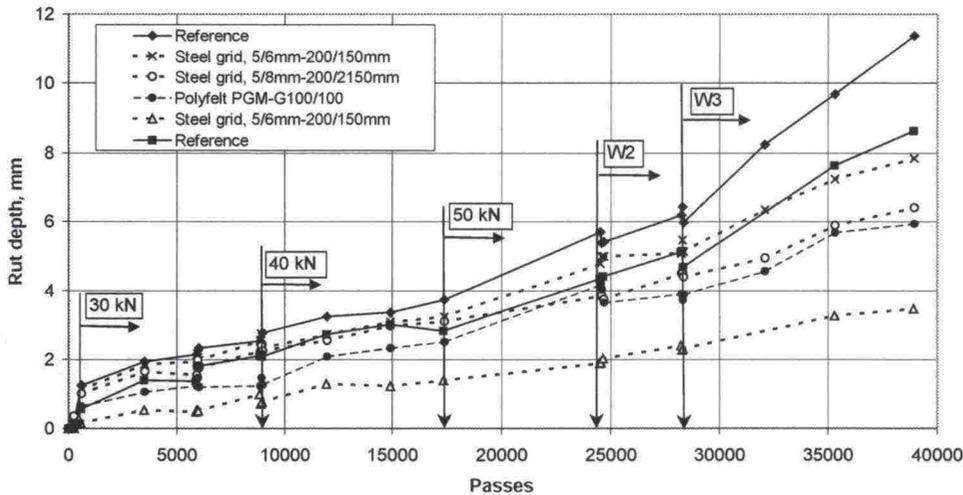
Figure 5.10. Rutting of the surfaces of the structures.

The rutting of the structures' surfaces was monitored with the profilometer line situated in the middle of each structure (Figure 5.10). Structures 24 and 29 were unreinforced reference structures. Structures 25 and 28 contained steel grid 1 (6 mm transverse wire), structure 26 steel grid 2 (8 mm transverse wire) and structure 27 fibreglass reinforcement.

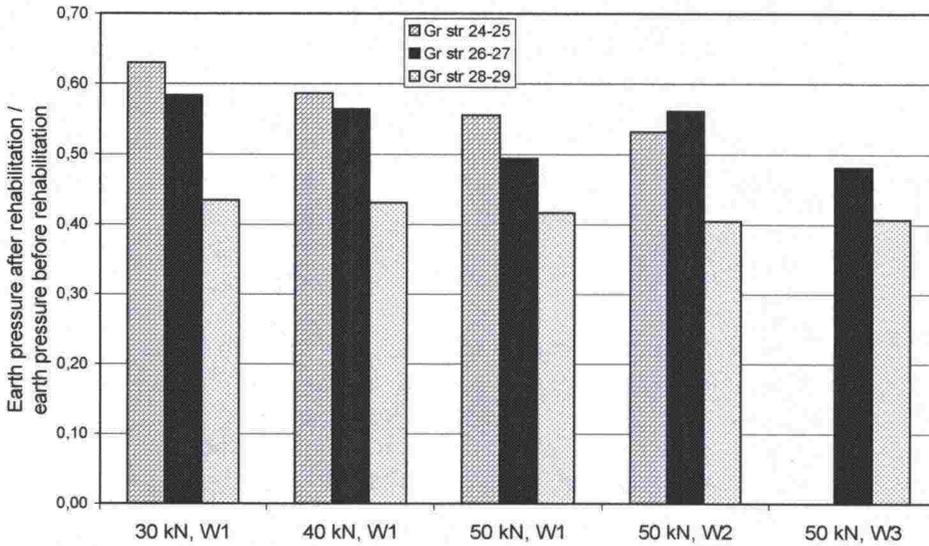
Figure 5.11. Ratio of earth pressure while loaded, top of the gravel layer (depth approximately 500–600 mm) (after/before loading).

Figure 5.11 shows the ratio of gravel layer earth pressures in the first phase (Low-volume roads study) to the rehabilitated structure on different load levels while Figure 5.12 shows the same for the clay layer. The earth pressure was measured while the structure was loaded.

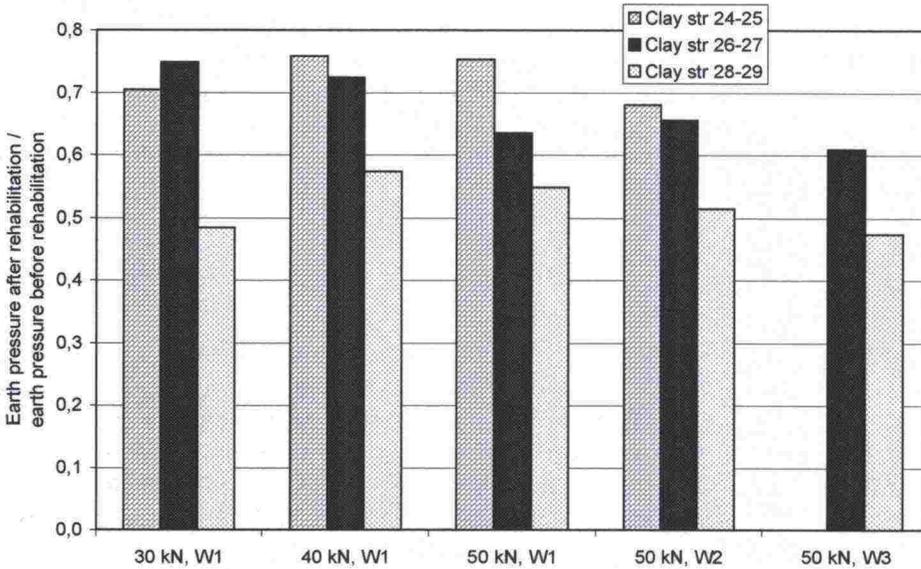
Figure 5.12. Ratio of earth pressure while loaded, top of the clay layer (depth approximately 700–800 mm) (after/before loading).

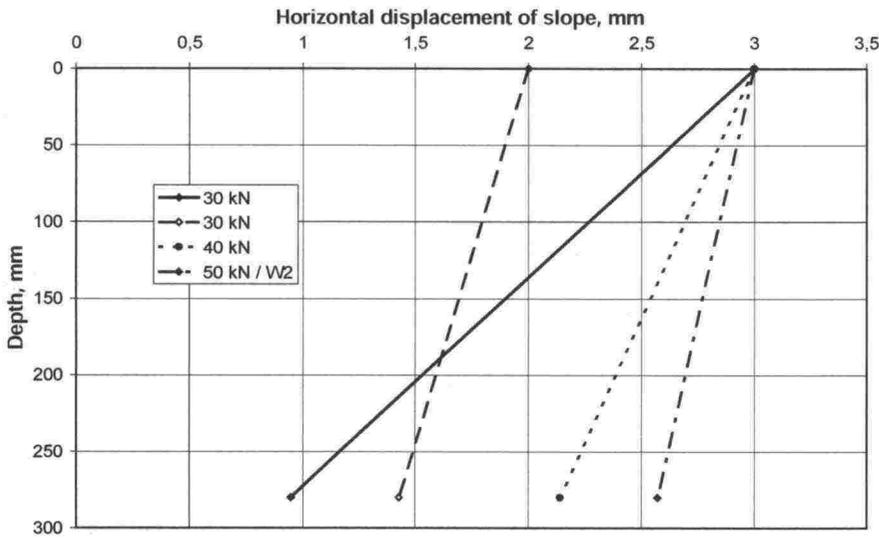
Figure 5.13. Permanent horizontal displacements in structure 24 on different loads.

The horizontal displacement of the slope was measured from the top of the structure and the middle of the base course. Horizontal displacements exhibit the same phenomenon as vertical displacements: the vertical displacements were clearly smaller than the corresponding displacements observed in the Low-volume roads study. The greatest horizontal displacements of the structure with 1:1.5 slope in the Low-volume roads study were in the order of 21 mm. Figure 5.13 shows the horizontal displacements in structure 24 on different load levels. On the basis of the measurements, it would seem that in this test, the horizontal displacements do not concentrate in the top part of the base course as clearly as was the case in the Low-volume roads study. However, there were only two measurement levels in this test and the deformations were small, so the conclusions are only tentative.

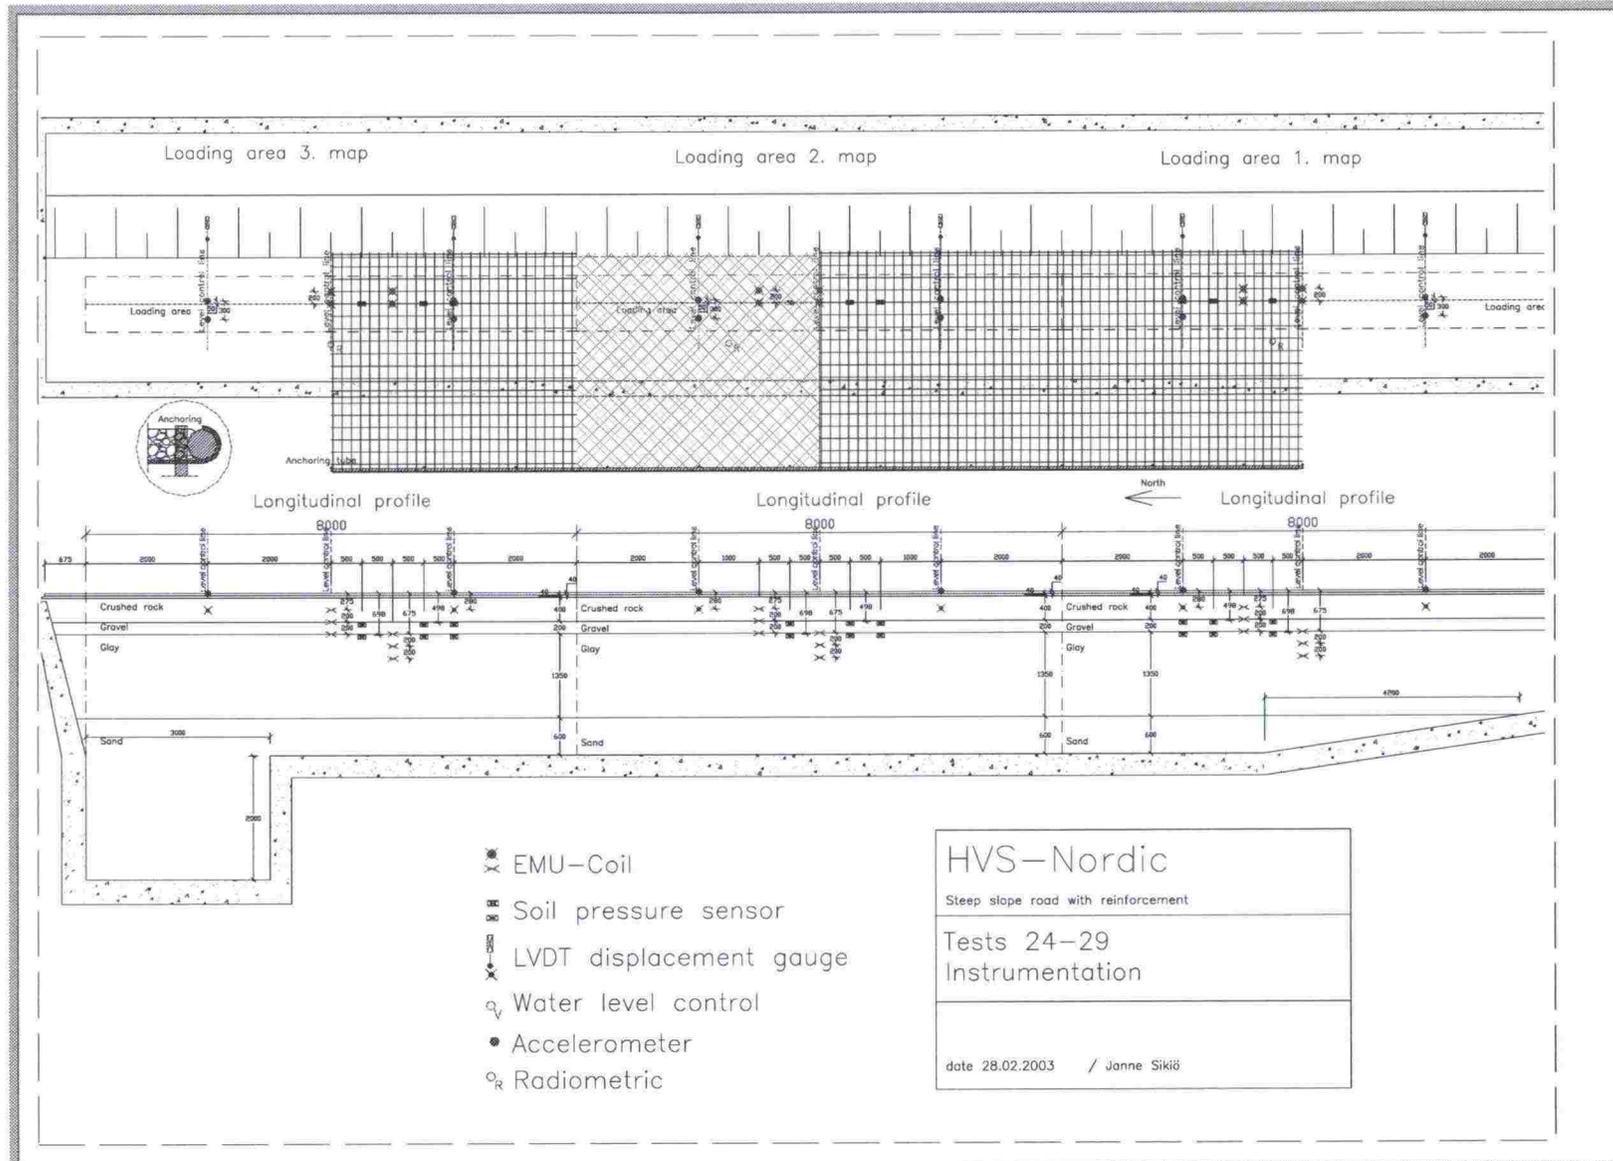
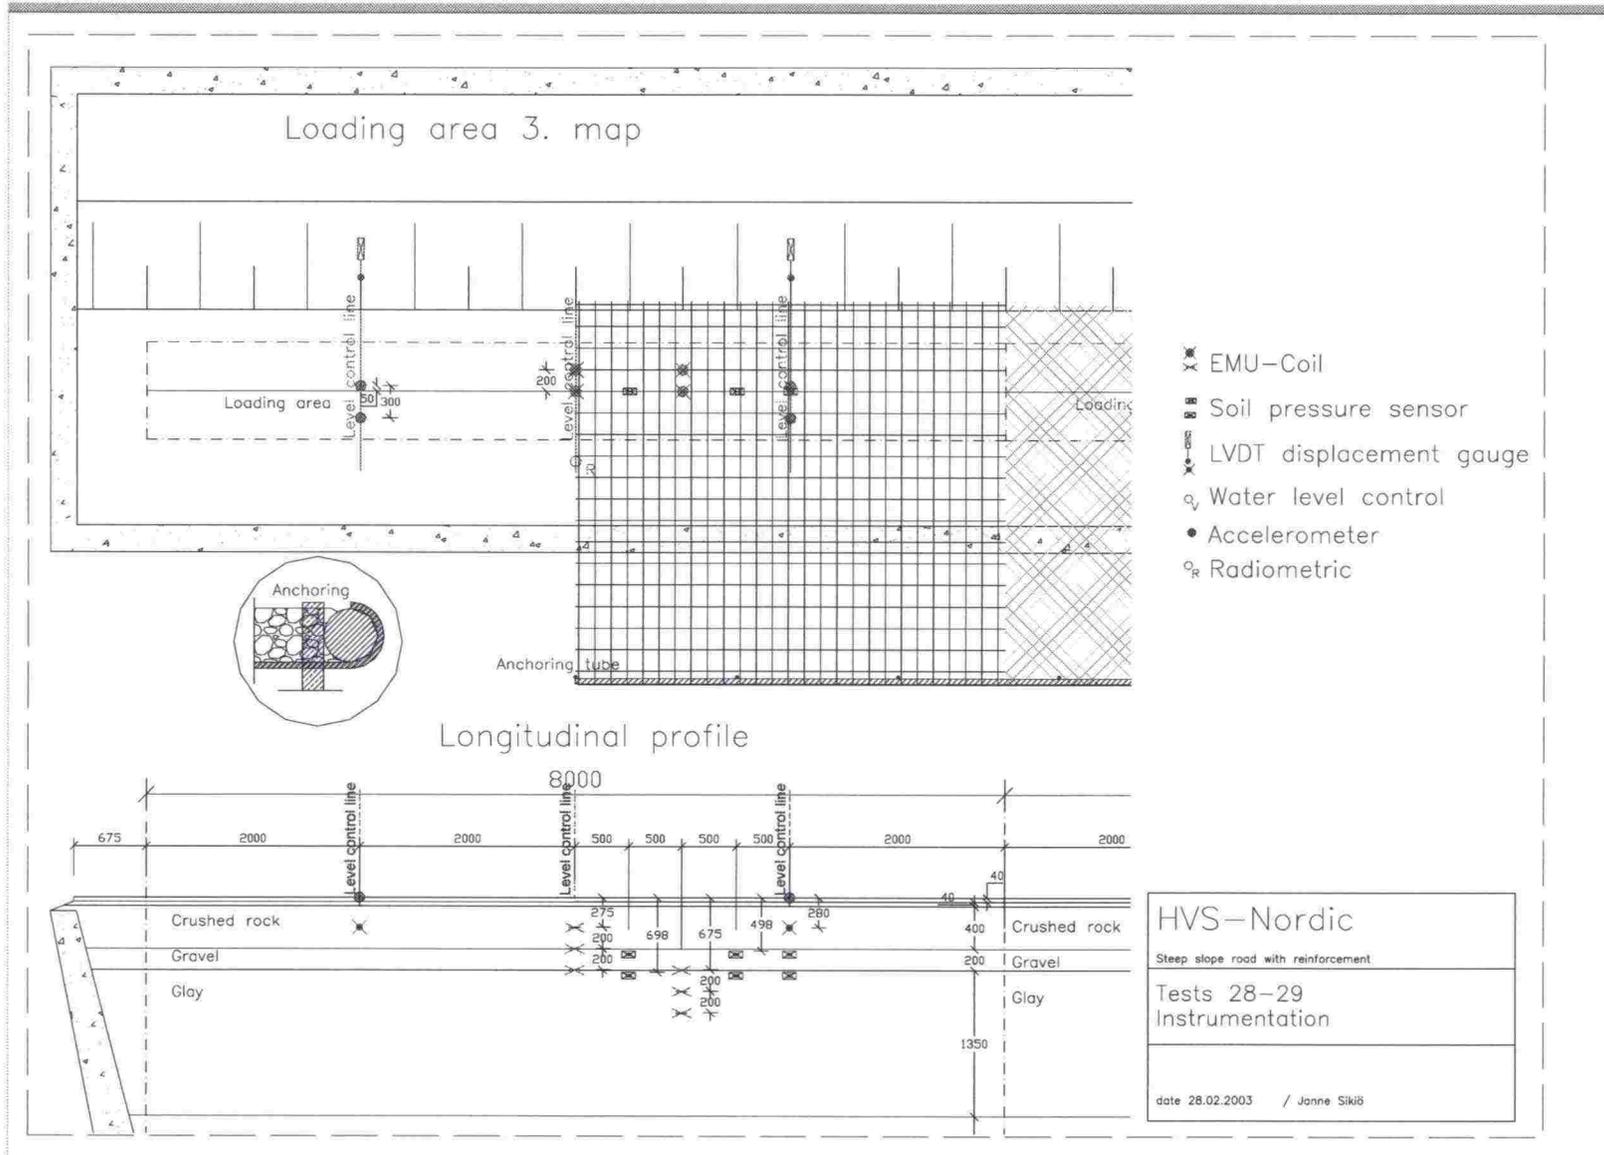
APPENDIX 1 MAP AND CROSS SECTIONS OF TEST SITE

- X EMU-Coil
- B Soil pressure sensor
- B LVDT displacement gauge
- V Water level control
- Accelerometer
- R Radiometric
