Reinforcement of the edge of a steep-sloped pavement

HVS-Nordic Heavy Vehicle Simulator test structures

Finra Reports 38/2003

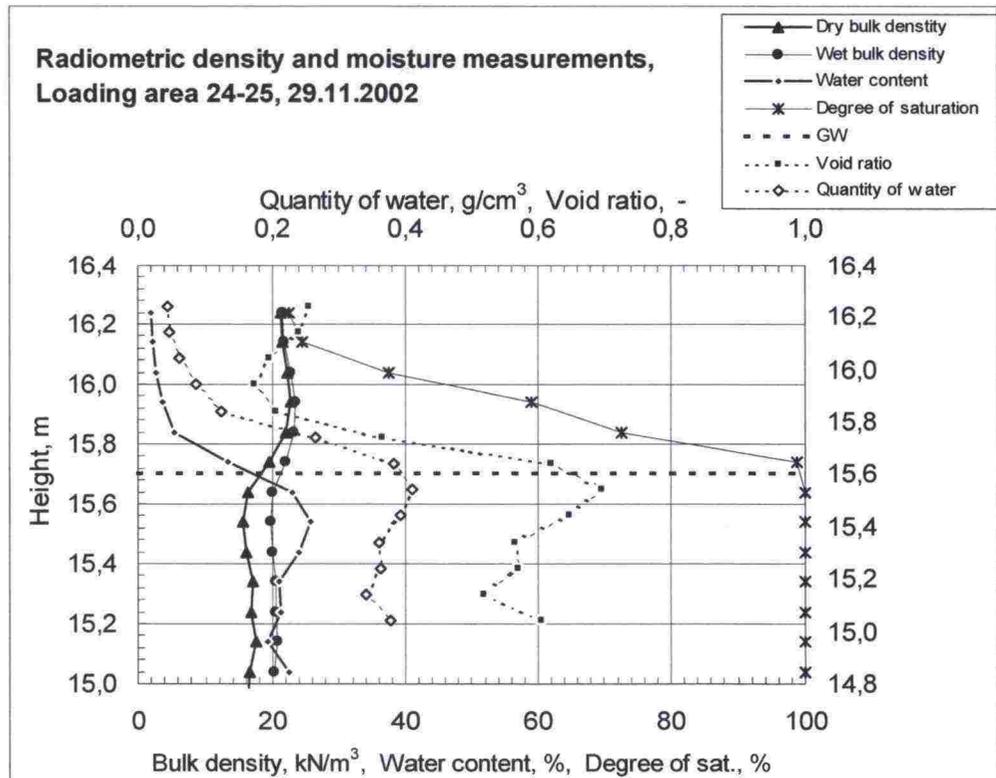
Figure L3.1. Structure 24 -25. Radiometric measurements before test W1.

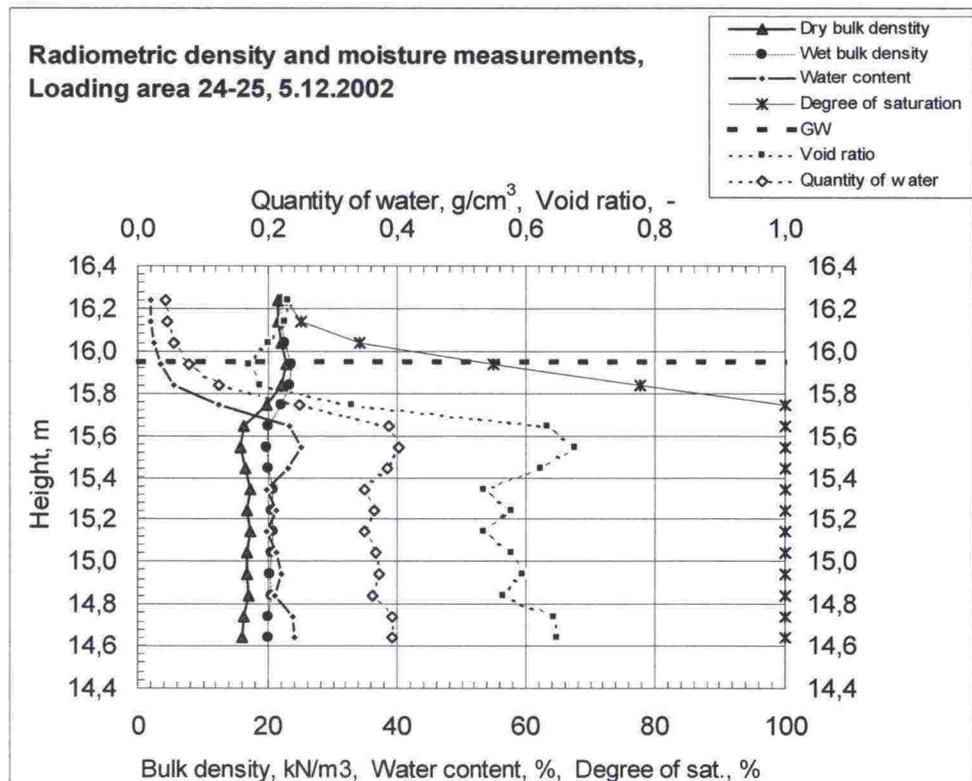
Figure A3.2. Structure 24 -25. Radiometric measurements during test, level W2.

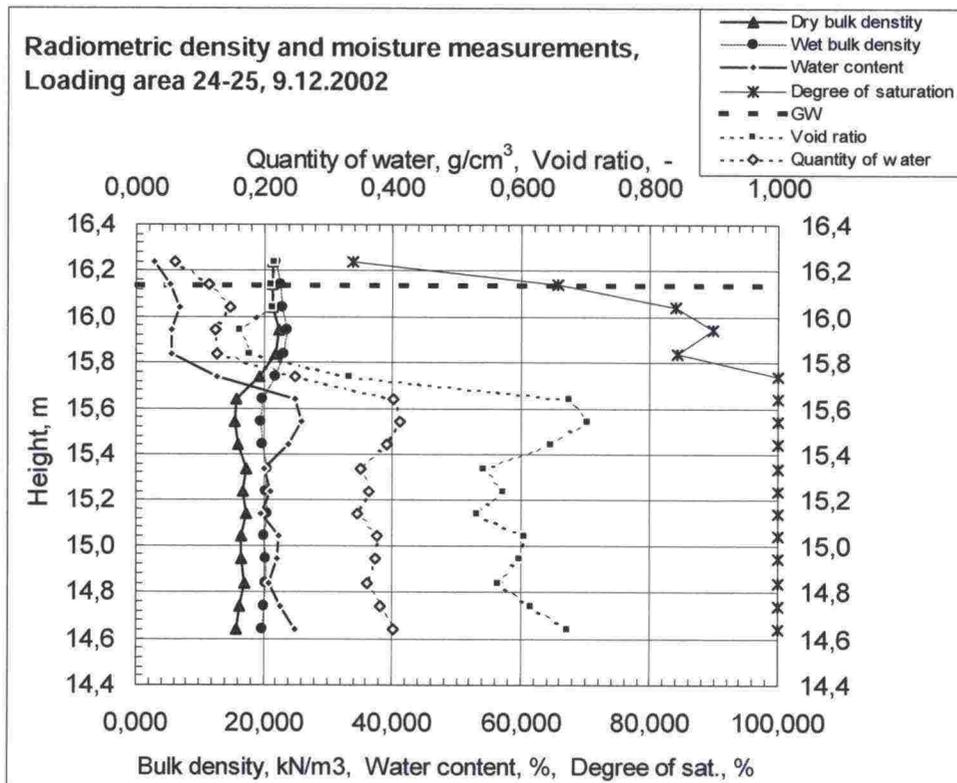
Figure A3.3. Structure 24 -25. Radiometric measurements during the test level W3.

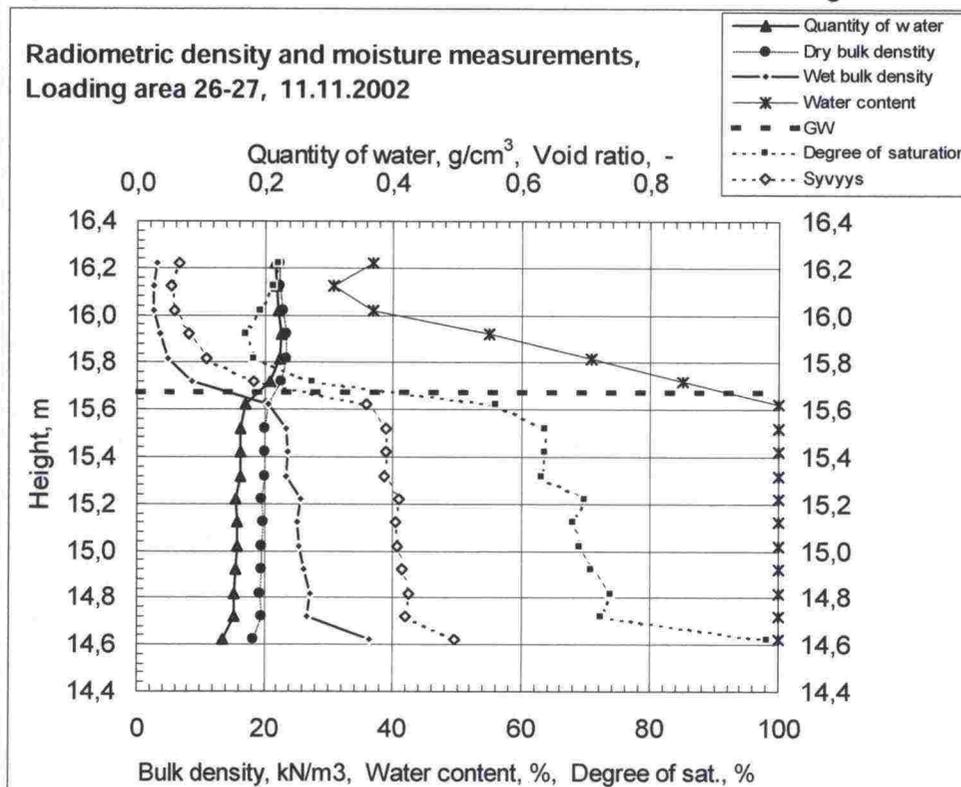
Figure A3.4. Structure 26 -27. Radiometric measurements before test W1.

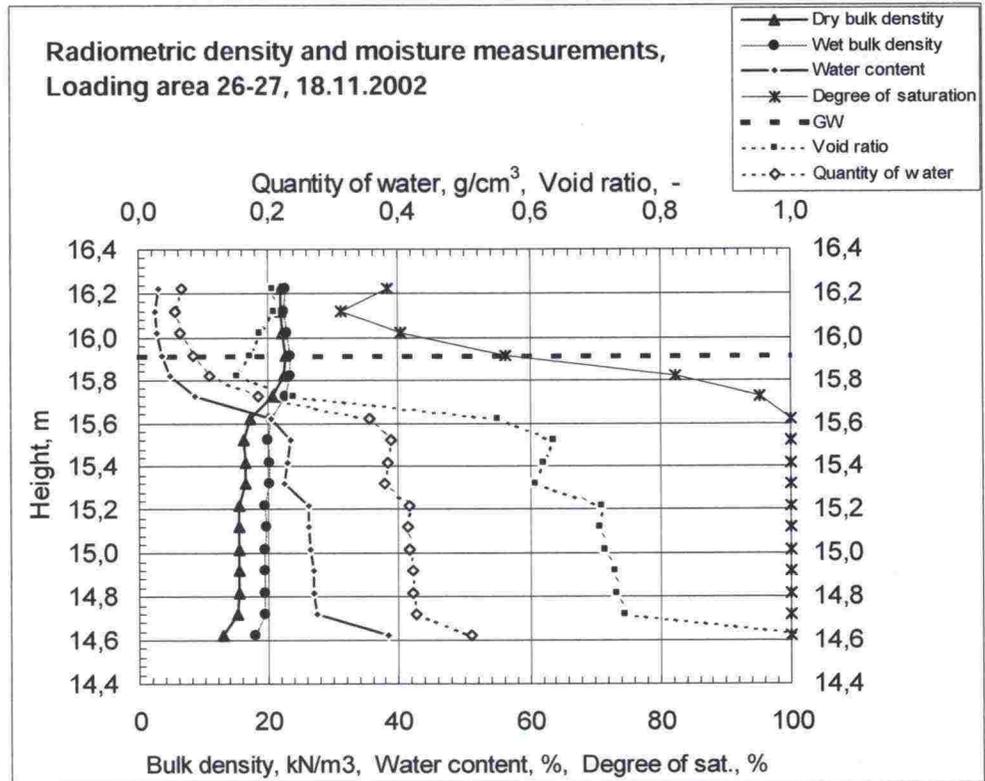
Figure A3.5. Structure 26 -27. Radiometric measurements during test level W2.

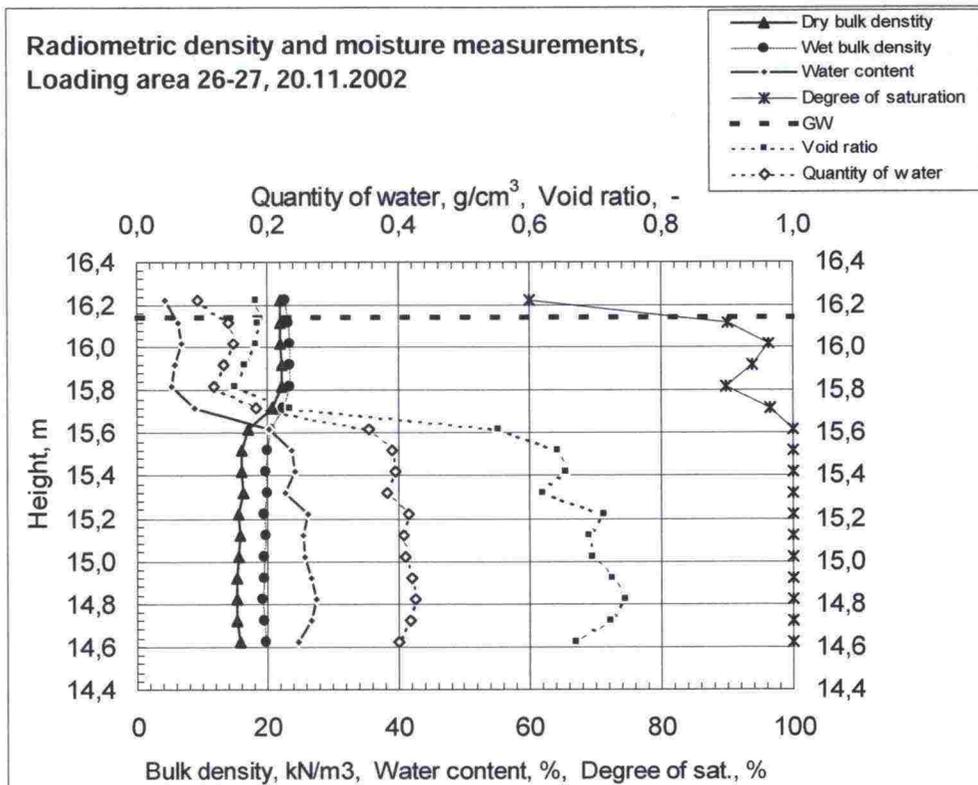
Figure A3.6. Structure 26 -27. Radiometric measurements during test level W3.

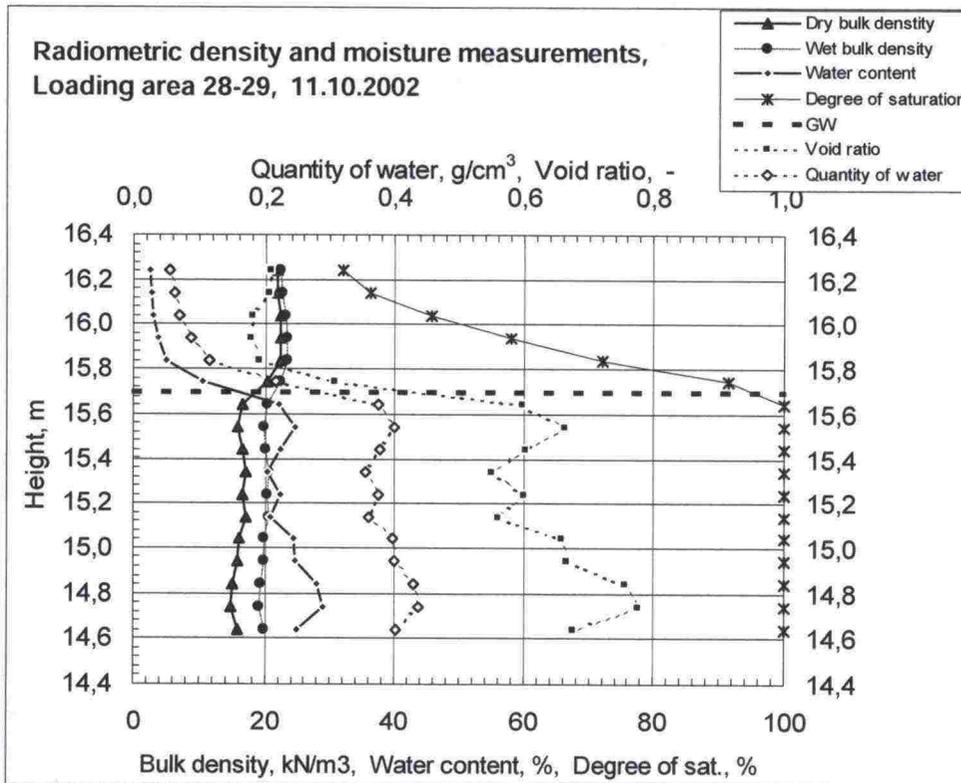
Figure A3.7. Structure 28 -29. Radiometric measurements before test W1.

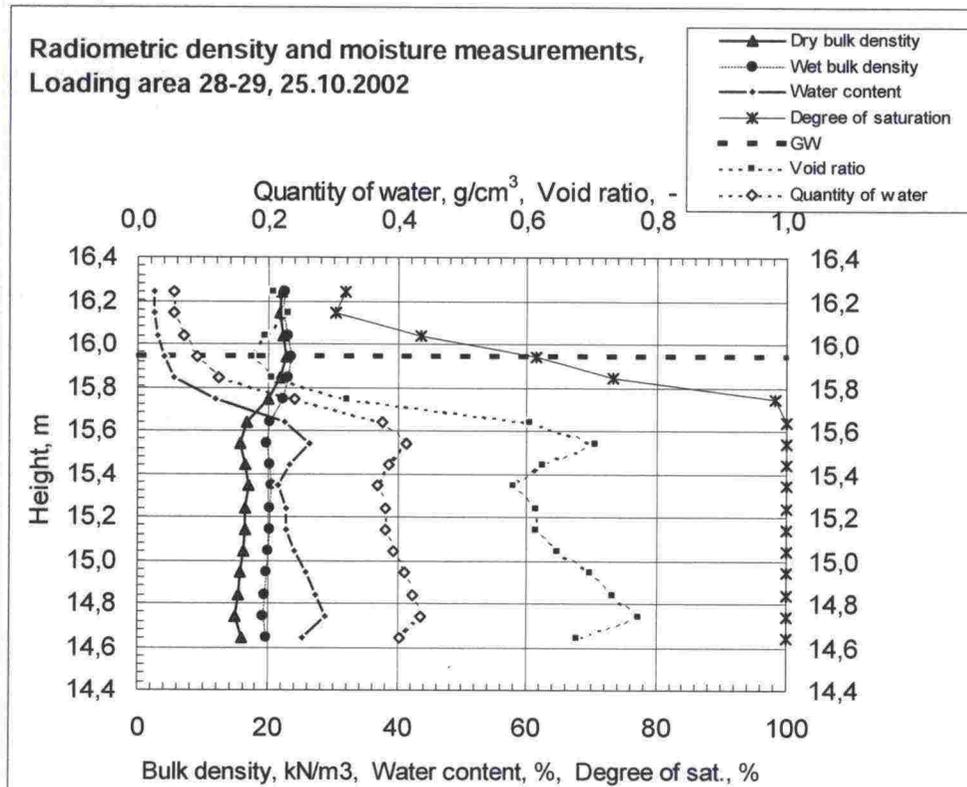
Figure A3.8. Structure 28 -29. Radiometric measurements during test level W2.

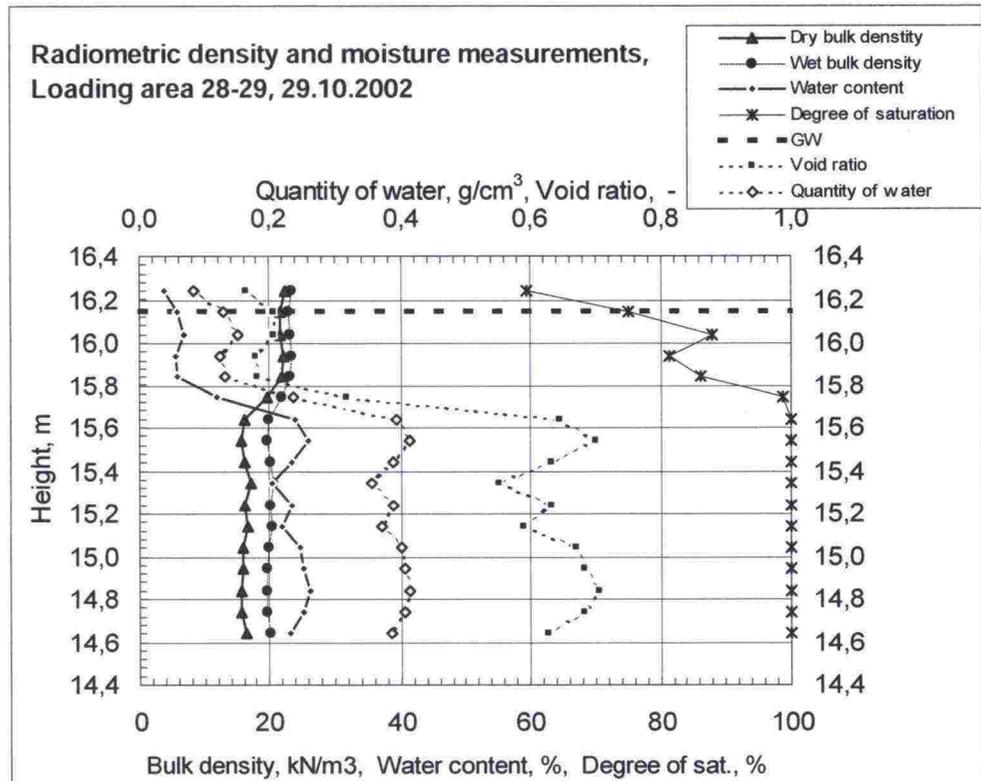
Figure A3.9. Structure 28 -29. Radiometric measurements during test level W3.

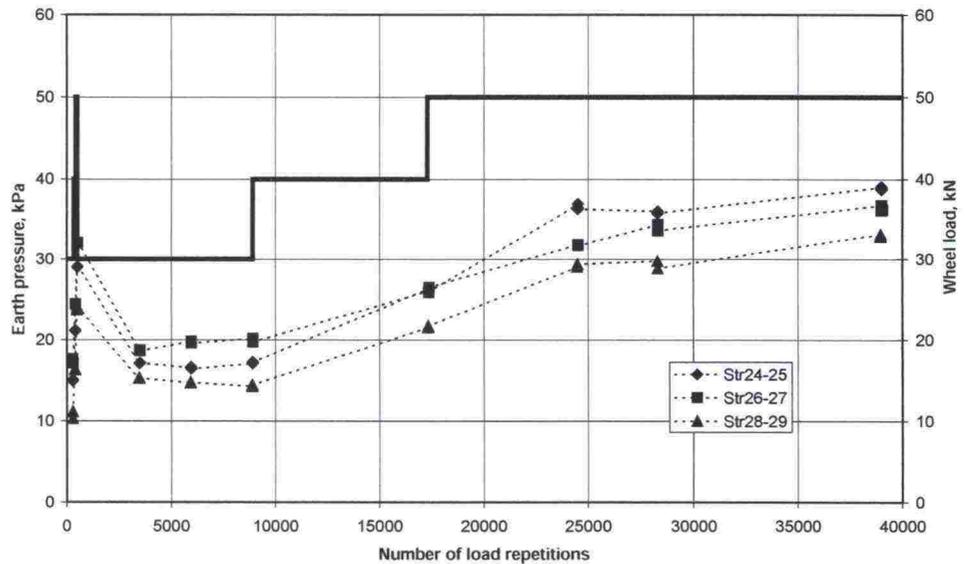
Figure A4.1. The transient earth pressure in the upper part of the clay in different structures. All earth pressure cells of the structure 24-25 have been situated in the structure 25 and respectively in the structure 28 of the structure pair 28-29. In structure pair 26-27 two earth pressure cells have been situated in structure 26 and one in structure 27.

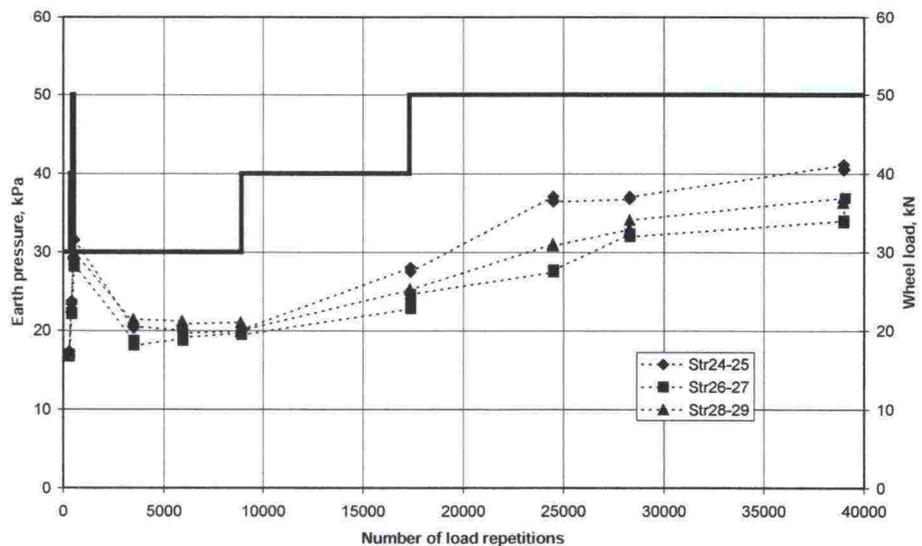
Figure A4.2. The transient earth pressure in the gravel in different structures. All earth pressure cells of the structure 24-25 have been situated in the structure 25 and respectively in the structure 28 of the structure pair 28-29. In structure pair 26-27 two earth pressure cells have been situated in structure 26 and one in structure 27.

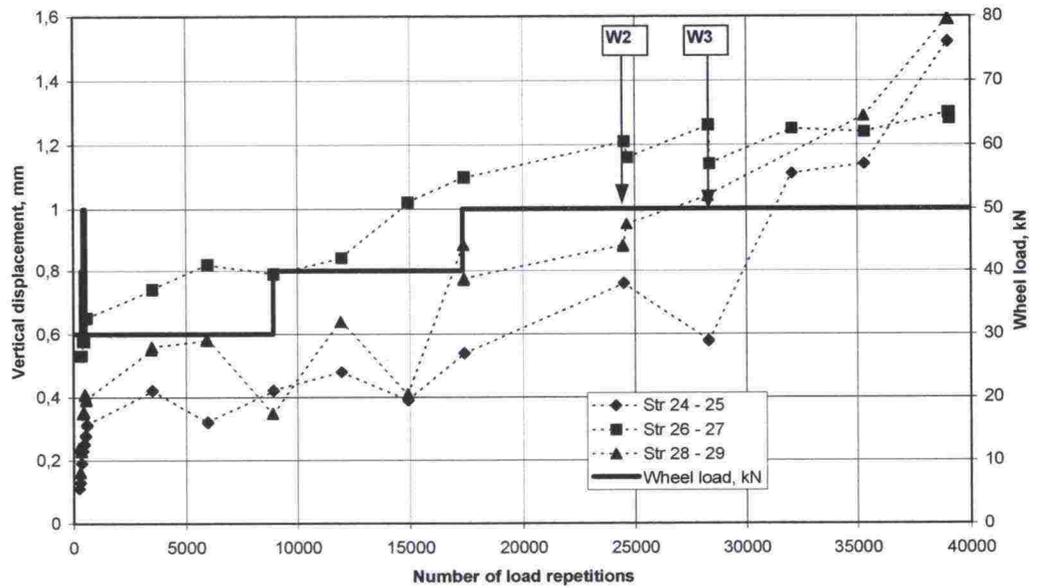
Figure A5.1. The permanent vertical displacement of the lower part of the crushed rock.

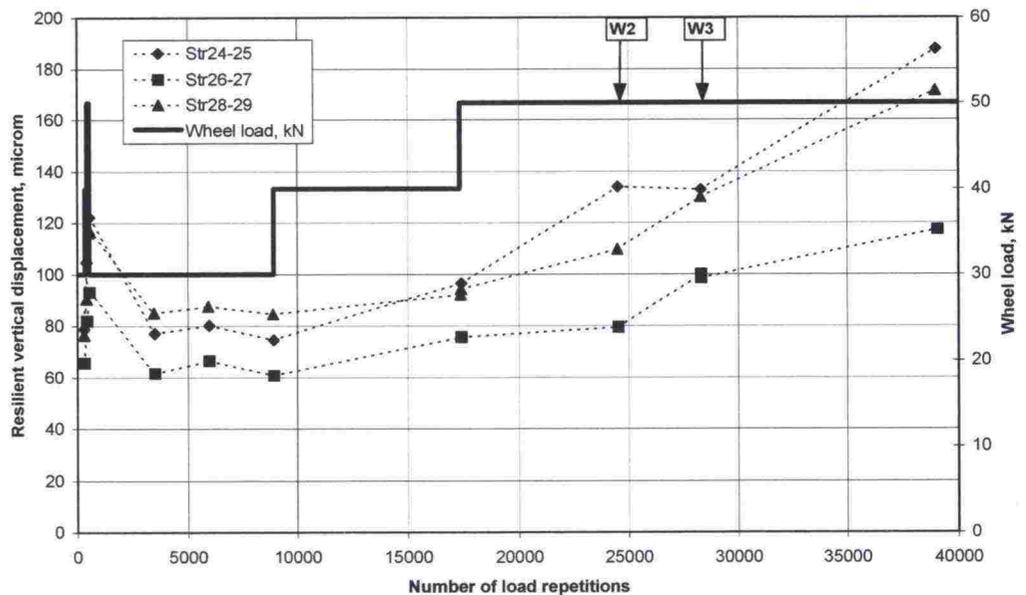
Figure A5.2. The resilient vertical displacement of the lower part of the crushed rock.

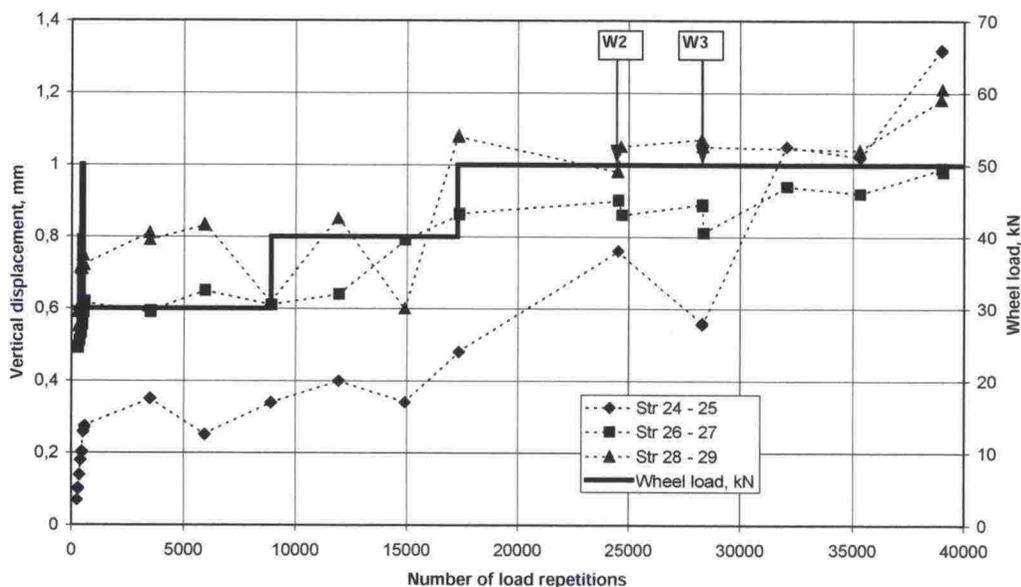
Figure A5.3. The permanent vertical displacement of the lower part of the gravel.

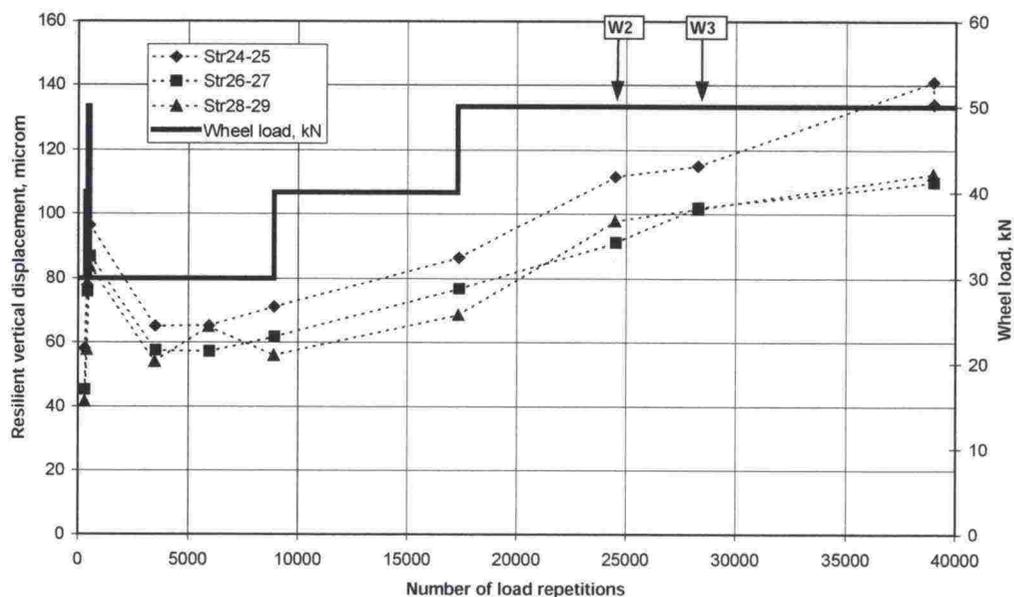
Figure A5.4. The resilient vertical displacement of the lower part of the gravel.

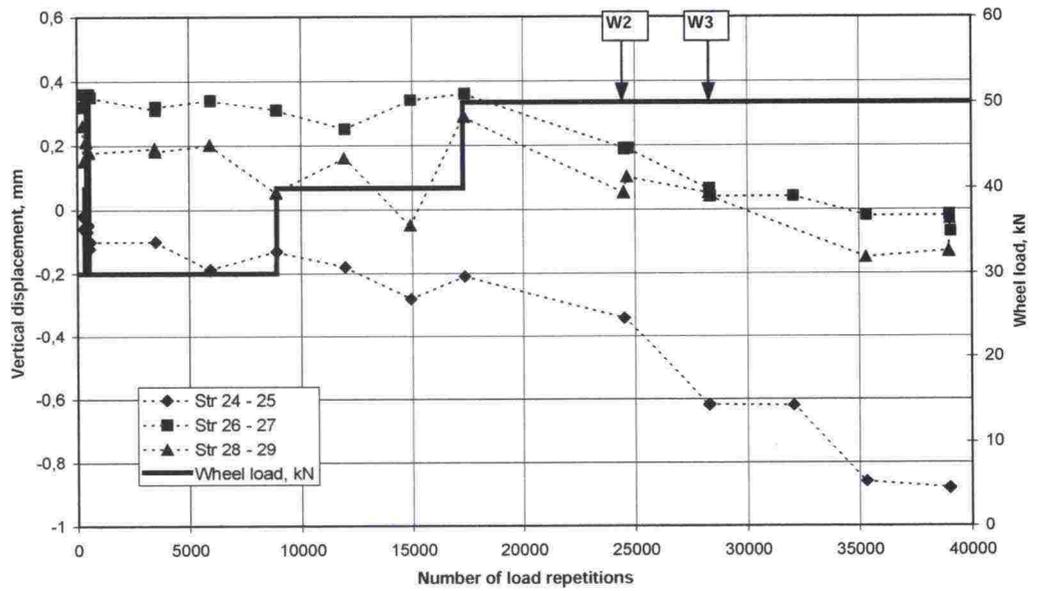
Kuva A5.5. The permanent horizontal displacement of the interface of the gravel and crushed rock.

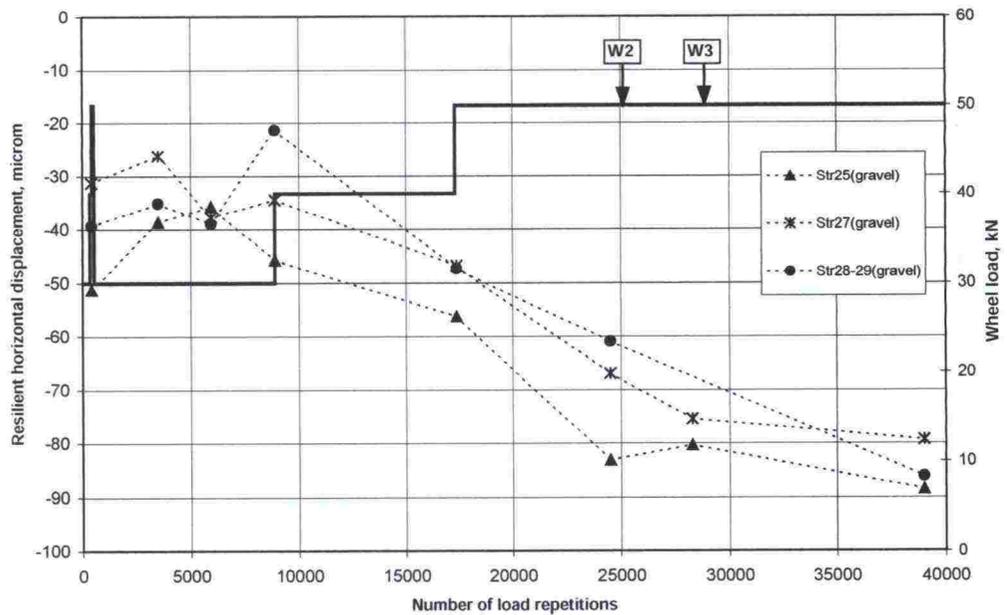
Figure A5.6. The resilient horizontal displacement of the interface of the gravel and crushed rock.

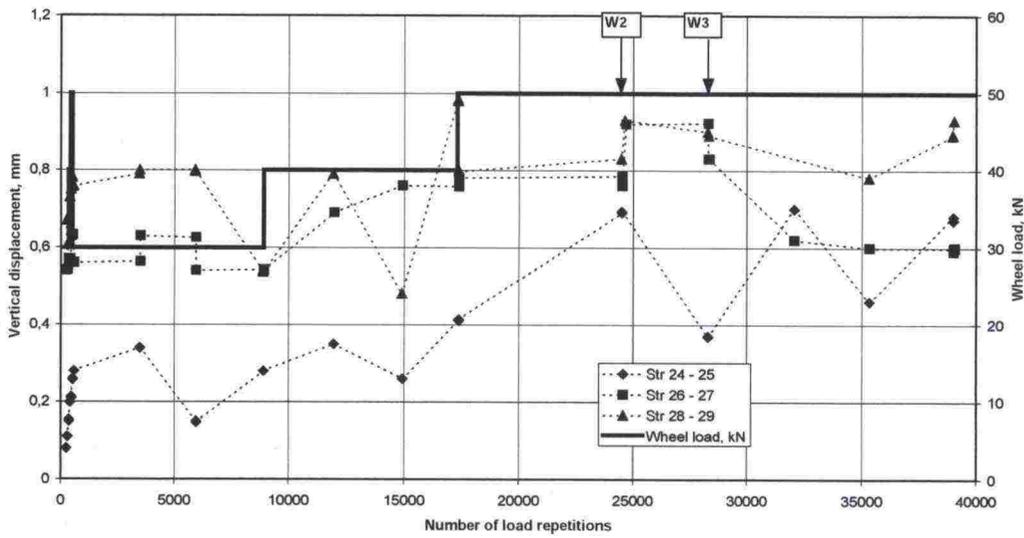
Figure A5.7. The permanent vertical displacement of the upper part of the clay (0-200mm).

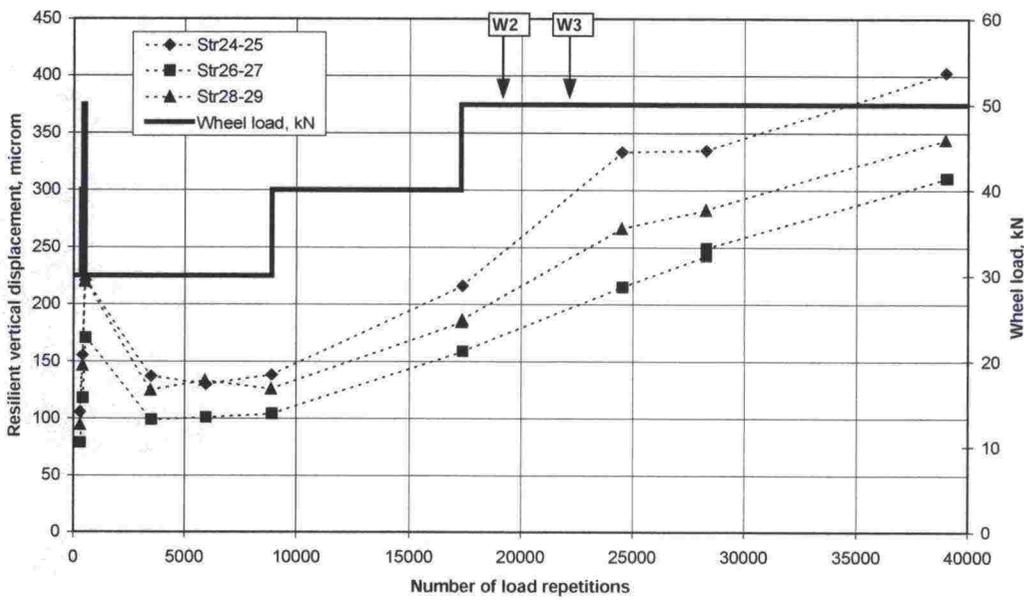
Figure A5.8. The resilient vertical displacement of the upper part of the clay (0-200mm).

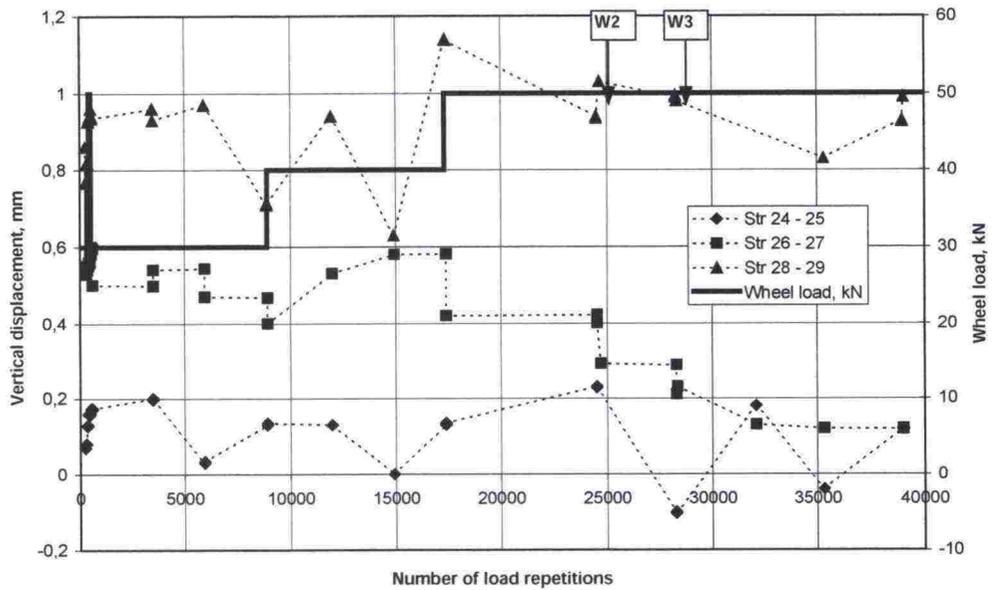
Figure A5.9. The permanent vertical displacement of the lower part of the clay (200-400mm).

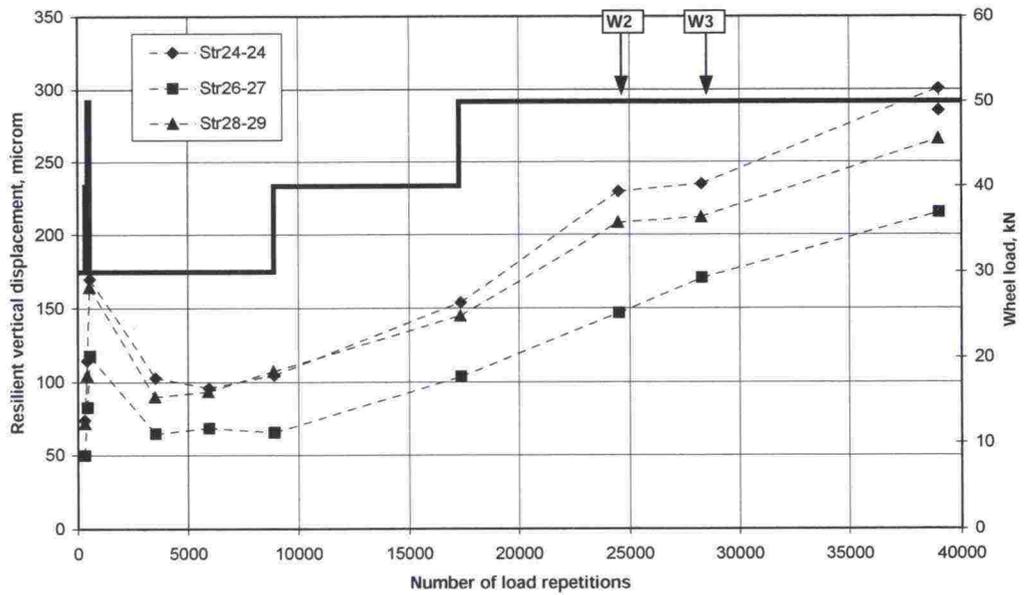
Figure A5.10. The resilient vertical displacement of the lower part of the clay (200-400mm).

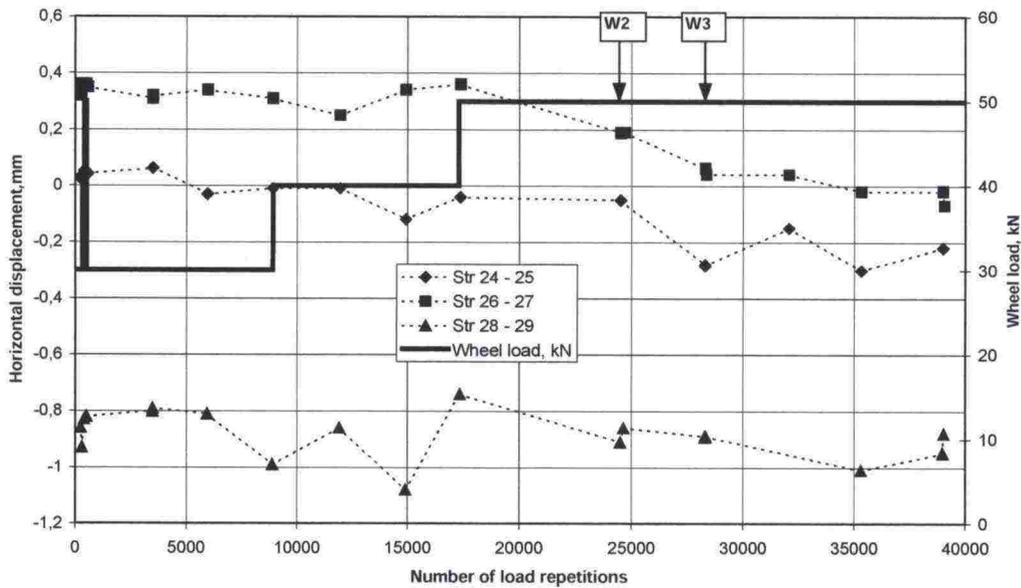
Figure A5.11. The permanent horizontal displacement of the interface of the clay in depth 200 mm.

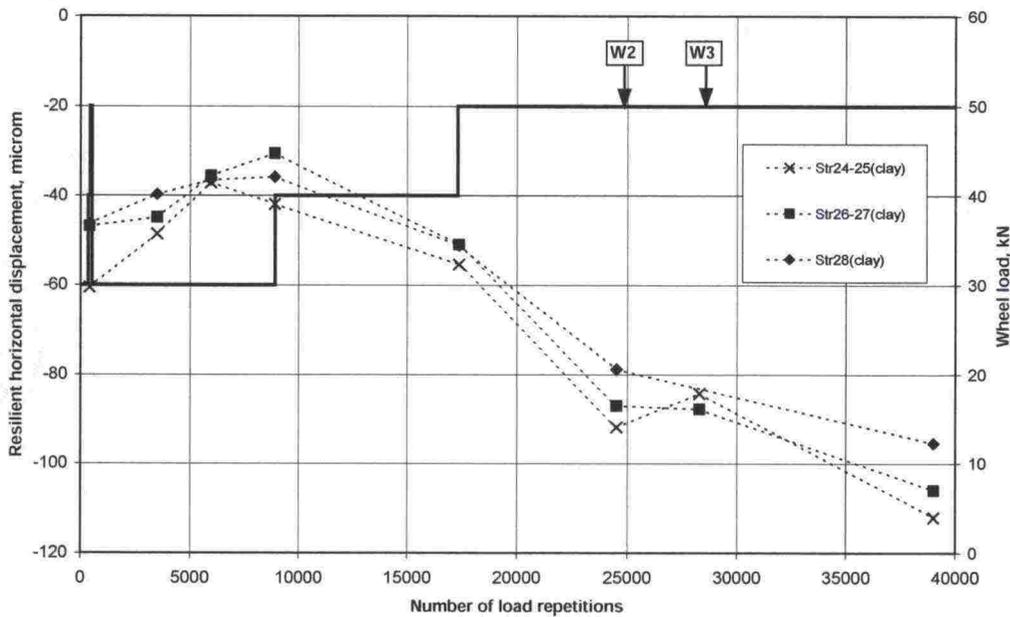
Figure A5.12. The resilient horizontal displacement of the interface of the clay in depth 200 mm.

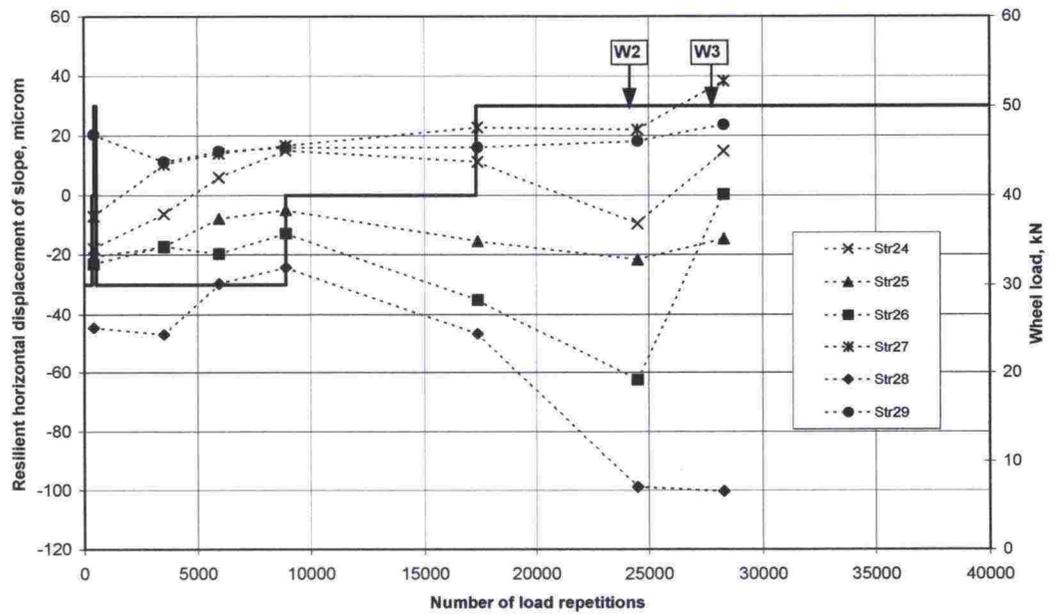
Figure A5.13. The resilient displacement of the slope in different structures. The negative value is for the pavement's displacement towards the slope.

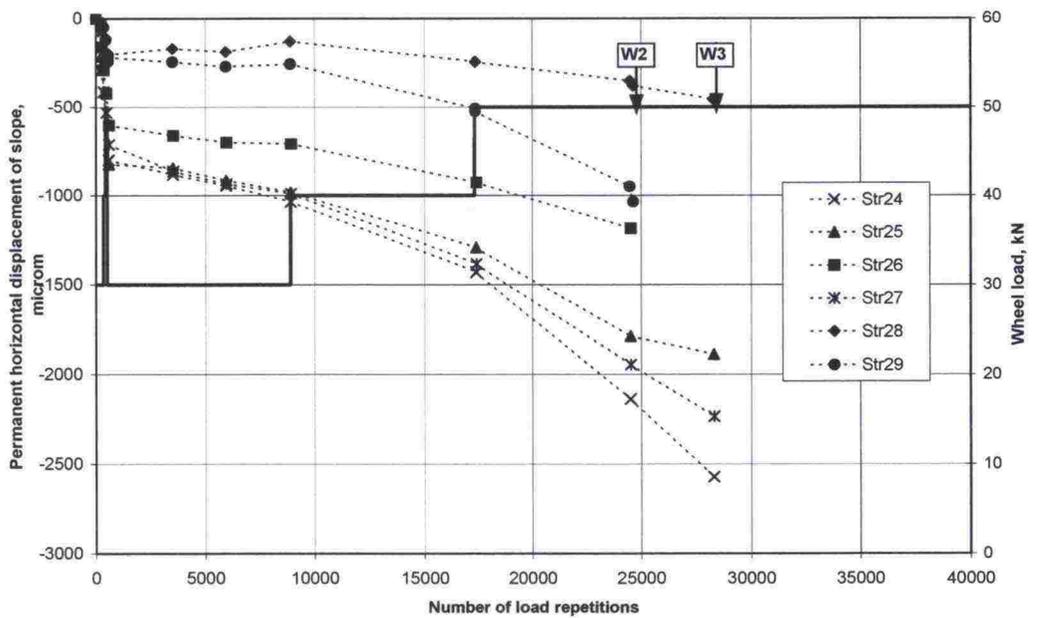
Figure A5.14. The permanent displacement of the slope in different structures. The negative value is for the pavement's displacement towards the slope.

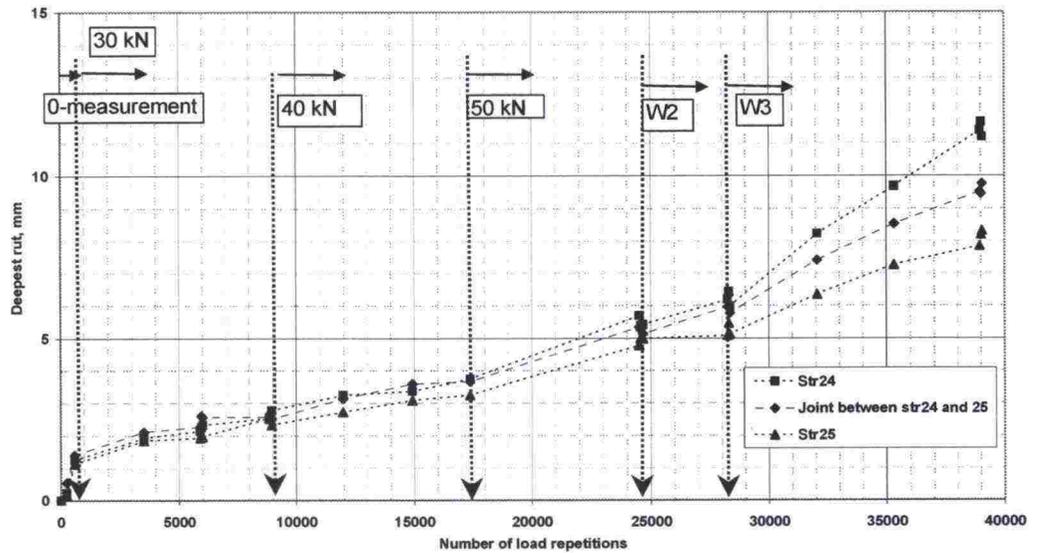
Figure A6.1. Average depth of the rut according to the profilometer measurements of the structure 24 - 25 in the deepest part of the rut.

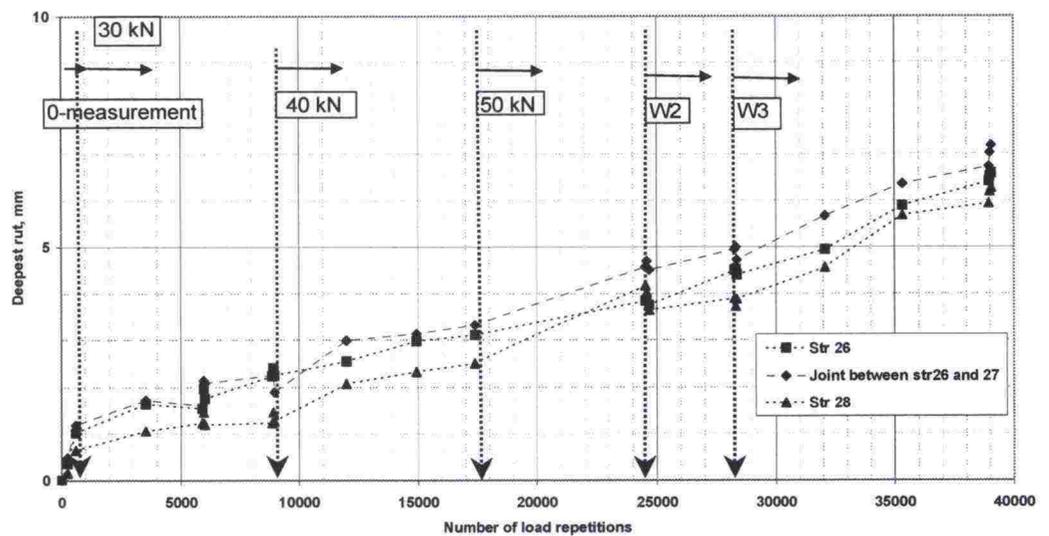
Figure A6.2. Average depth of the rut according to the profilometer measurements of the structure 26 - 27 in the deepest part of the rut.

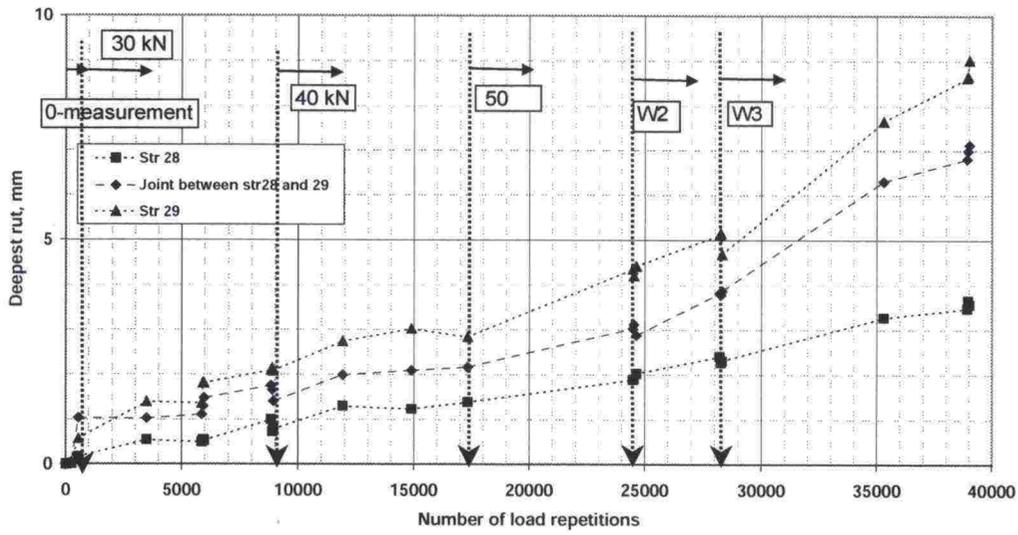
Figure A6.3. Average depth of the rut according to the profilometer measurements of the structure 28 - 29 in the deepest part of the rut.

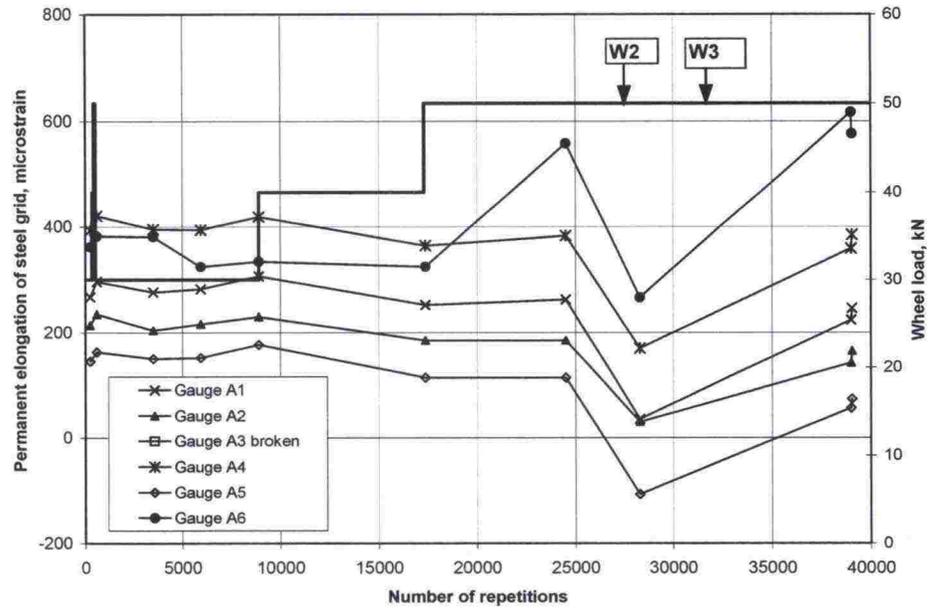
Figure A7.1. The permanent elongation in the steel grid in structure 25.

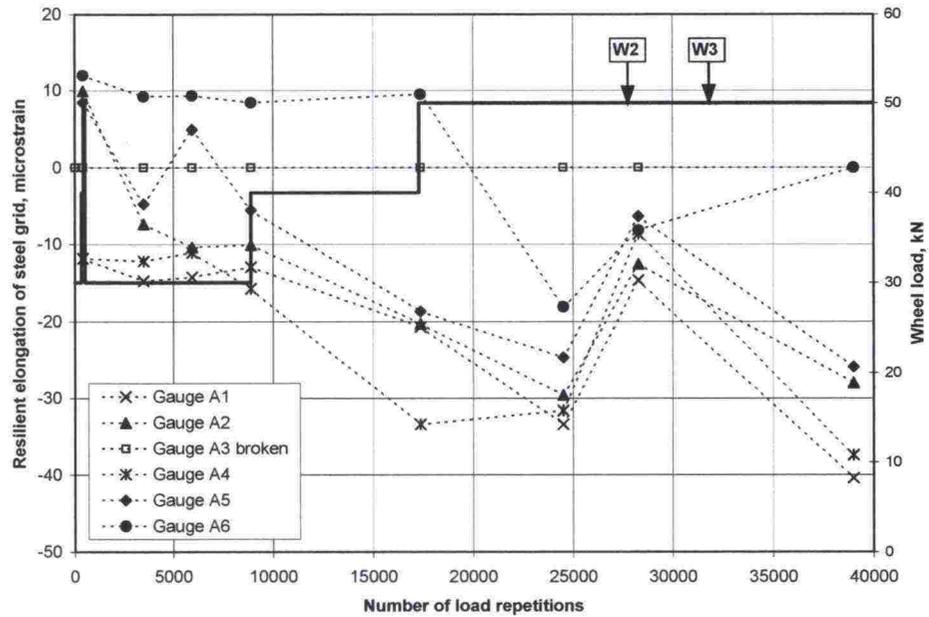
Figure A7.2. The resilient elongation in the steel grid in structure 25.

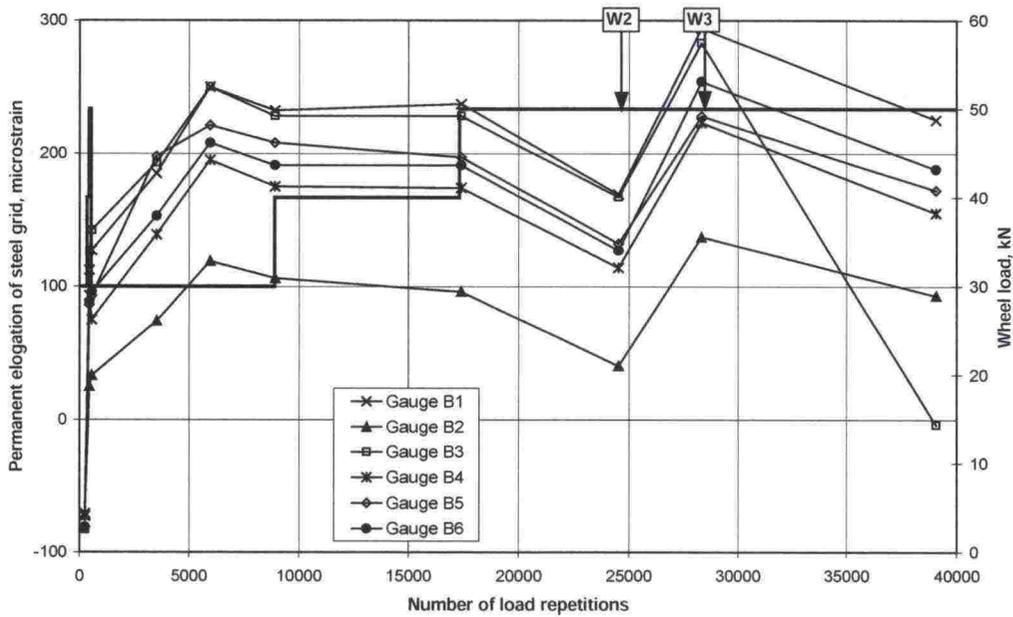
Figure A7.3. The permanent elongation in the steel grid in structure 26.

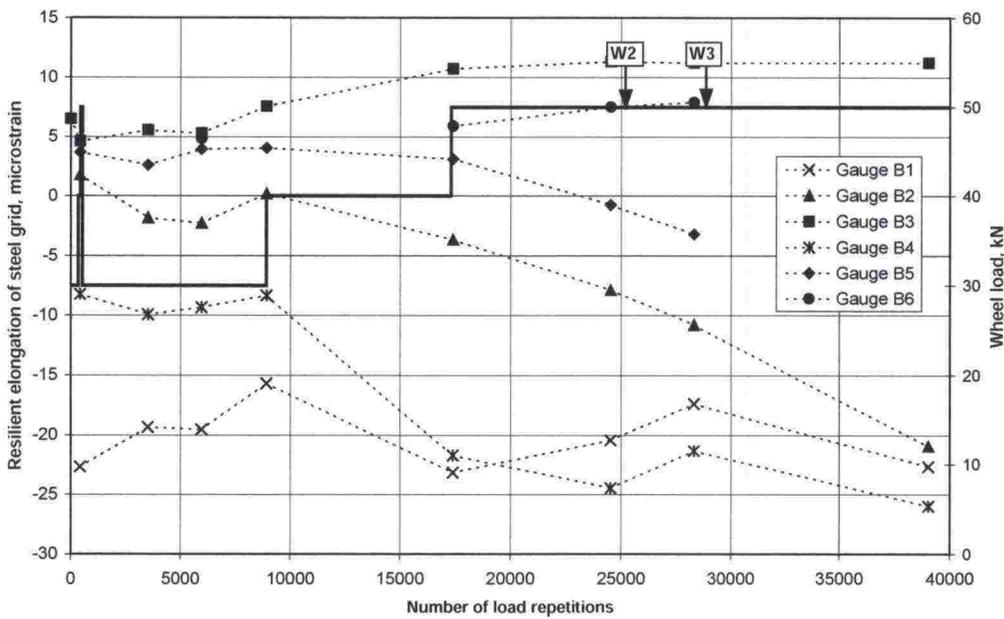
Figure A7.4. The resilient elongation of the steel grid in structure 26.

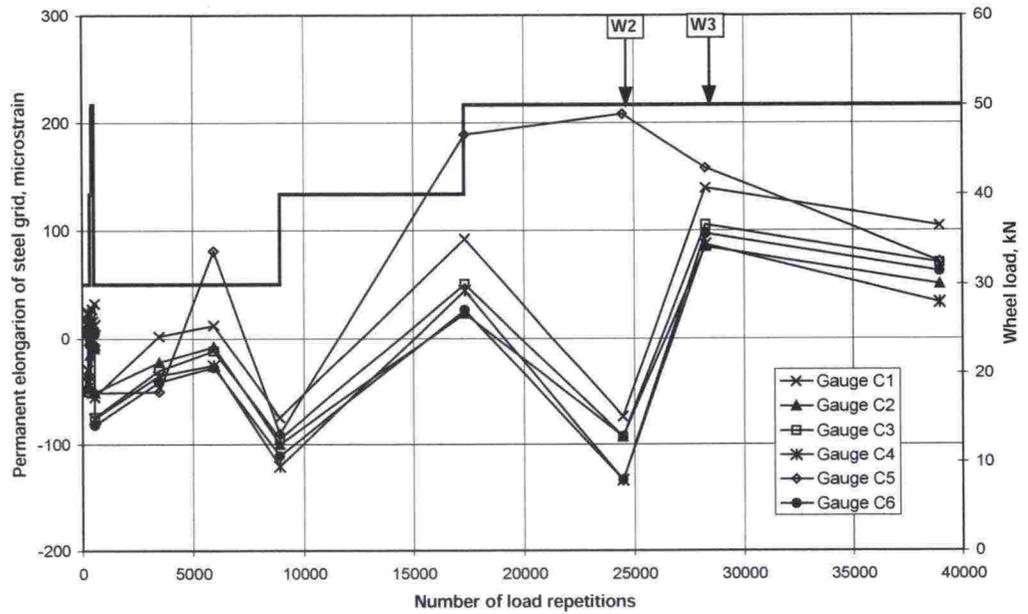
Figure A7.5. The permanent elongation in the steel grid in structure 28.

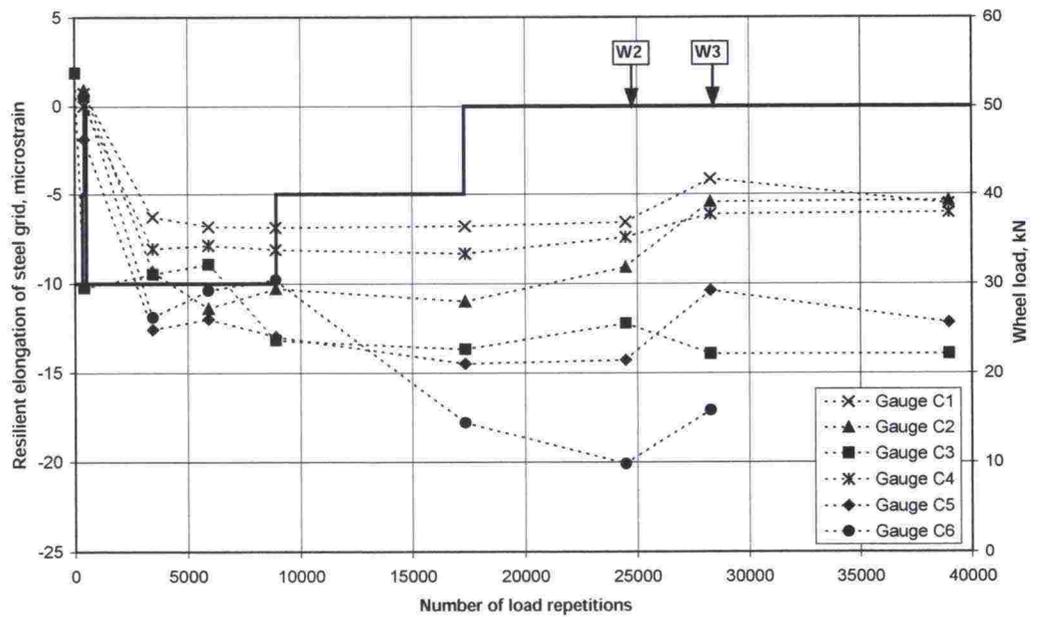
Figure A7.6. The resilient elongation of the steel grid in structure 28.
