Effect of steepness of sideslope on rutting

**Research of low-volume roads
HVS-test structures**

Finnra Reports 19/2003

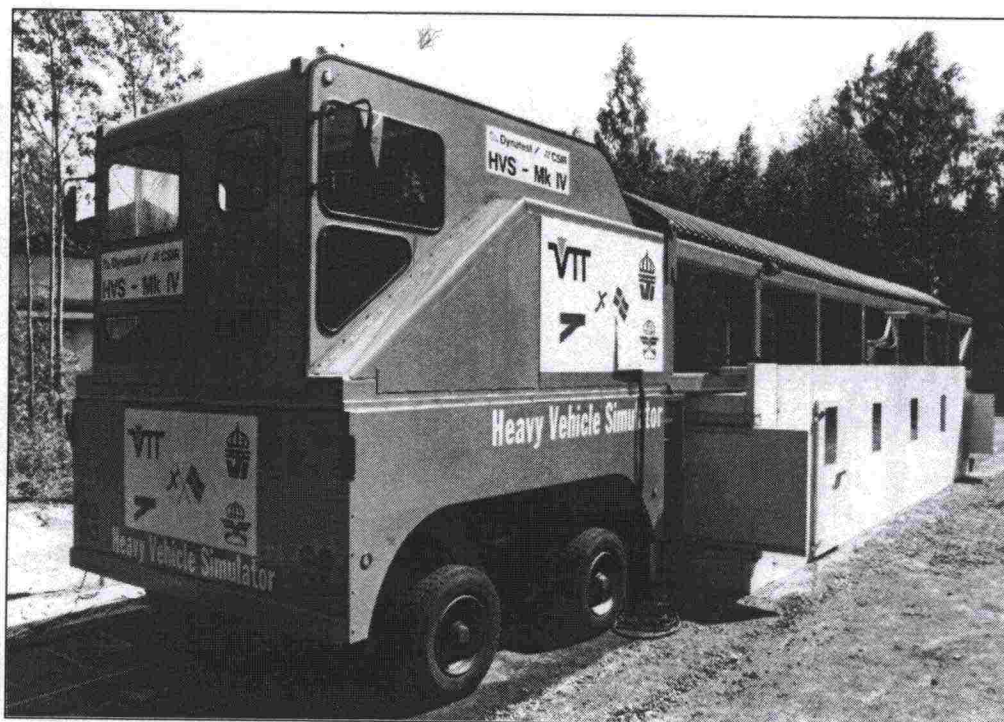
Figure 1.2 The Heavy Vehicle Simulator (HVS).

The maximum load achieved with the simulator is 110 kN and the minimum 25 to 30 kN. The load can be applied on the structure via either a lorry single tyre or twin tyre. The simulator includes a heating/cooling unit for keeping the road structure to be tested at a desired temperature. In this test, the temperature was +10 °C.

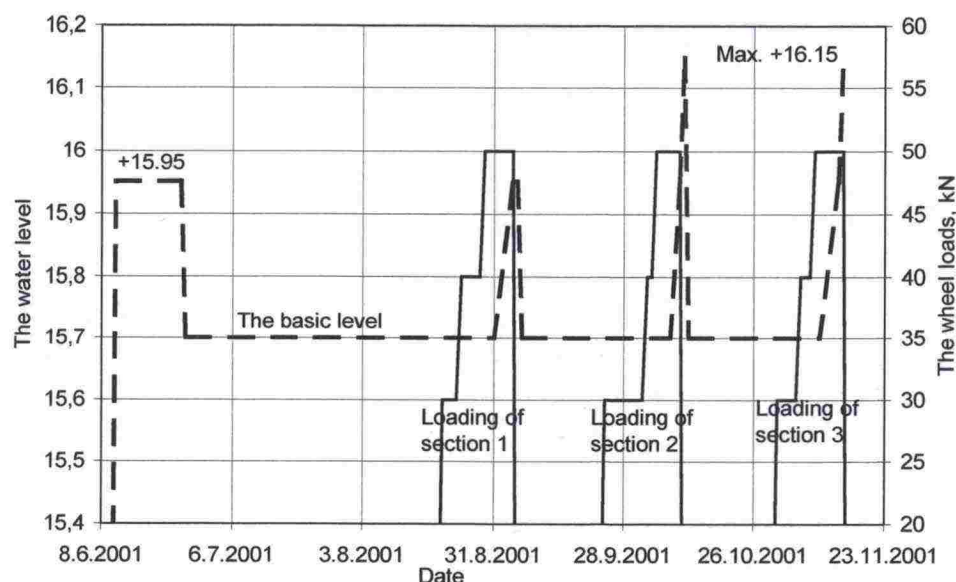
Figure 2.2 The ground water level and the loading times of the different sections.

The basic water table level was +15.70. In the final phases of loading each section, the ground water table was elevated to the level of the top of the gravel layer (W2) at the minimum, and on sections with gentle or steep slope, also to the layer of crushed rock (W3 +16.15). The variation in the ground water level and the loads on each section are presented in Figure 2.2.

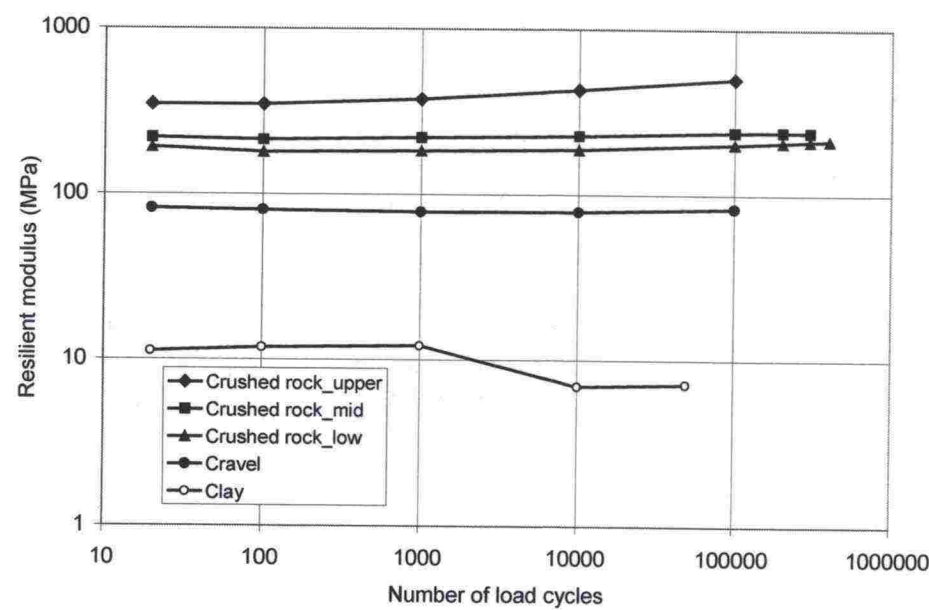
Figure 4.2. Resilient modulus values as a function of a cumulative number of load repetitions (cycles).

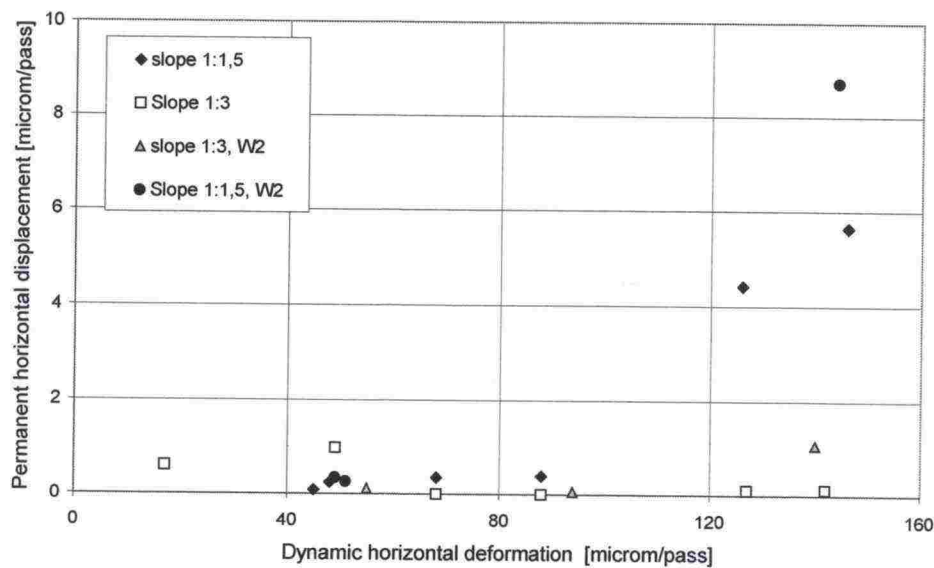
Figure 7.9 Ratios of horizontal deformations in the lowest part of crushed rock under a load of 50 kN.

The great differences in resilient horizontal deformations, while the steepness of the slope and the water content remained the same, are due to the way the structure was loaded. The structure was loaded in cycles of 600 passes so that the loading wheel was first positioned on the left side of the rut, approximately 300 mm from the centre, then in the centre and finally 300 mm to the right of the rut (positions 1, 2 and 3 in Figure 1.1). The greatest displacements were naturally observed in load position 3 when the wheel was nearest to the slope, and the smallest when the load was the farthest from the slope.

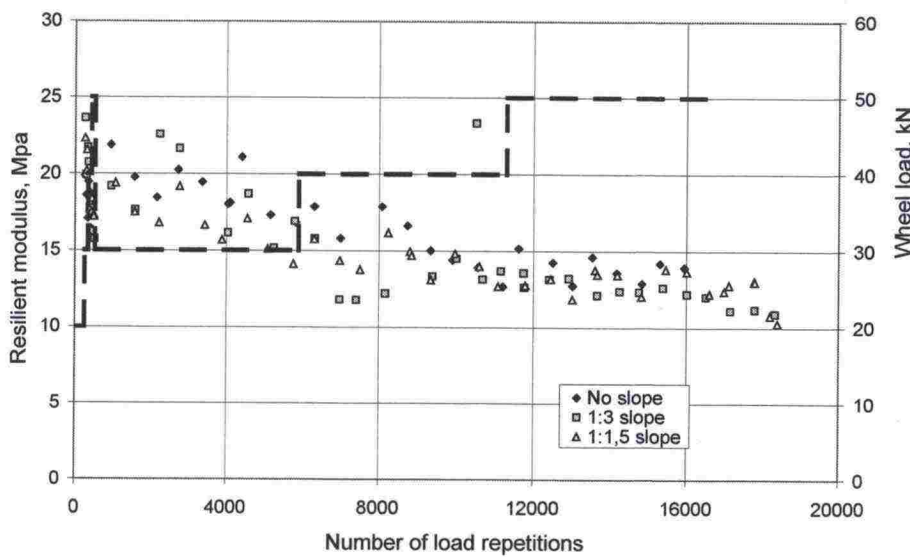
Figure 7.12 The dynamic resilient modulus of the clay layer (determined from the top part of the layer).

On the basis of the results, it cannot be said that the steepness of the slope influenced the values of the modulus in an unambiguous way. The structure with steep slope received higher modulus values than structures with no slope or gentle slope, particularly in the gravel layer. The greater variation in measurement results in the gravel layer can be due to defective functioning of earth pressure cells and/or Emu-Coil measurements in granular materials. The modulus defined for clay in laboratory tests after 10,000 load cycles is approximately 7.0 MPa and for gravel after 100 cycles 80 MPa in the corresponding range of stress. The E_{300} resilient modulus values (Loadman) measured from the surface of the gravel varied between 20 and 25 MPa.

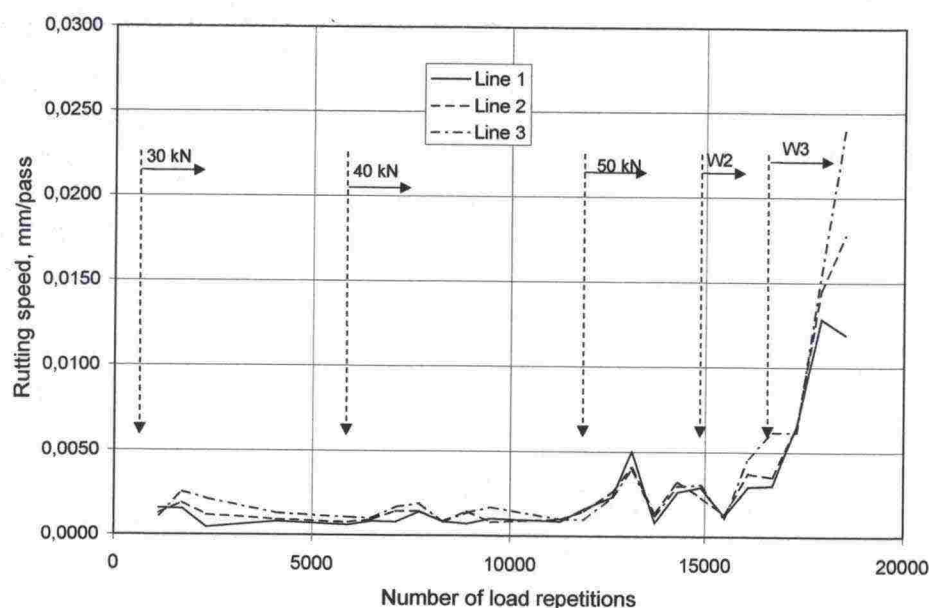
Figure 7.14 Rutting speed, slope 1:1.5

According to profilometer measurements, the speed of rutting within each load step decreased (Figures 7.13 and 7.14) in all structures. The results show some variation, but, on average, the trend is clear. However, if the material's water content increased (heavy rains, elevating the water table level to W2 and W3), rutting speed also increased. In the structure with steep slope, the elevation of the water table level to the crushed rock (W3) significantly accelerated rutting speed. It is even possible that continuing the loading might have caused a local failure.

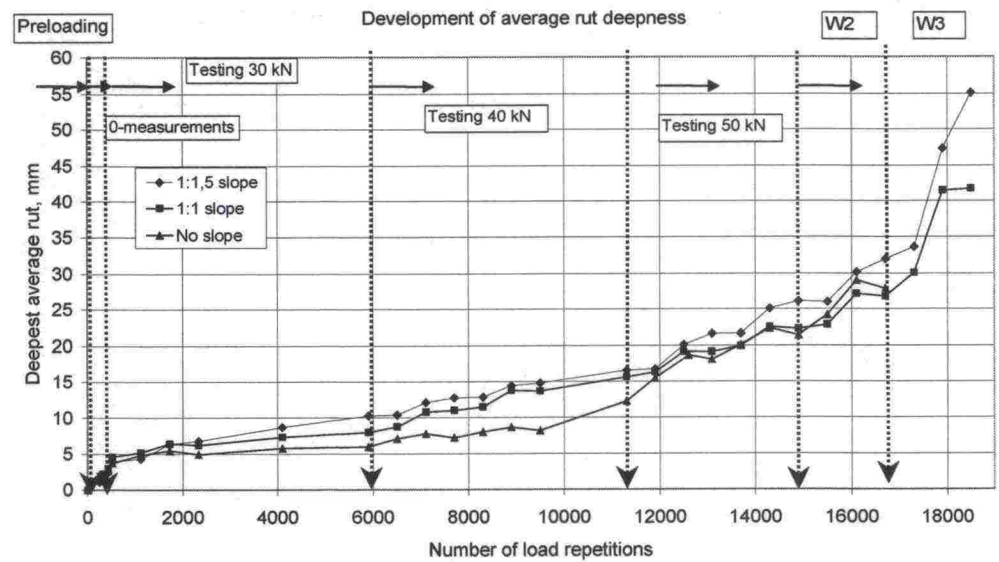
Figure 8.1 Development of rut deepness as a function of load.

The results for rutting speed are comparable, except for the results on the structure with no slope after 9,500 load repetitions. After this number of load repetitions, the development of rut deepness shows a strong increase as compared with the corresponding results for other structures. This was due to the structure getting wet because of heavy rains, thus increasing rutting.

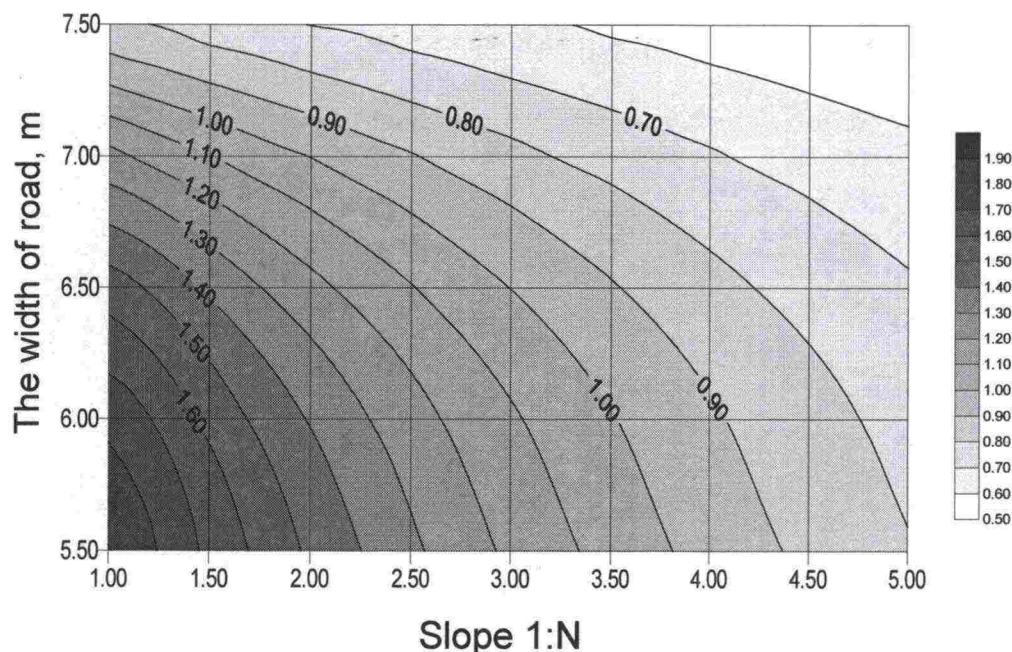
Figure 8.2 The GEOM factor as a function of slope steepness and road width.

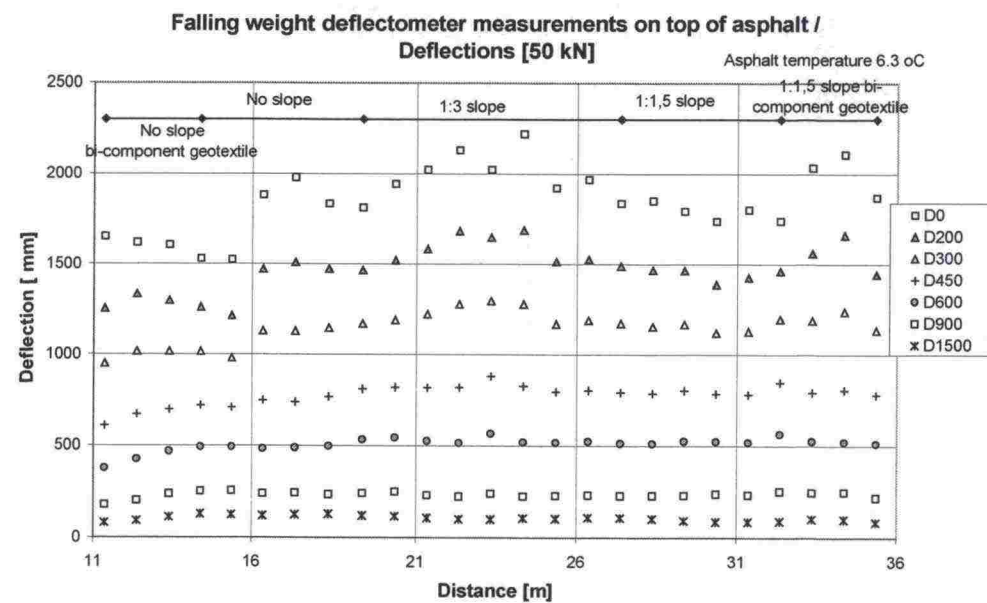
Falling weight deflectometer measurements on top of asphalt measured
immediately after building. Deflections.

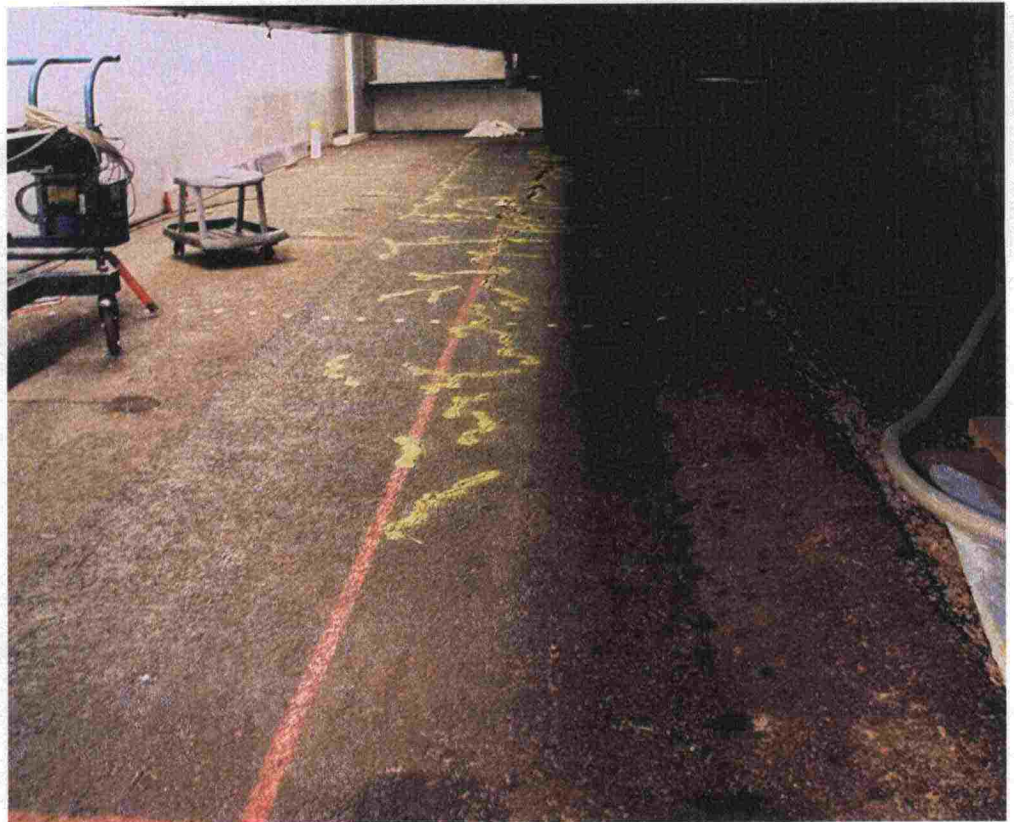
Figure 1. Cracks of the entire structure. Slope on right.

Distress surveys were made on the top of the surface layer immediately after the first cracks appeared. Subsequently, the damage was surveyed after each loading phase. The damage was recorded on maps, which indicated when they appeared and the corresponding loading figure. Only some minor damage (short, narrow cracks) was observed in structures with no slope or gentle slope. The structure with steep slope, however, showed significant

cracks, with the largest appearing behind the rut. Appendix 17 presents images of the damage in the structure with steep slope.

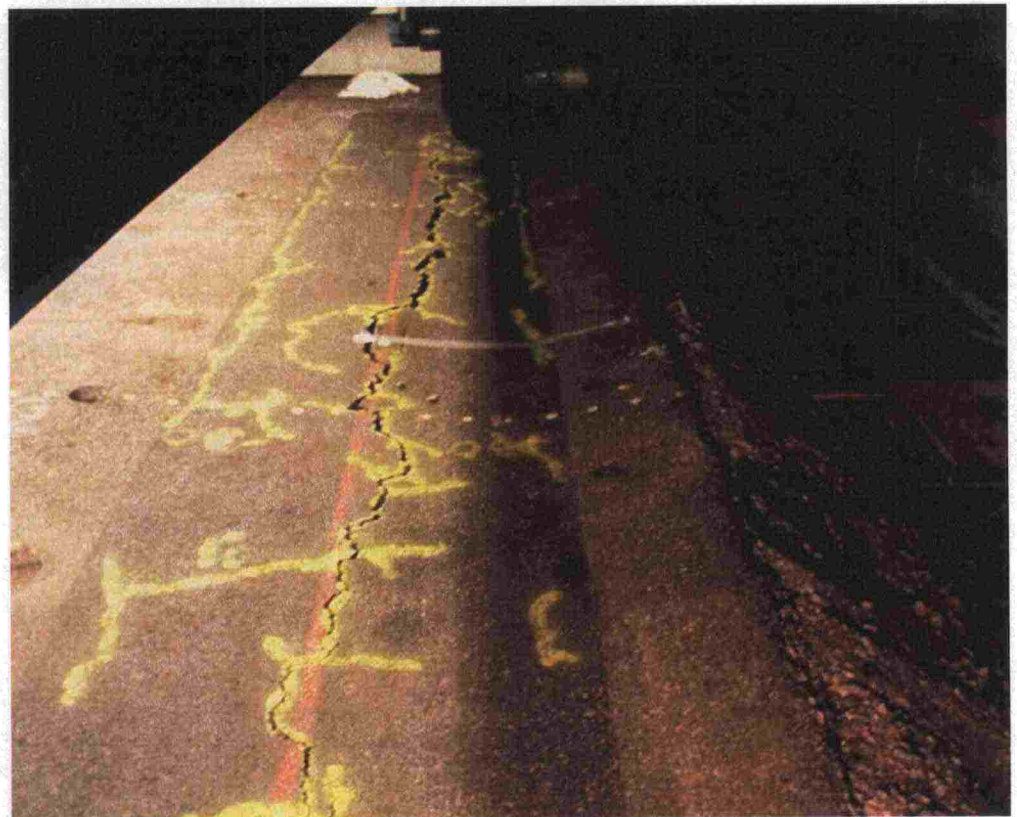
Figure 2. Cracks of middle part of structure.
