# **Automated Crack Measurement Test in Finland 2004**

**Finnra Reports 5/2005**

**Finnish Road Administration**

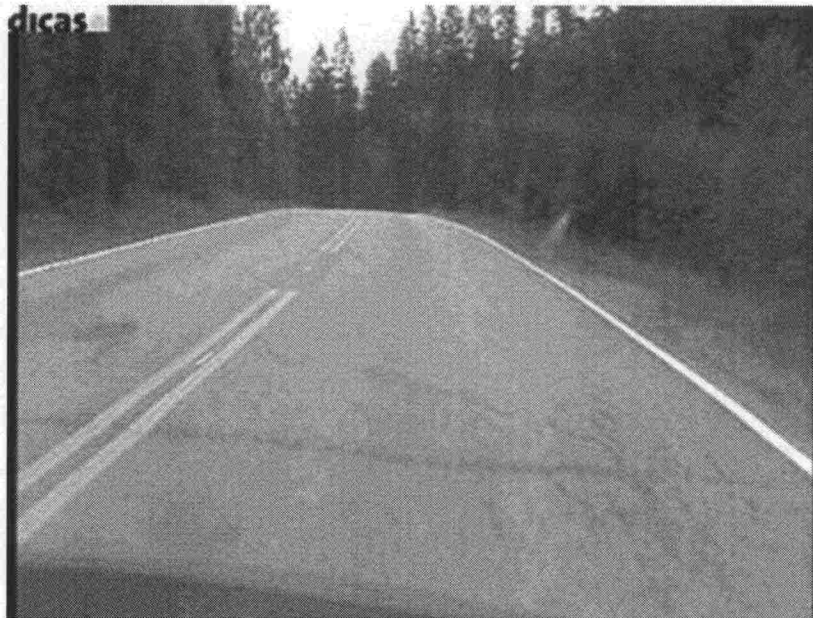
Figure 1. Example from the video, screen dump from the player.

Example from the video figure is from test site 5, 1075 m from the beginning.

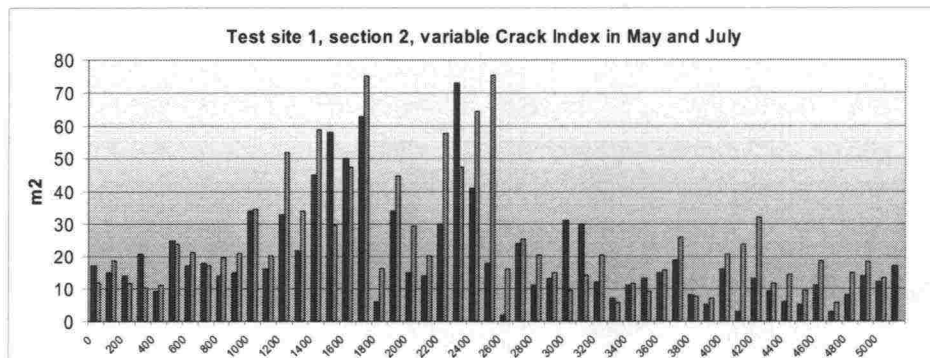
Figure 2. Example from test site data, PVI(May) and PVI(July) results.

The crack index results from both PVI inventory runs are presented in figure 2.

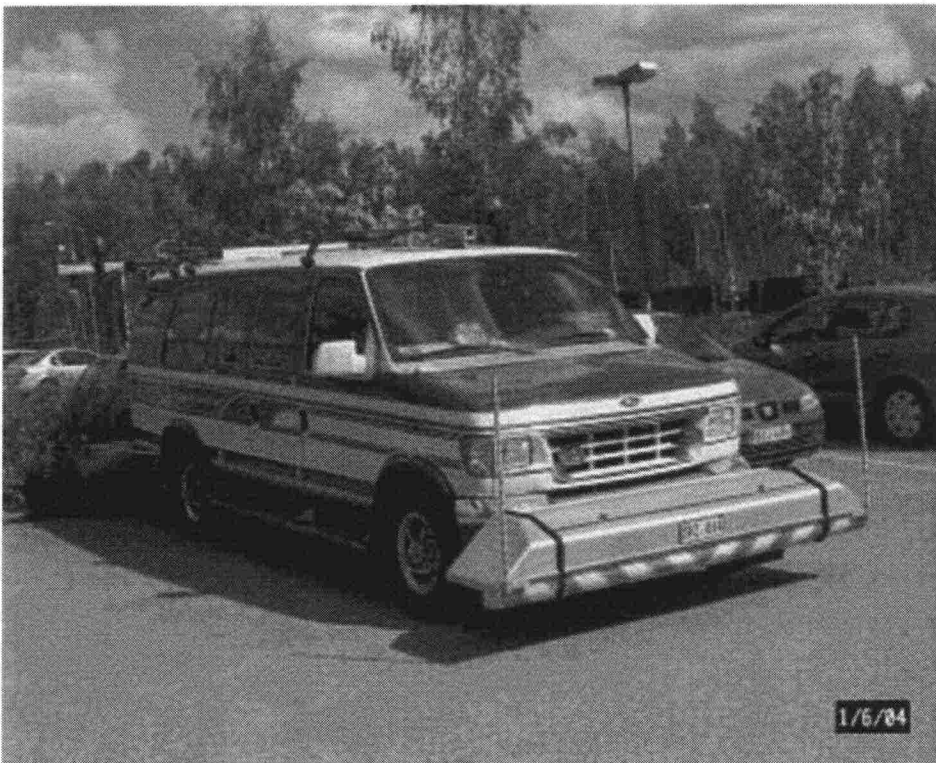
Figure 5. Ramboll RST measuring vehicle, version 2004.

Ramboll RST provided to the test a measurement device called Laser RST PAVUE, version 13. The company, Ramboll RST has currently a 5 year contract to measure the road surface features of the Finnish public road network, which includes automatic measurements of rutting, unevenness, texture etc. Ramboll RST has a long experience in road surface measurements and together with Ramboll OPQ (a part of Ramboll RST), the company has a complete array of techniques and equipment for the automatic crack measurements with production capability beginning in 2005.

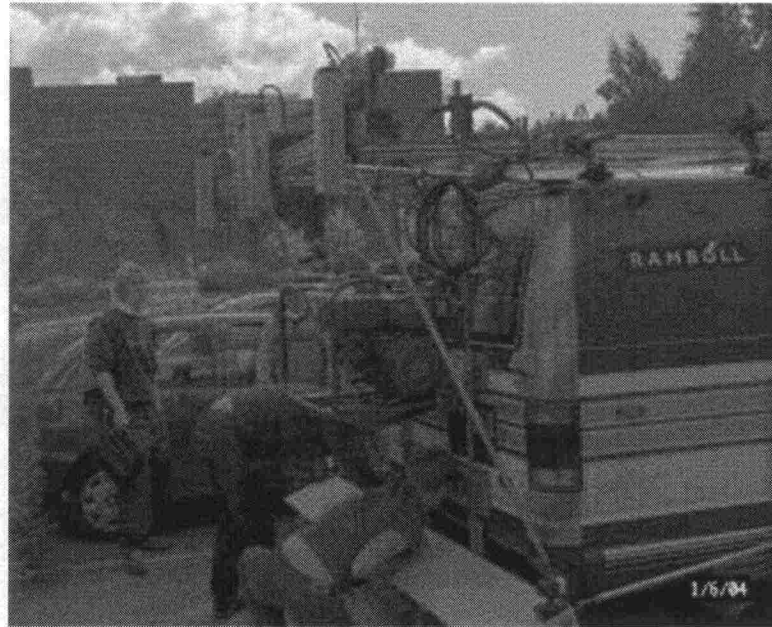
The measuring instrumentation used in this test was a Laser RST vehicle that was equipped with 4 cameras on the back side of the vehicle, facing the road surface and collecting images at highway speed limits. The vehicle also has a video camera directed forward to gather a pictorial overview of the road section measurements. The report of the measurements is on appendix D (Offrell 2004).

Additional lightning equipment is located at the back of the car, close to the pavement.

Figure 6. Cameras and the lightning system.

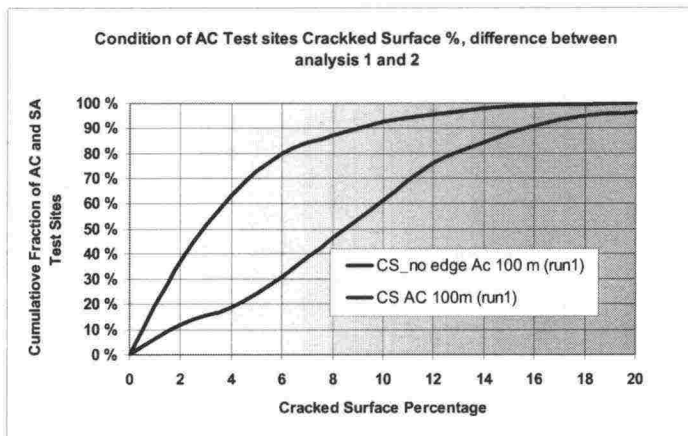
Figure 8. Difference between analysis settings 1 and 2.

- This overload can be different at different measurements, up to 5m in a 100m section.
- The analysis settings are very important input variables for the automated analysis: First analysis with the test data was done with too wide analysis area. The current system can not automatically adjust the edge of pavement, so too wide area was chosen to the first set of results. It gave a lot of cracks from the right hand side of the road. In the second analysis was the last 40 cm left out from the right side of the lane and 20 cm from the left side of the lane. The difference is shown in figure 8.

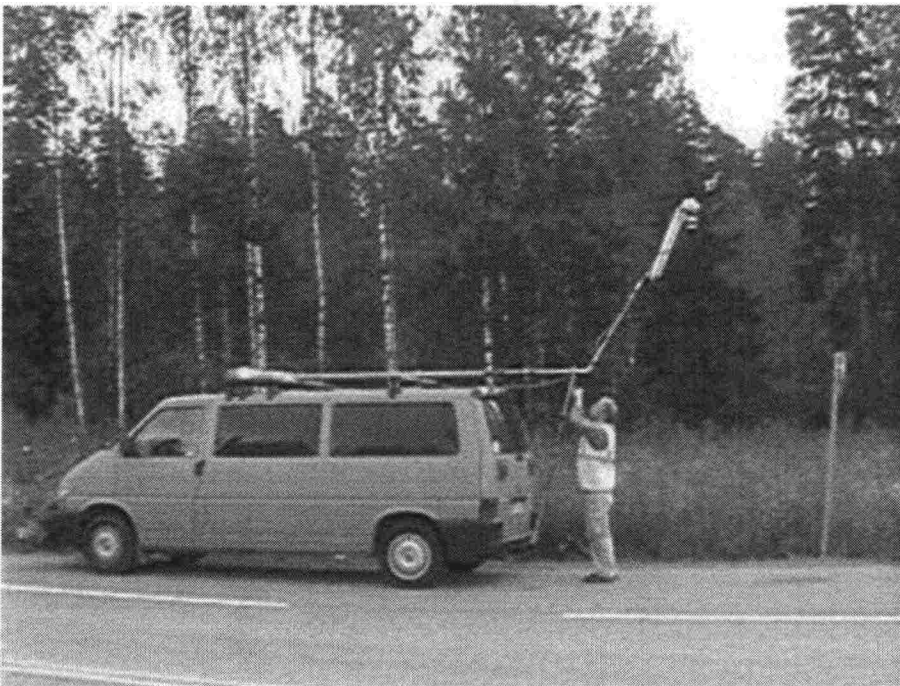
Figure 11. Crack measuring device, The Finnish Road Enterprise, version 2004

The Finnish Road Enterprise provided a second measurement device for the test. The Enterprise has done semi-manual PVI inventory since the methodology was introduced in the beginning of 1990's. The Finnish Road Enterprise has followed the development of the automated systems for a long period and was one of the main participants for the previous crack measurements test in 1998 with the GIEtech Inc. The Finnish Road Enterprise can also provide a wide range of measurement services for network and project level measurements.

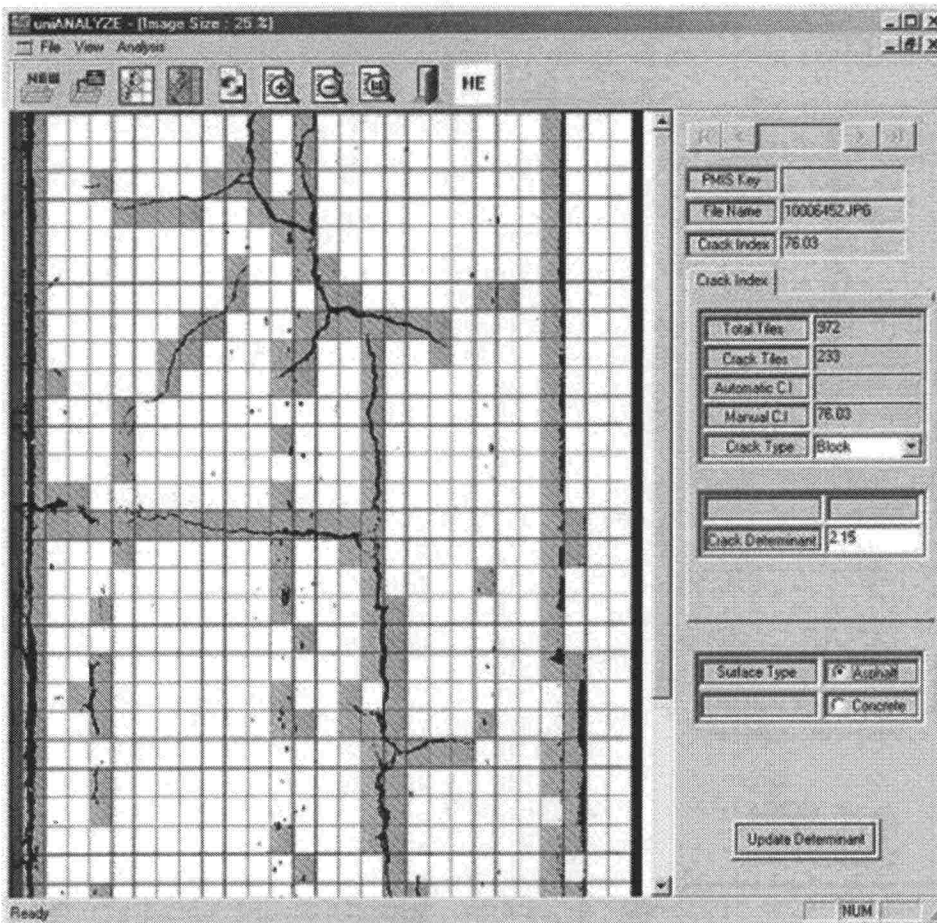
Unified Crack Index (UCI) is the percentage of the road surface affected by cracking and patching. Dr. H. Lee first introduced the Unified Crack Index classification standard (Pavement Management Implementation, ASTM STP 1121). uniANALYZE counts the number of cracked grids. Then, it divides the counted number by the total number of grids to compute a unified crack index for each pavement image. The size of grids can be chosen by the customer in this test we have used 20 cm x 20 cm grid. Figure 13 shows a sample of the unified crack index.

Figure 13. The Unified Crack Index analysis window displaying a processed unified crack index of 73.03 % (100 – 233 cracked grids out of 972 total grids)

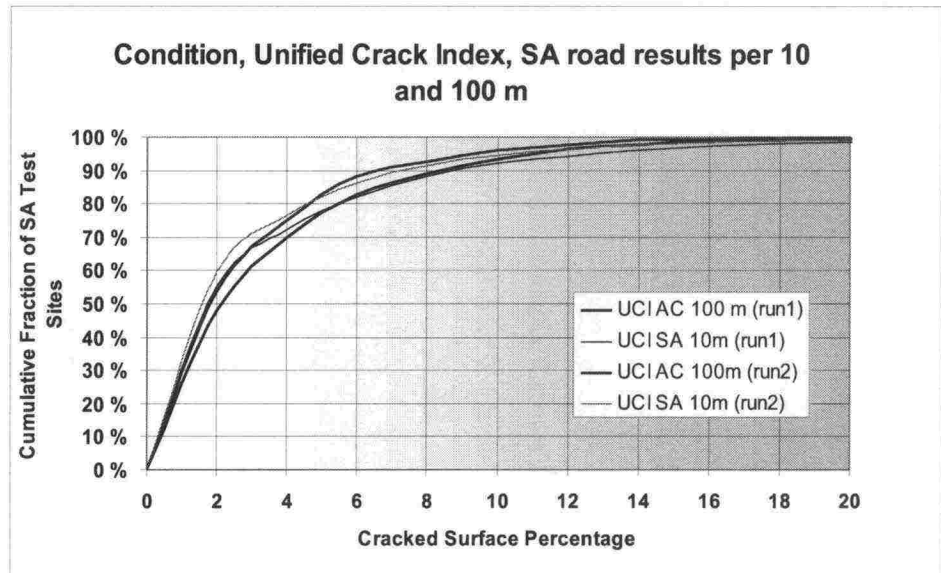
Figure 21. The condition distribution for soft asphalt (SA) roads with Unified Crack Index variable, System T.

Same test sites are presented with Unified Crack Index % with 10 and 100 meter sections in Figure 21.

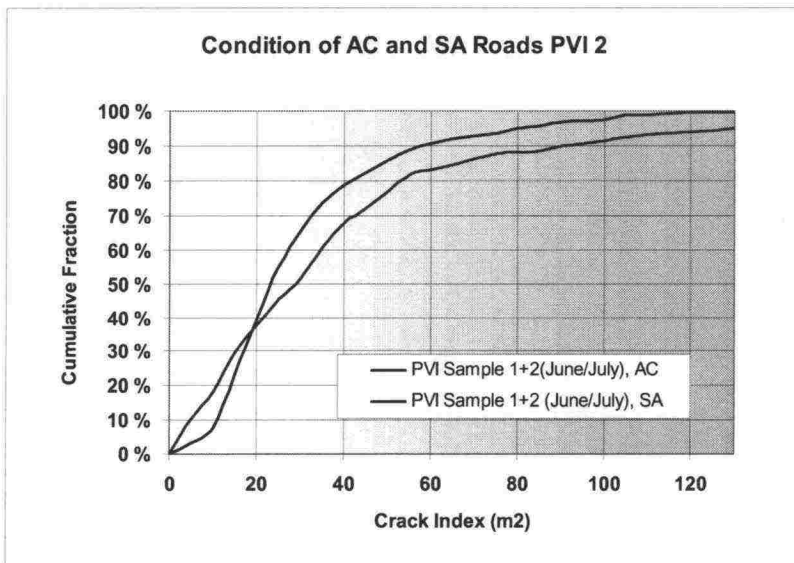
Figure 22. The condition distributions for AC and SA roads with PVI variable.

The traditional result from PVI shows the difference in Figure 22.

SA test sites have less little cracked and a lot more very cracked sections.

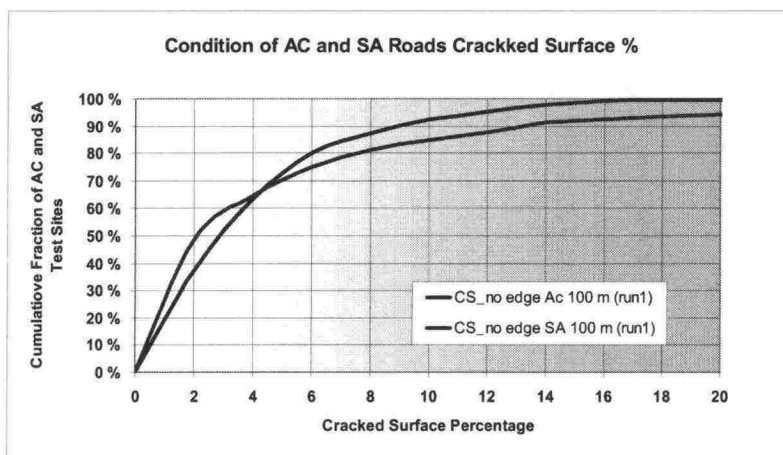
Figure 23. The condition distributions for AC and SA roads with Cracked Surface variable by System R.

System R, Cracked Surface percentage, shows similar trend than PVI variable. For example the crossing of AC and SA lines.

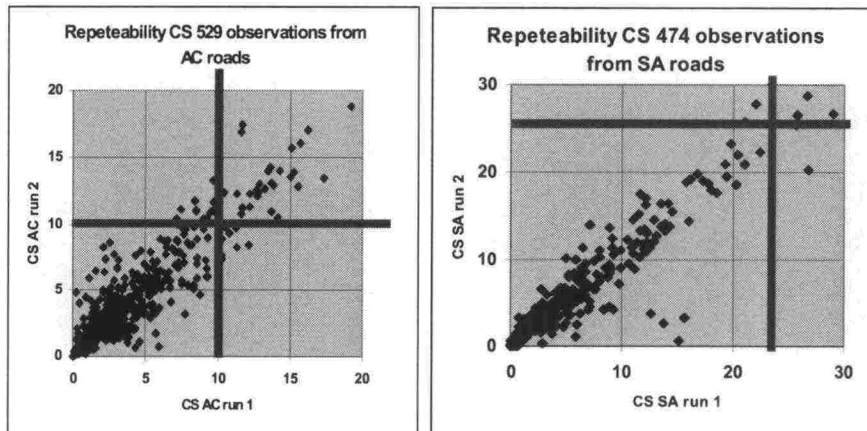
Figure 30. System R observations (CS) from 2 runs, AC and SA test sites.

All observations from run 1 and run 2 are presented in Figure 30 for AC and SA 100 meter observations.

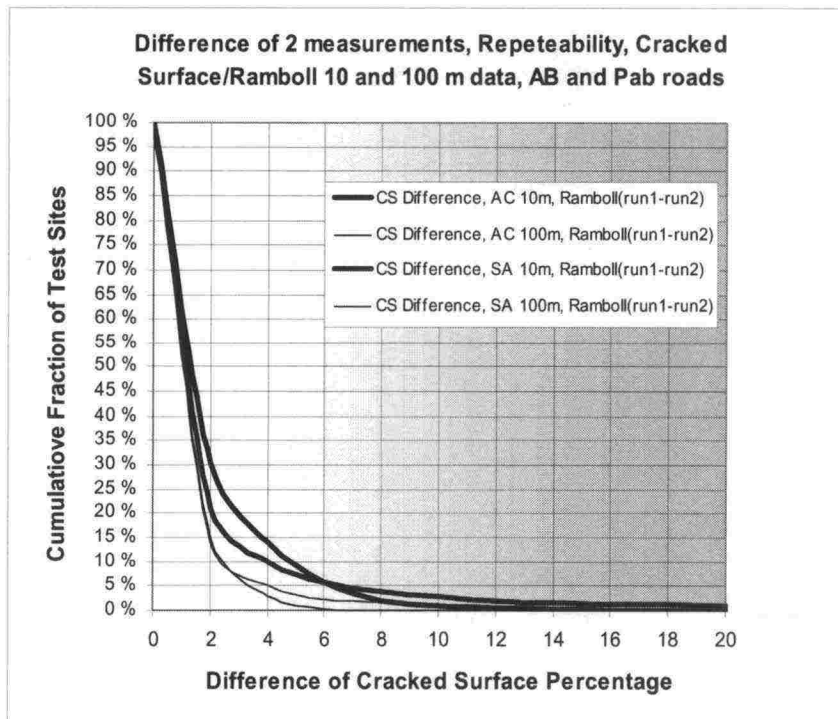
Figure 31. System R (Ramboll 2004) repeatability AC and SA test sites.

All observations from run 1 and run 2 are presented in Figure 31 for AC and SA 100 meter observations.

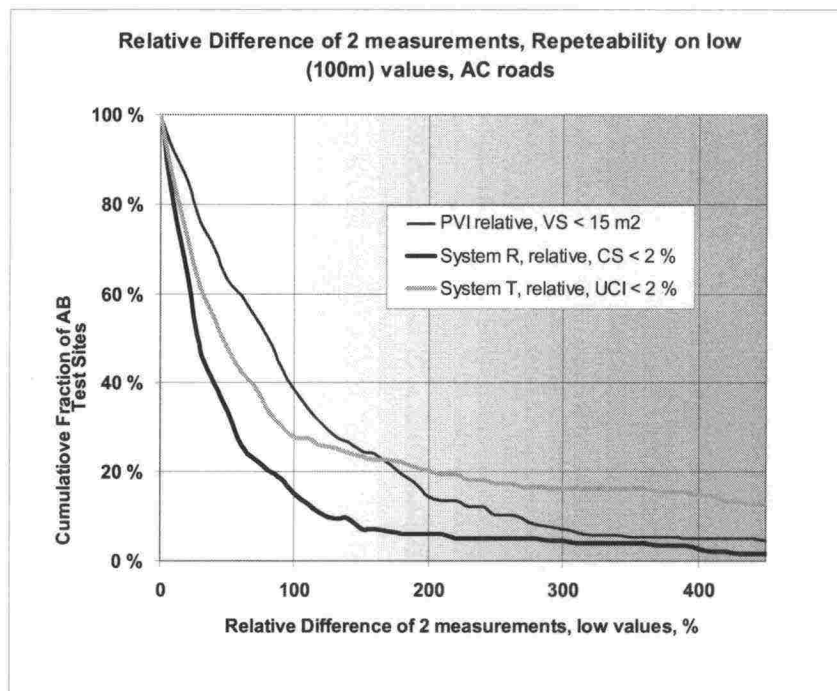
Figure 34. Relative difference on AC test sites with low cracking.

- Low is 40 % of observation (PVI value is  $\leq 15 \text{ m}^2$  and CS and UC values  $\leq 2$ ).
- Medium are 30 % of observations (PVI value is 15-30  $\text{m}^2$  and CS and UC values 2-5).
- High is 30 % of observation (PVI value is  $> 30 \text{ m}^2$  and CS and UC values  $> 5$ ).

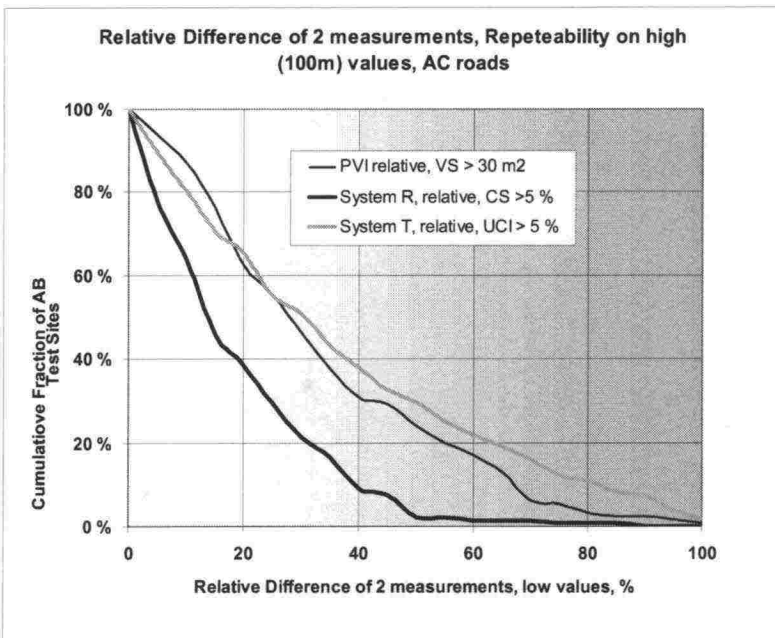
Figure 36. UCI condition distribution and the reliability on AC test sites with high amount of cracks.

On medium (PVI value is 15-30 m<sup>2</sup> and CS and UC values 2-5). System 2 behaves similar way as the PVI.

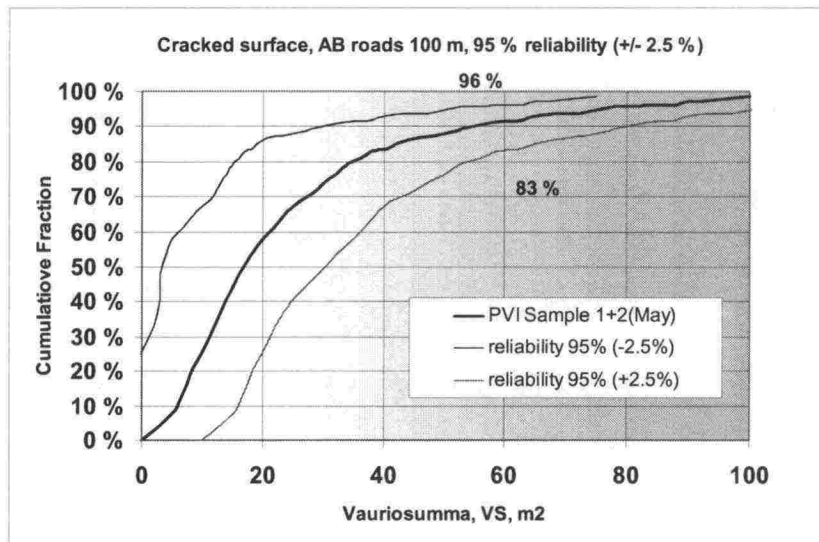
Figure 37. PVI condition distribution and the reliability on AC test sites.

The figures 37 - 39 show the range for 95 % reliability of each variable. The curve has defined separately for previous presented low, medium and high crack samples. In Figures 37 – 39 is presented the condition curve (from chapter 4.1) and upper limit (97.5 % observations are below the light red curve) and lower limit (2.5 % of observations are above to brown curve). At the limit for “poor road”, PVI 60 m<sup>2</sup>, the reliability of the variable is between 83 % and 96 %.

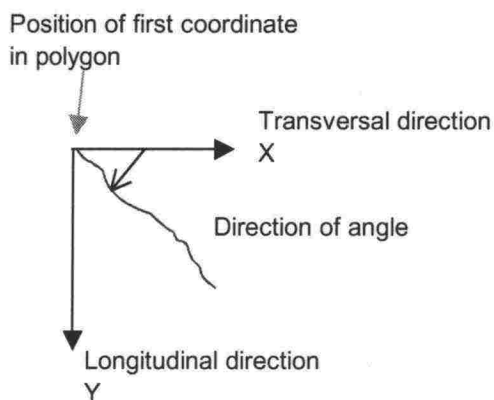
Figure 41. Basic information for one crack.

In Figures 41 and 42 are presented some decision rules to define the crack type.

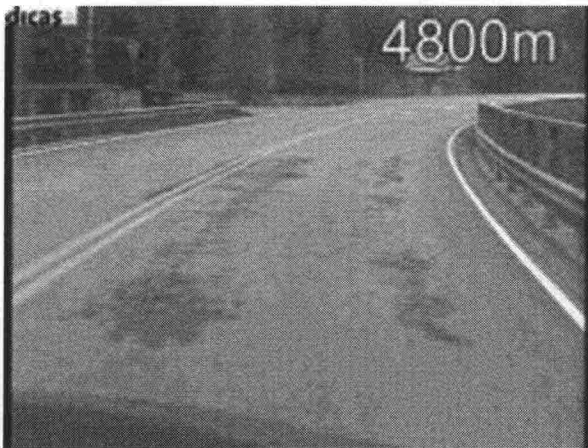
Figure 43. Video image from the test site 5.

1. The overview image from video
2. Compiled images from Ramboll PAVUE vehicle
3. Polygon data after the DIP(digital image process) analysis
4. Black and white crack map report
5. Grid for definition of cracked surface

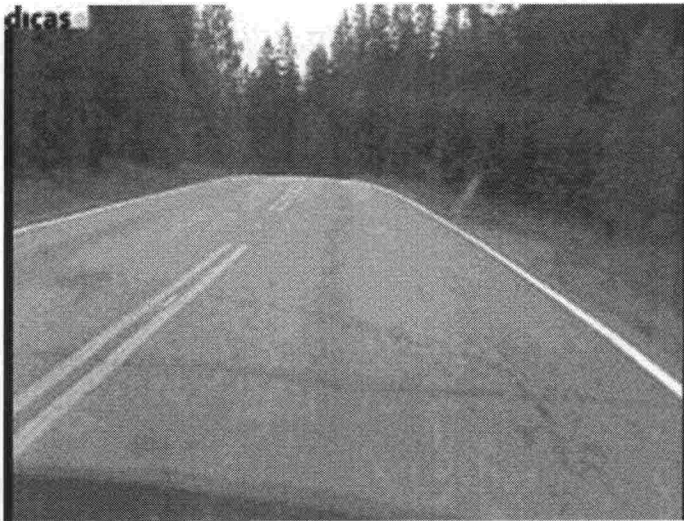
Figure 47. Polygon data usage.

1. The first figure shows the overview image from video
2. Compiled images from Ramboll PAVUE vehicle
3. Polygon data after the DIP analysis
4. Black and white crack map report
5. Grid for definition of cracked surface

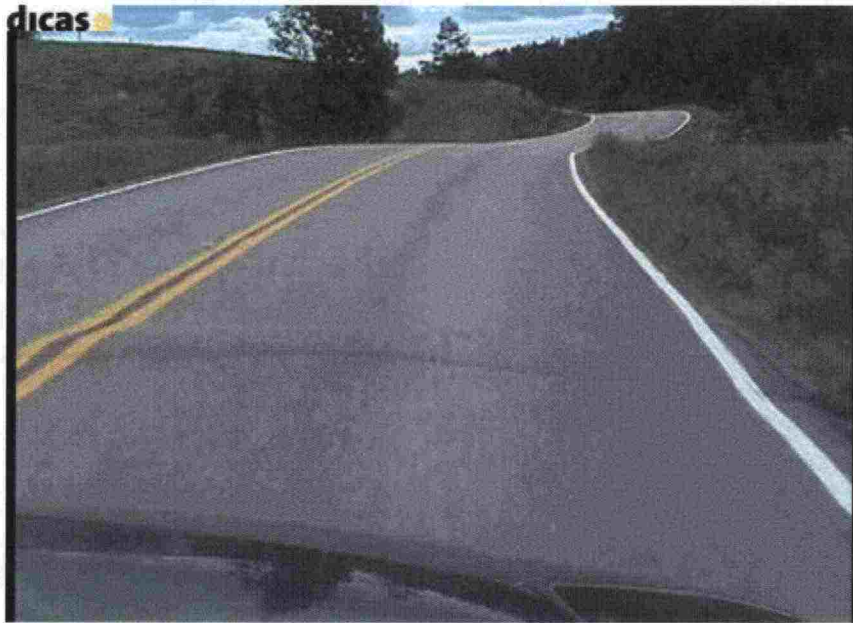
Centerline crack

PVI: narrow transversal crack on smooth AC pavements  
System1: Only half of the crack was detected, similar result with PVI  
System 2: Most of the small cracks were not detected

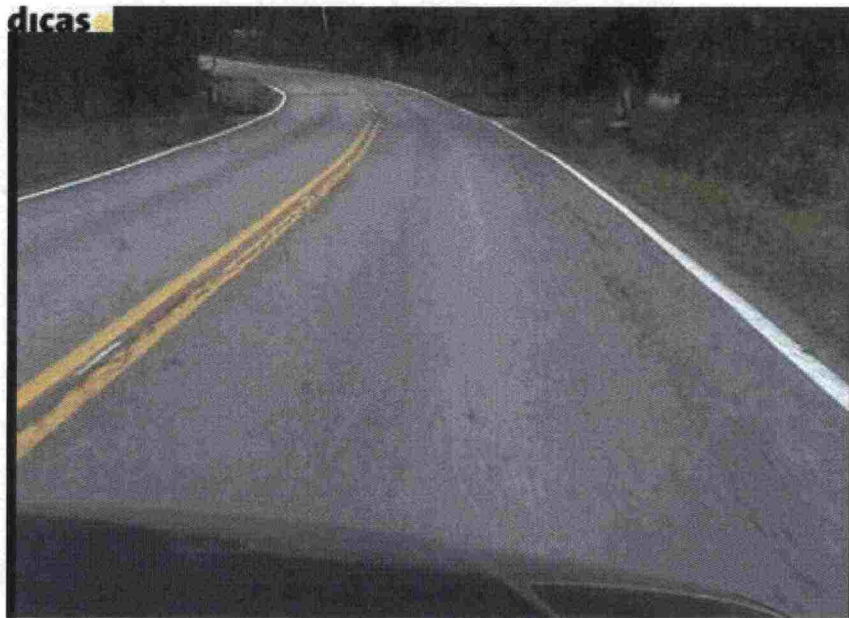
Alligator crack initiates in wheelpath

PVI: Defined as one longitudinal crack  
System 1: Good result  
System 2: Good result

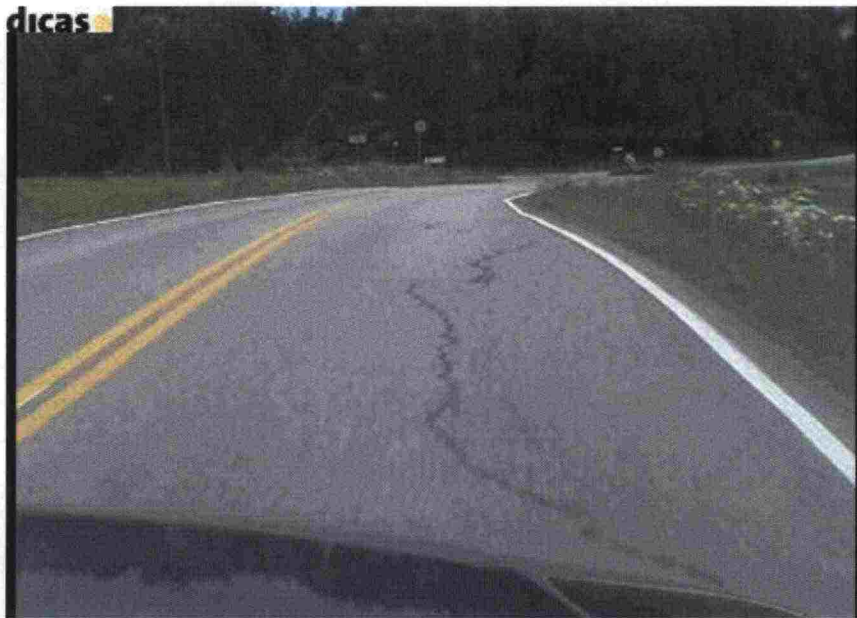
**Wide Longitudinal Crack**  
PVI: Crack defined as narrow  
System 1: Good result  
System 2: Crack was not detected

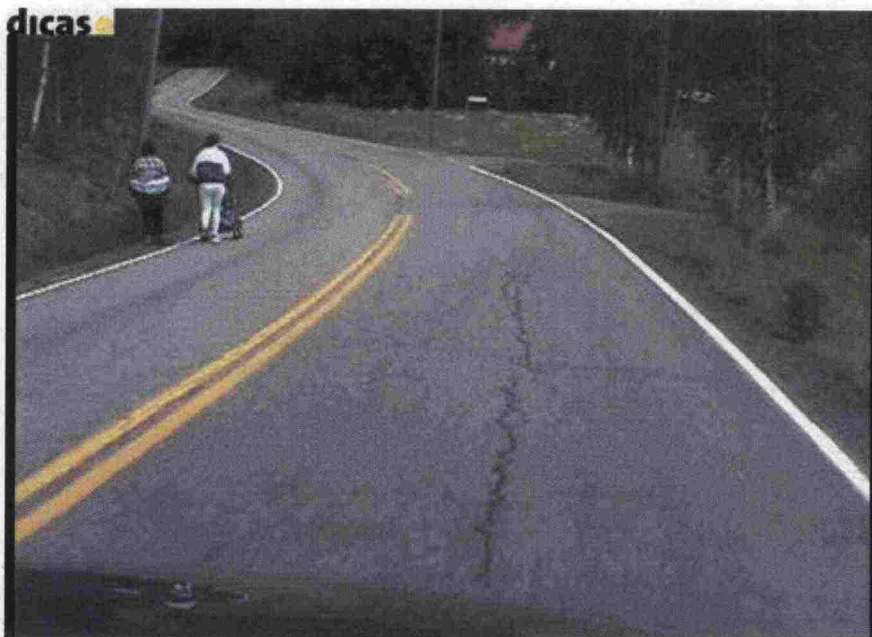
Longitudinal Crack

PVI: Many cracks, one meter alligator crack  
System1: Good result on both runs  
System 2: A lot of cracks were not detected

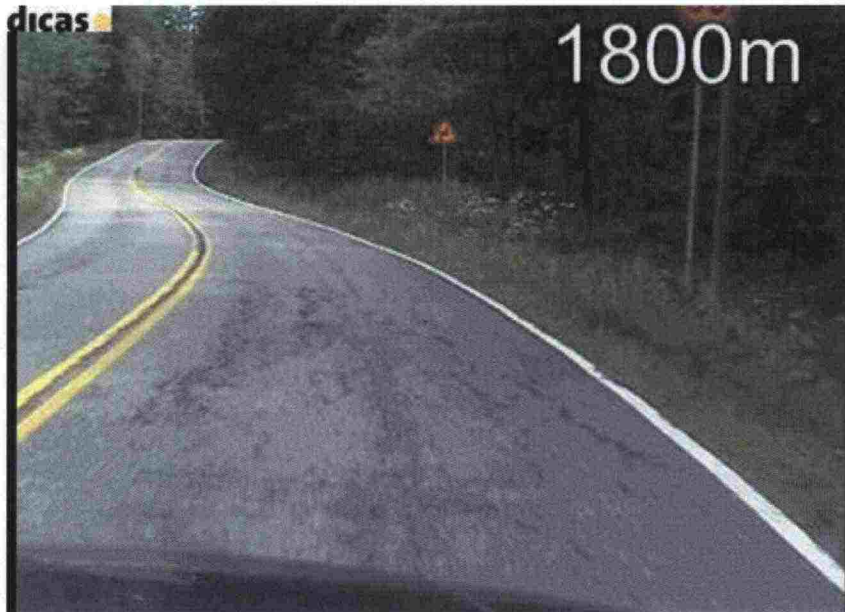
Test Site 4  
Road Section 1  
1820

**Longitudinal Cracks or initiating Alligator cracks**  
PVI: Not very useful definition, VS only 6.7  
System 1: Good result on both runs  
System 2: Rough surface was not detected as cracks

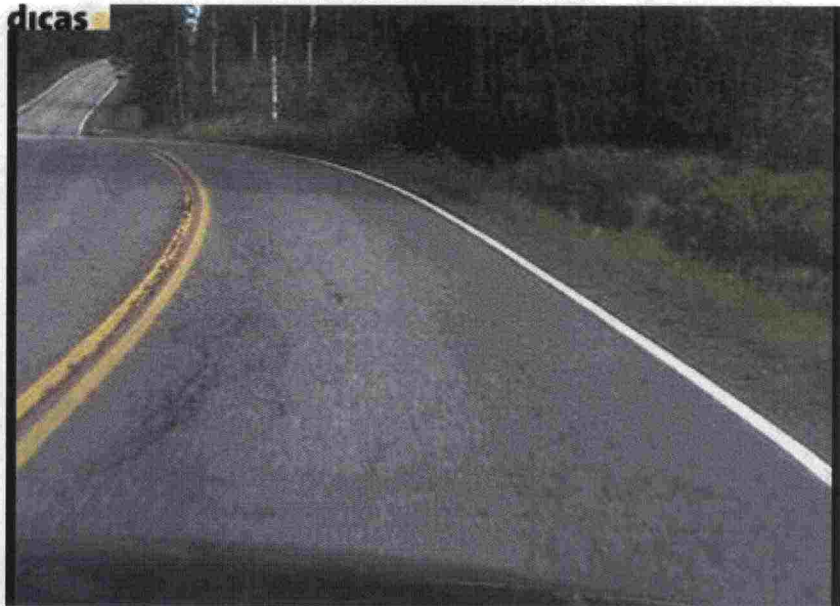
Alligator crackking  
PVI: 50 % crackked  
System1: Detected a lot of these cracks  
System 2: Crack was not detected

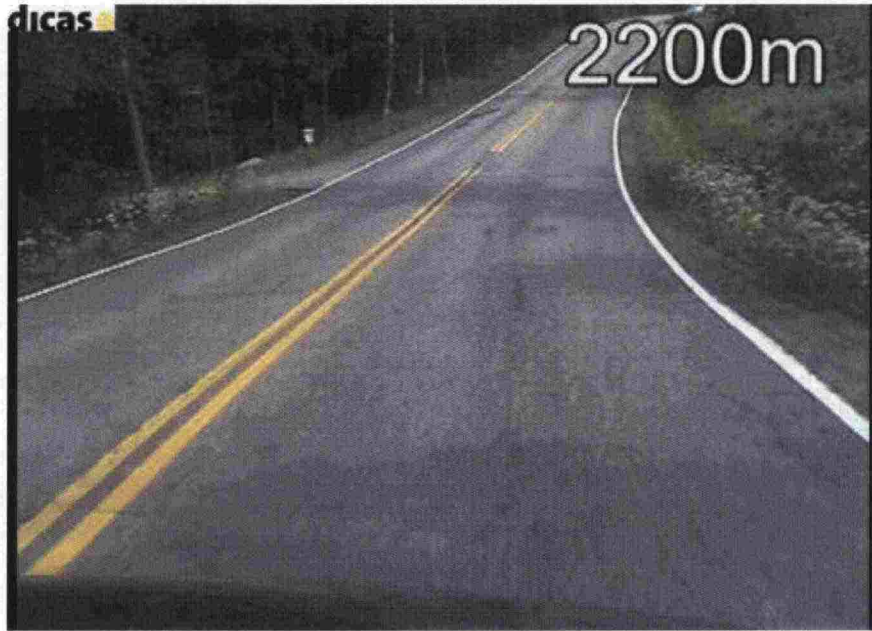
Several crack types:  
Alligator crackking  
Transversal Crack  
Centerline Cracks  
PVI: All detected, VS 11  
System1: Similar results with PVI  
System 2: Cracks were not detected

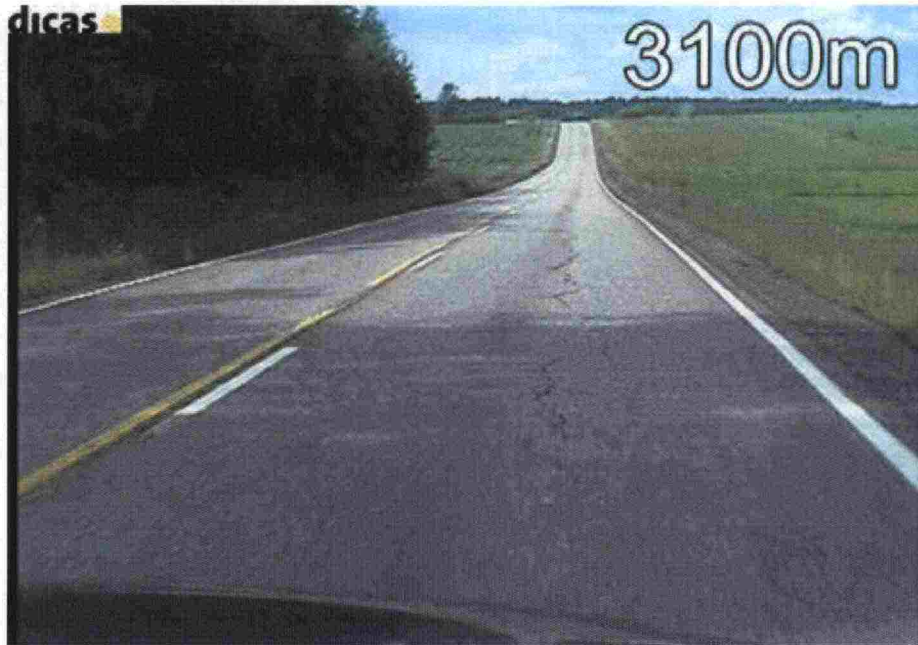
System1: Similar result with PVI

System 2: Similar result with PVI
