# Roundabouts and heavy vehicles

Finnra Reports  
13/2000

**RAHMAN, Hafizur, ELORANTA, Anu, ERNVALL, Timo: Roundabouts and heavy vehicles.** Helsinki 2000. Finnish National Road Administration (Finnra), Traffic and Road Engineering, Finnra reports 13/2000, 66 p. + apps. ISSN 0788-3722, ISBN 951-726-624-3, TIEL 3200602E

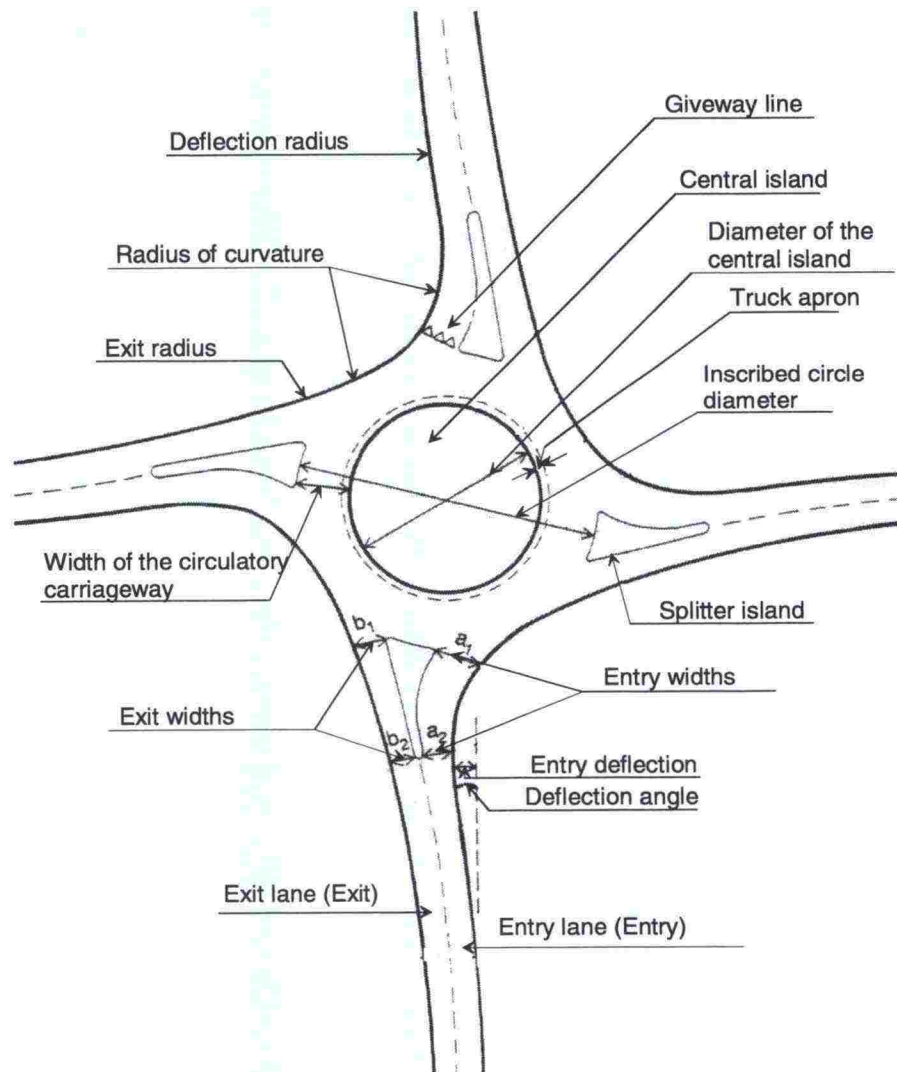
Figure 1: The basic design elements of a roundabout /2/.

**Central island:** Central island is a circular island in the middle of the roundabout and designed for not to drive-over. The radius varies according to the design parameters. The visibility of central-island is one of the significant factors in roundabout design.

**Entries and exits:** The width of the entry roadway is one of the most important factors in designing roundabout. The entry width depends on design vehicles and their speed. When the approaching speed is high, it is better to reduce traffic speed gradually by introducing a horizontal reverse curve. Reversed curves are not suitable, when they cause obstructions or reduce visibility of the central island. A larger radius of exit lane will provide easier acceleration.

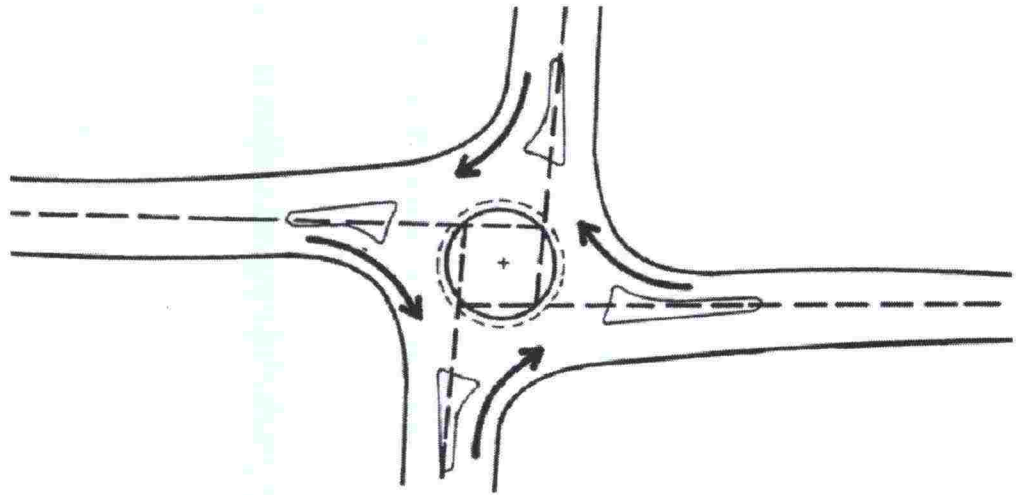
Figure 2: The staggering of a roundabout.

**Staggering at the entry:** The roundabout's entries ensure safety and adequate capacity /18/. It should be designed so that there is not possible to drive at high speed. Therefore the staggering is arranged at the entry lane, which will develop the perception of the junction and at the same time slow down the speed of vehicles /2/.

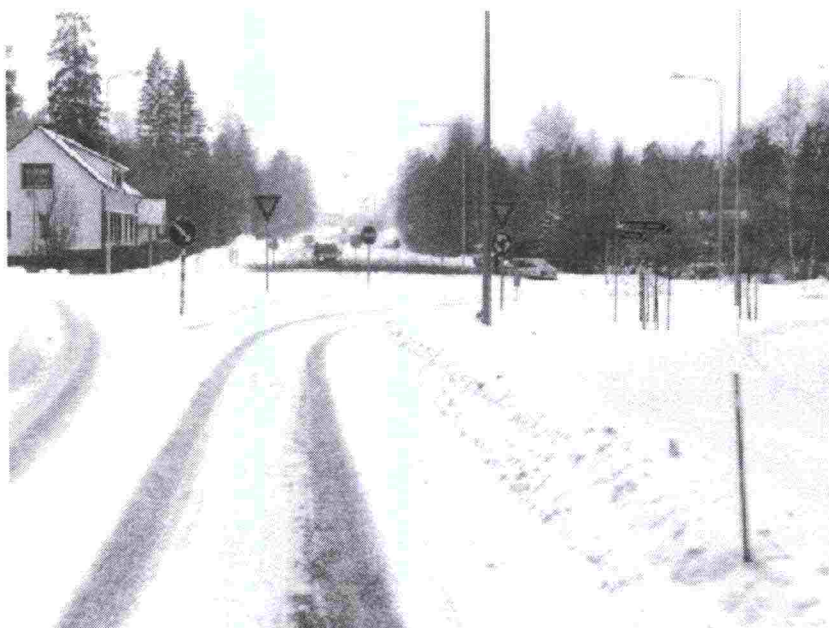
*Figure 11: The winter circumstances at the roundabout of Alasentie (Kangasala).*

At Kangasala there were two sites, one was at Valkeakoskentie and another was at Alasentie. On the both observed days in winter, the road surface was slippery because of hardened snow, which perhaps affected to the normal driving behaviour. For improving the service level at Valkeakoskentie the road surface was first plowed and then treated with salt and sand. But still for the slipperiness there were trouble at the circulatory carriageway, where the rear wheels skidded to the outer direction. In case of Alasentie, there was snowing all the time and no maintenance work had been done. For these circumstances, the conditions were weaker than that of Valkeakoskentie. On the both sites accumulated snow covered the truck apron, which was icy and made the vehicles skid outwards. Also it was very difficult to the drivers to locate the kerb of the central island. *Figure 11* shows the circumstances in winter at the roundabout of Alasentie. In summer no environmental effects were observed in both intersections.

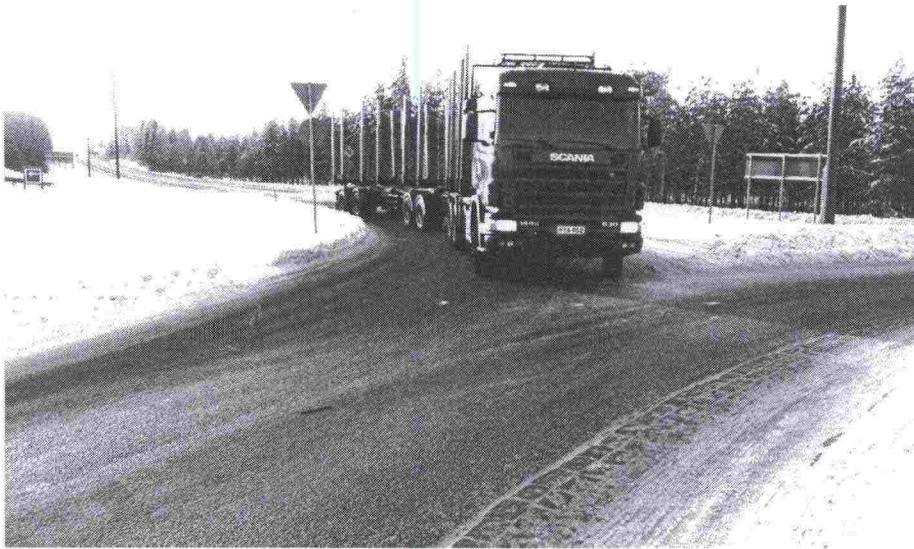
*Figure 12: The winter circumstances at the roundabout of Hämeenkyrö-2 (Esso).*

At Hämeenkyrö-2, there was snowing gently and the road surface covered by snow. Maintenance work has been done at about 11:00 and 12:30 PM. But still the worst part of the roundabout was the truck apron. *Figure 12* shows the winter circumstances at the roundabout of Hämeenkyrö-2.

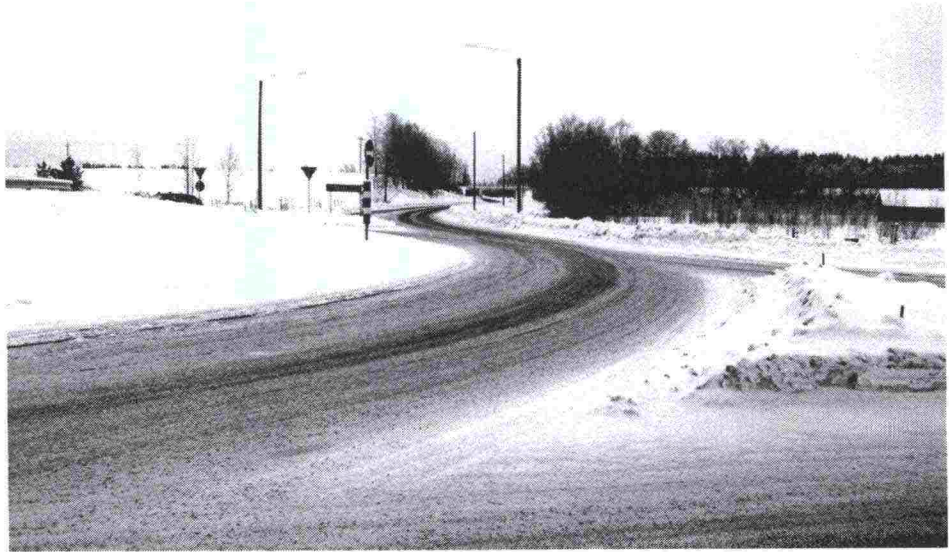
*Figure 13: The winter circumstances at the roundabout of Jämsä.*

The road surface was slippery for hardened snow and also there was snowing gently all the time when the observation was performed in winter. To increase the service level the road surface was treated with salt and sand. But still for the slipperiness, there were troubles at the circulatory carriageway, where the rear wheels skidded towards the outer direction. Accumulated snow covered the central island's kerb and the truck-apron. The worst part was the area, which covered the distance of 0.5 meter from the kerb to the outer direction of the central island. Also the drivers had difficulties to detect the kerb of the central island. No environmental effect observed in summer though the day was lightly cloudy. The winter circumstance at Jämsä is shown in the *Figure 13*.

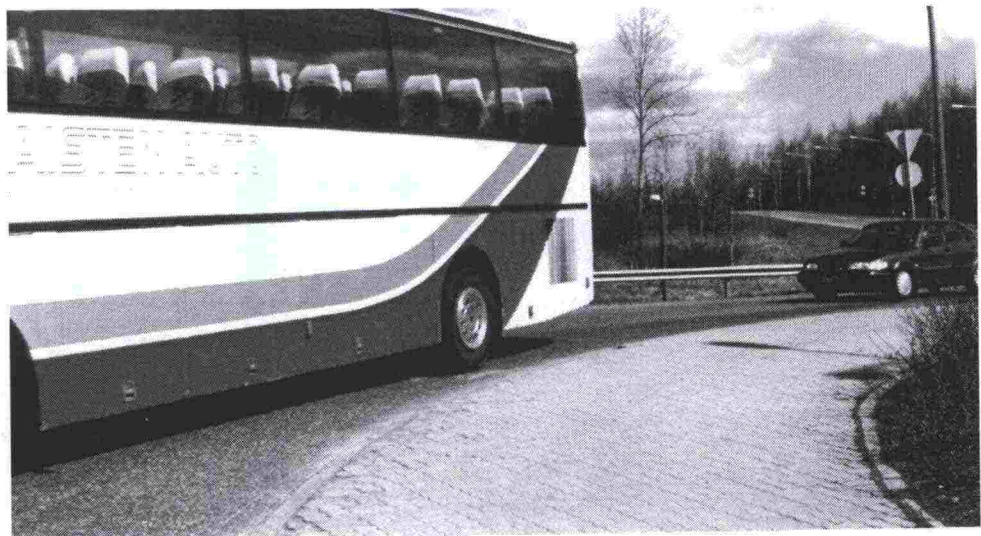
*Figure 17: Truck apron structure at the roundabout of Hämeenlinna.*

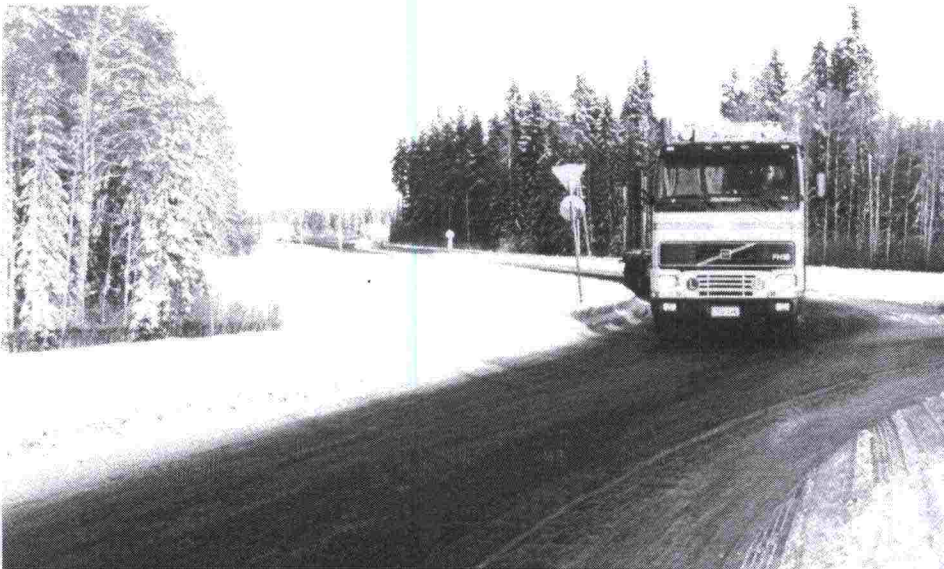
*Figure 18: The entry of a Category 2 vehicle into the roundabout of Hämeenkyrö-1 (Härkikuja).*

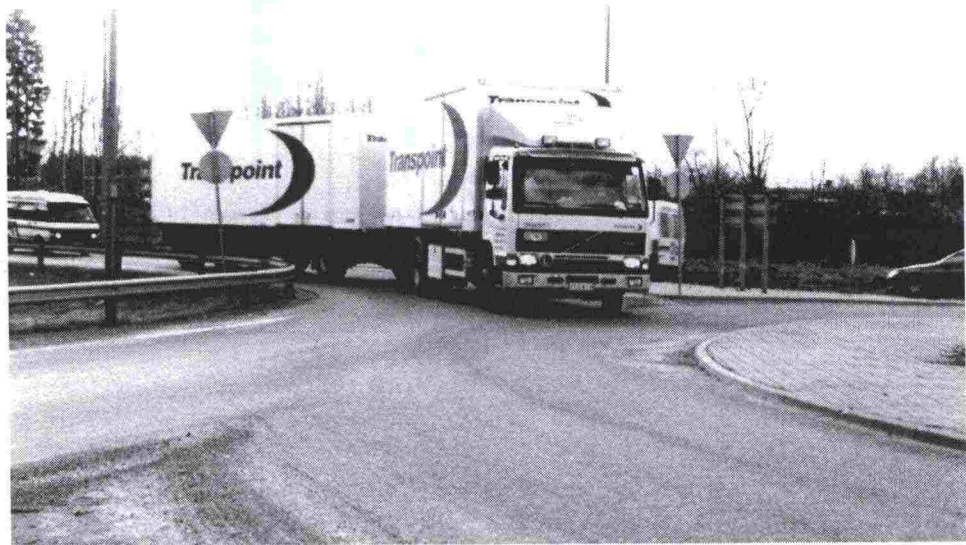
*Figure 19: The entry of a Category 2 vehicle into the roundabout of Hämeenlinna.*

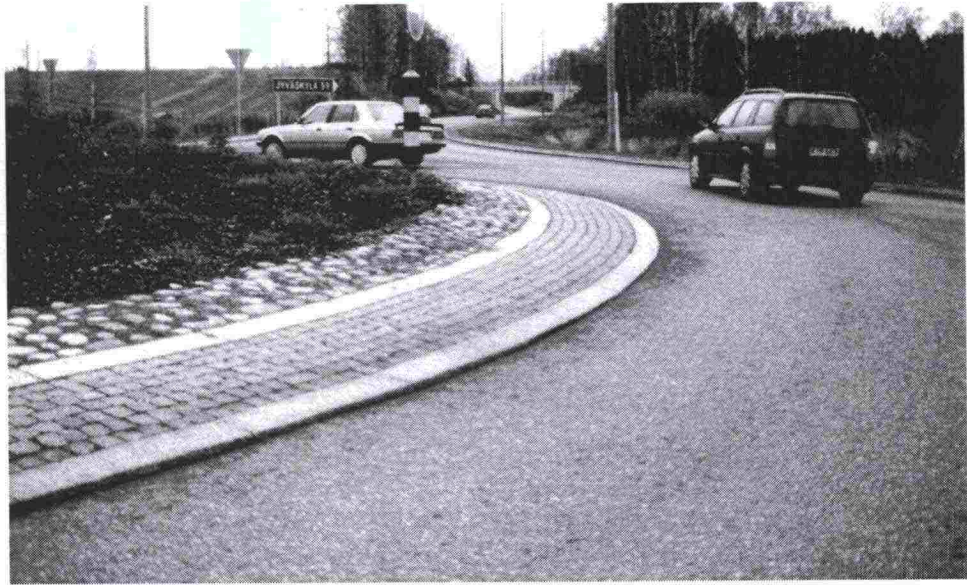
Figure 21: The truck apron structure at the Jämsä roundabout.

At the roundabouts studied the increased deflection of vehicle paths tended to reduce speeds though the diameter of the central island was larger. Vehicle paths were closer to the central island in summer at the Kangasala and Hämeenkyrö roundabouts. The paths were furthest from the central island at the Jämsä roundabout, but the speeds at the circulatory carriageway were lower; the truck apron was a factor in this. At Jämsä the kerb of the truck apron structure was about 5 centimetres high, making it inconvenient to drive over it. Vehicles were driven as near the truck apron as possible to pass through the roundabout. The truck apron structures of the roundabouts at Kaustinen and Kangasala (Alasentie) were similar. Though the kerb of the truck apron at Kaustinen was at a slight angle, no one drove over it because it was still raised too much from the road surface. At Alasentie some drivers did drive over the truck apron because the circulatory carriageway is narrower and the path curvature smaller. *Figures 21 and 22* show the structure of the truck apron at the Jämsä and Kaustinen roundabouts.

1. At the Hämeenlinna, Kangasala, Kaustinen and Jämsä roundabouts the truck apron is not useable enough. The stones set in the truck apron at Kangasala and Kaustinen could be replaced with other a rough surface treatment. This would help vehicles to drive over them more comfortably and at the same time decrease the chance of car drivers using them. The slope of the truck apron could be steeper than that of the road. It would be best to design truck aprons without using high kerbing. *Figure 23* shows a successful truck apron structure at Hämeenkyrö. Two other examples of successful truck apron structures, from Denmark, are presented in *Figure 24*.

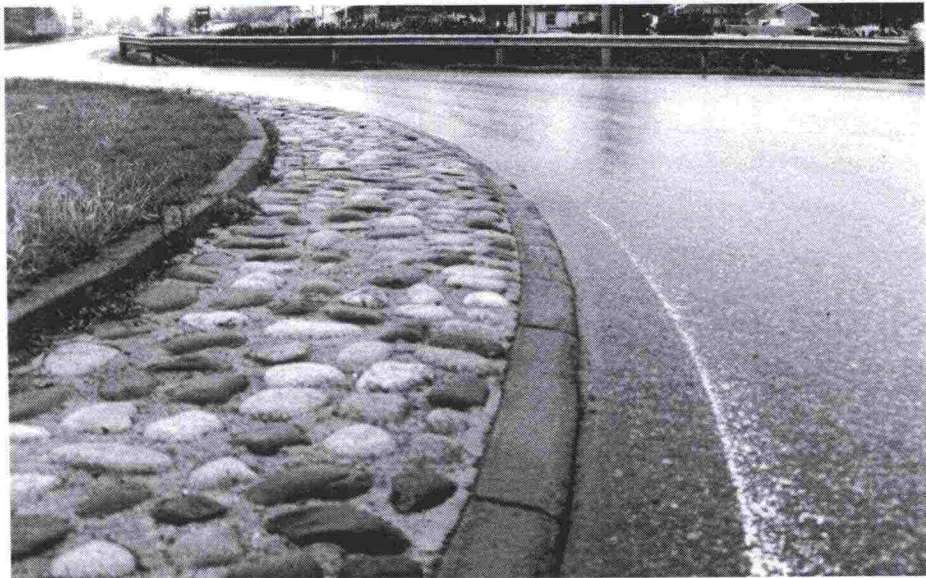
Figure 22: The truck apron structure at the Kaustinen roundabout.

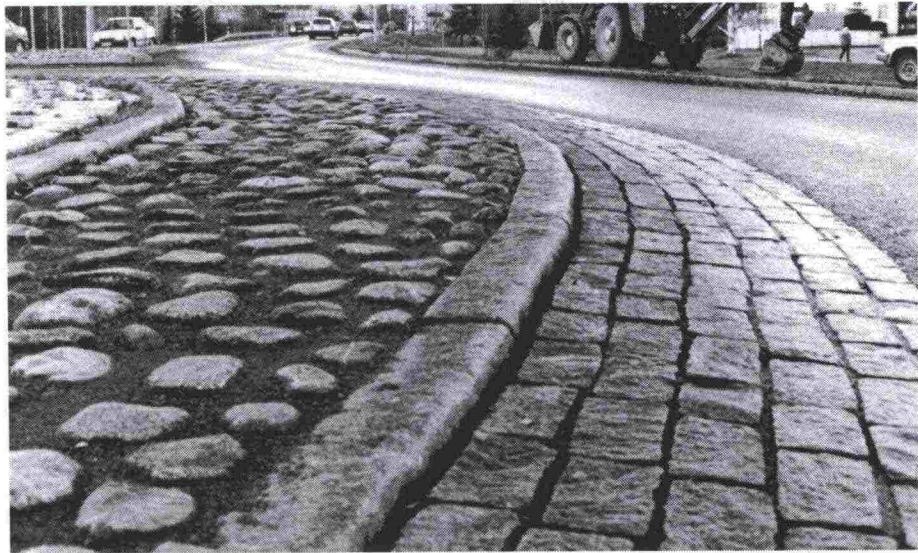
Figure 23: Truck apron structure at the Hämeenkyrö roundabout.

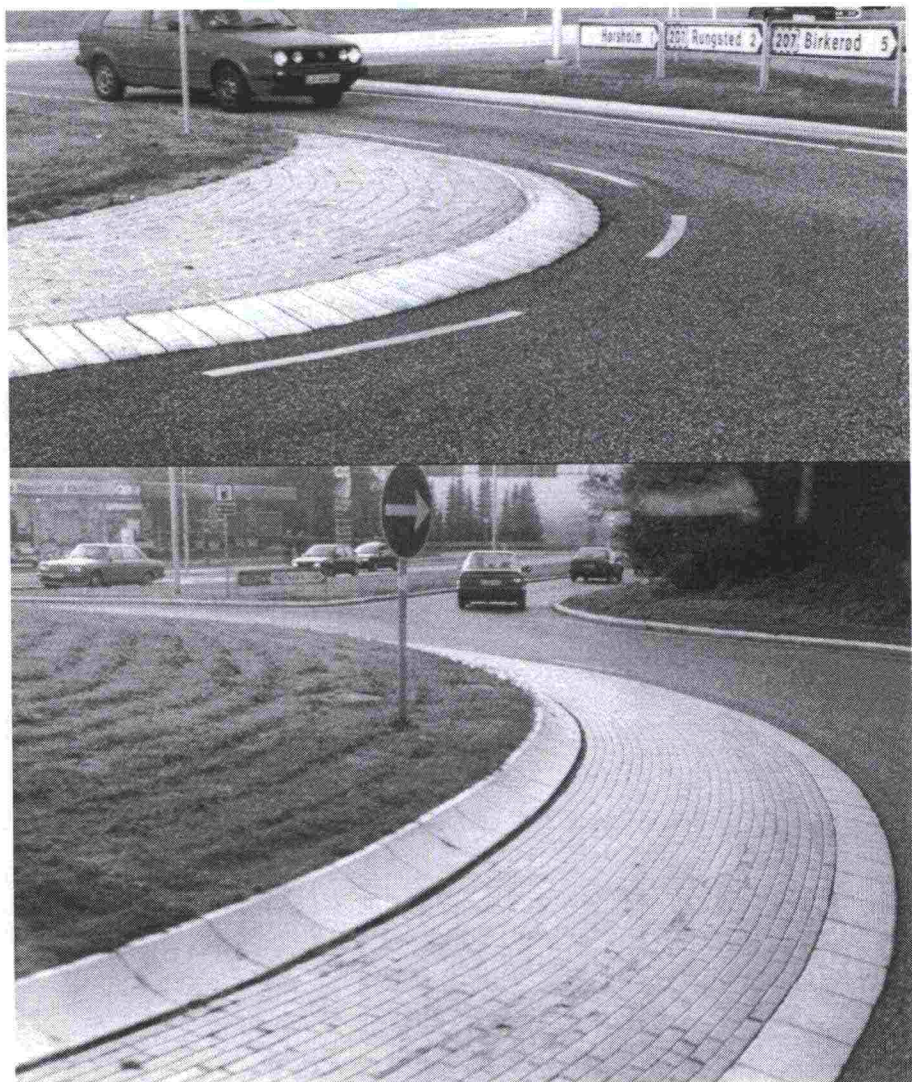
Figure 24: Truck apron structures used in Danish roundabouts.

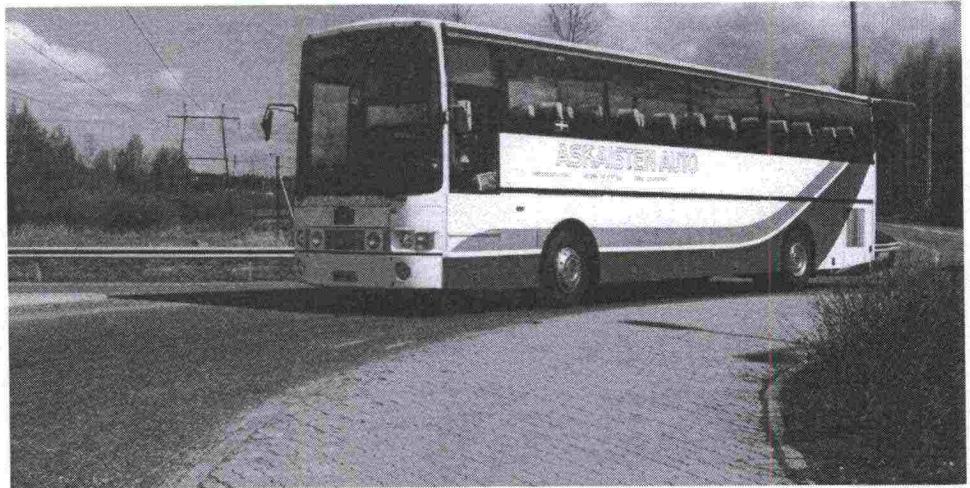
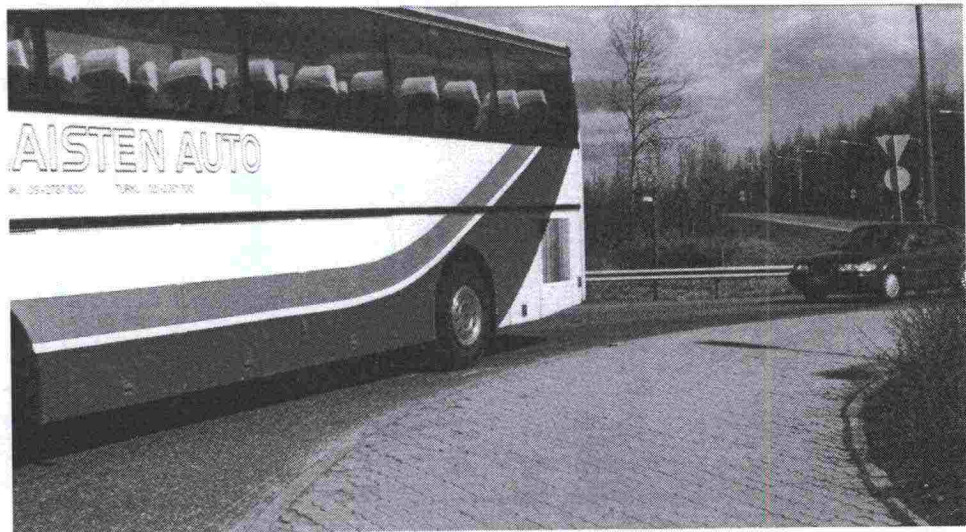
## A TYPICAL VEHICLE PATH AT THE HÄMEENLINNA ROUNDBABOUT

*Figure: A typical vehicle path from the Hämeenlinna roundabout. The path was straight through the roundabout.*
